# Survey Report

Rochester Pier, Medway Towns

Condition of jetty structure, pontoon and Brows

## Introduction

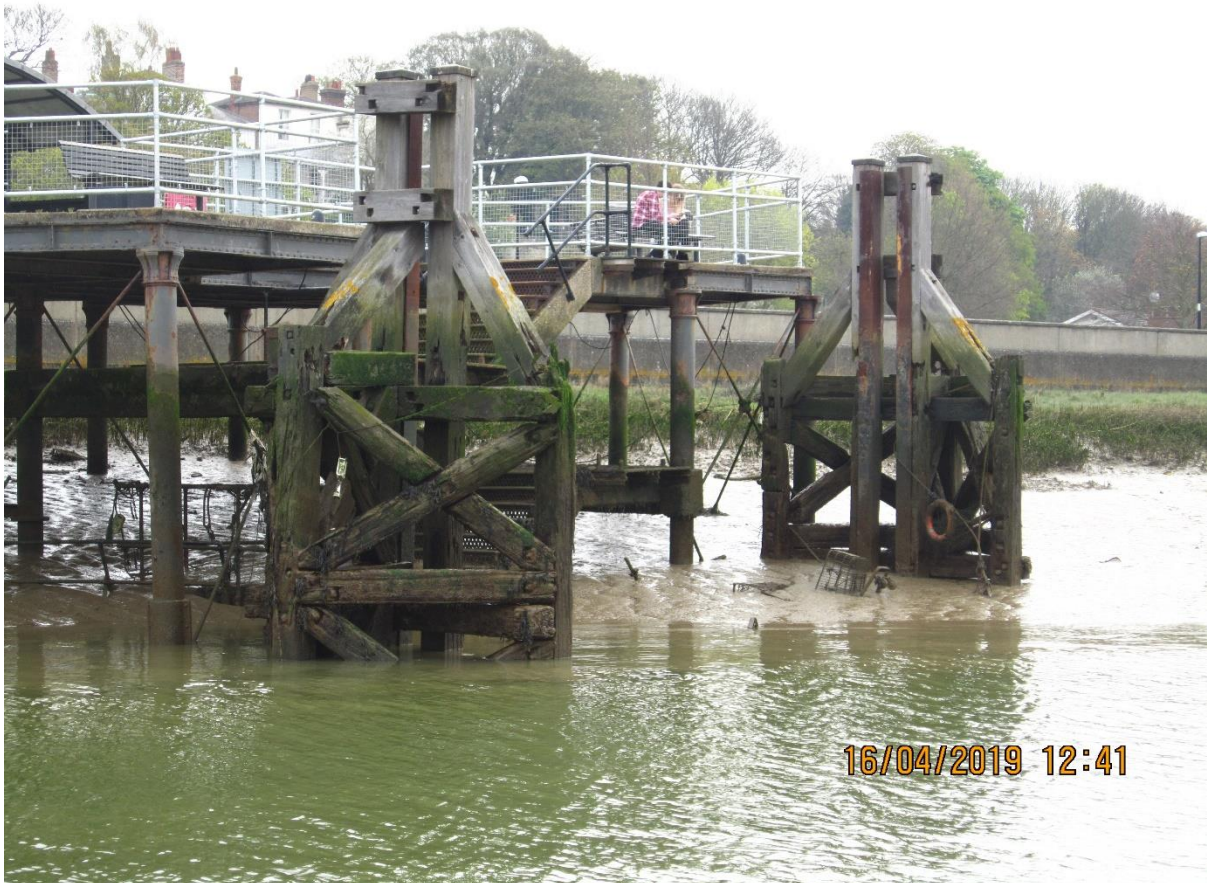
The two redundant timber dolphins at the front of the “T” head are rotten and of no use. In the near future these will start to fall apart and large chunks of timber will float off down river, with the possibility of damage to river craft and structures.

We would recommend the removal of the top sections (above higher horizontal bracing) as very urgent and the remainder within ten years. The top section is made up of Douglas fir and will float. As the river is very densely leisure craft, impact with this could be catastrophic.

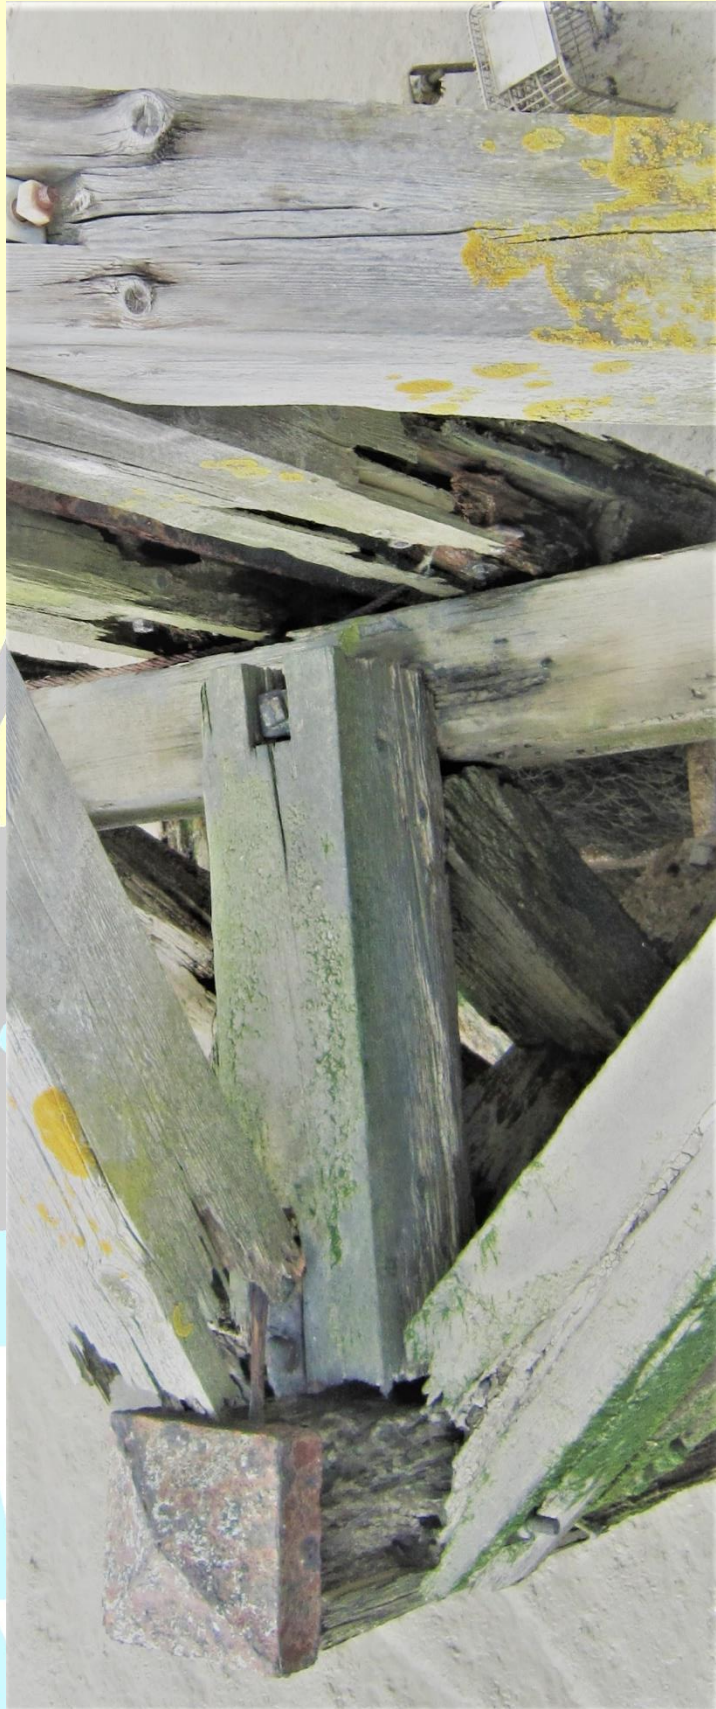
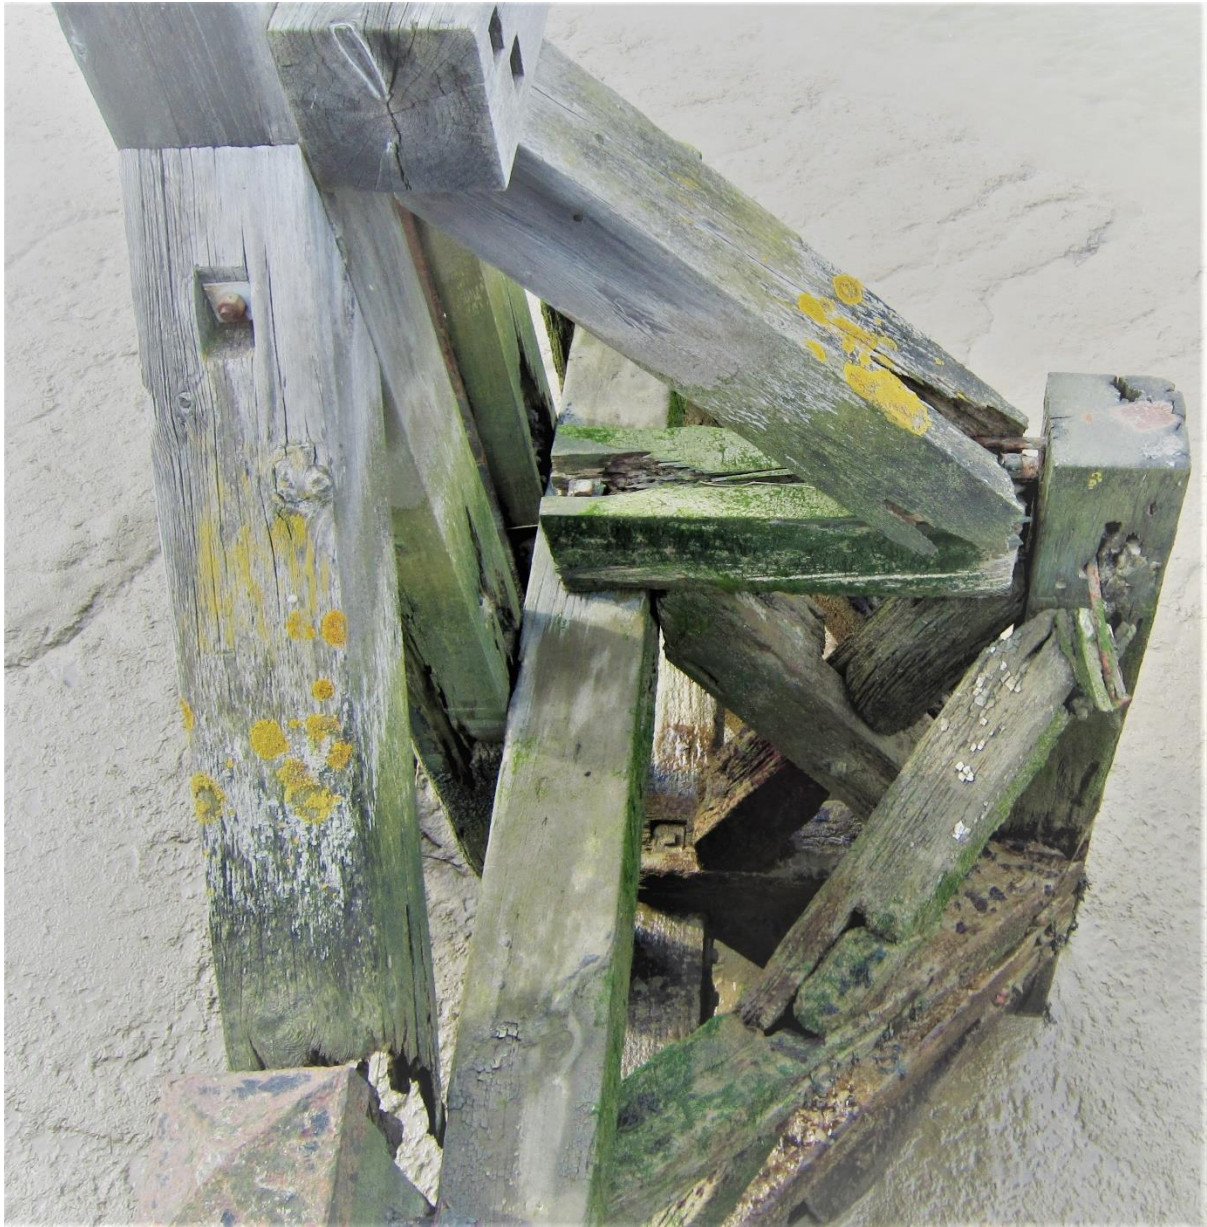
There, is very little holding the top section together.

With the deterioration in the last three years, we are surprised that there are not more timbers missing.

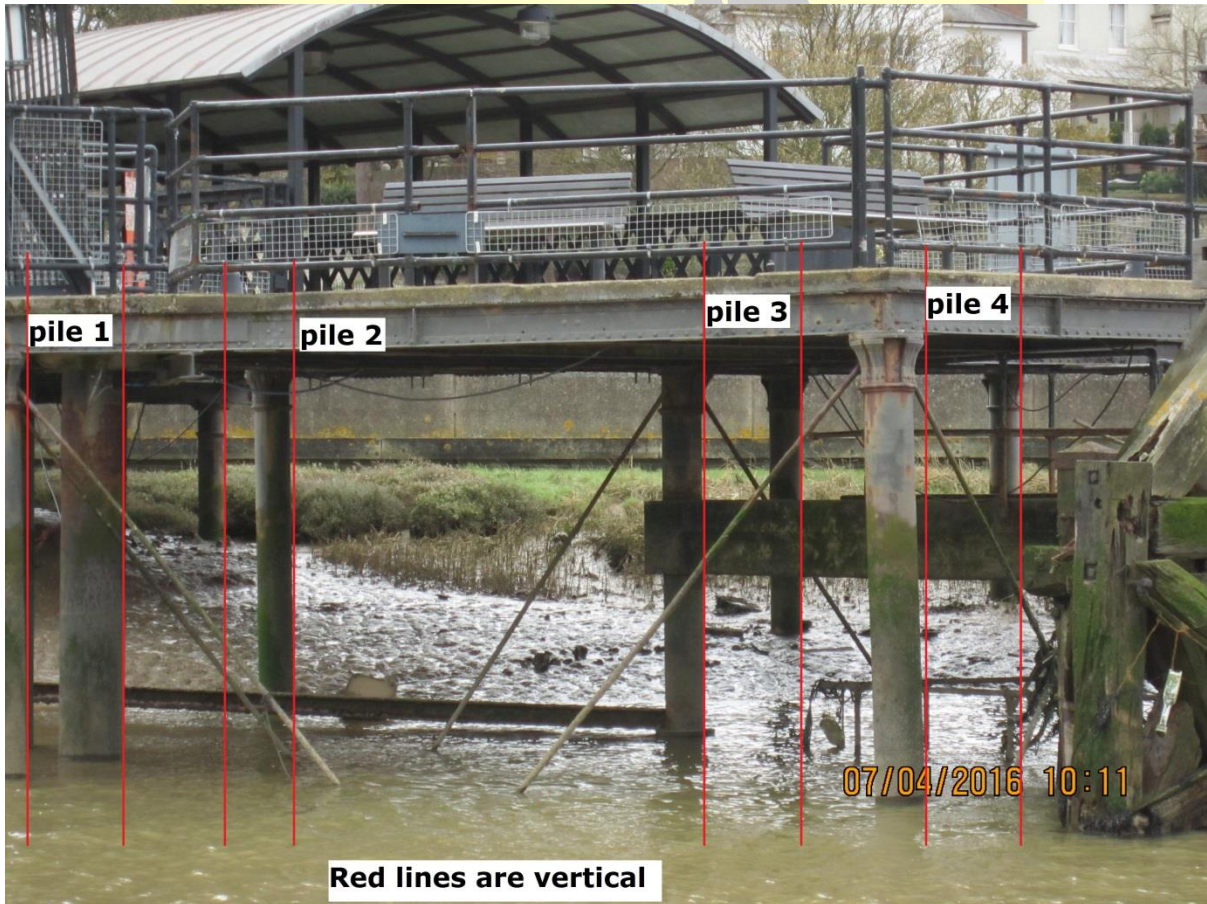
There are four of the cast piles on the down river end that have at some time in the past moved and are not vertical. Pile 1 and 4 are worst.

We would support historic movement theory, as no further movement was noted.

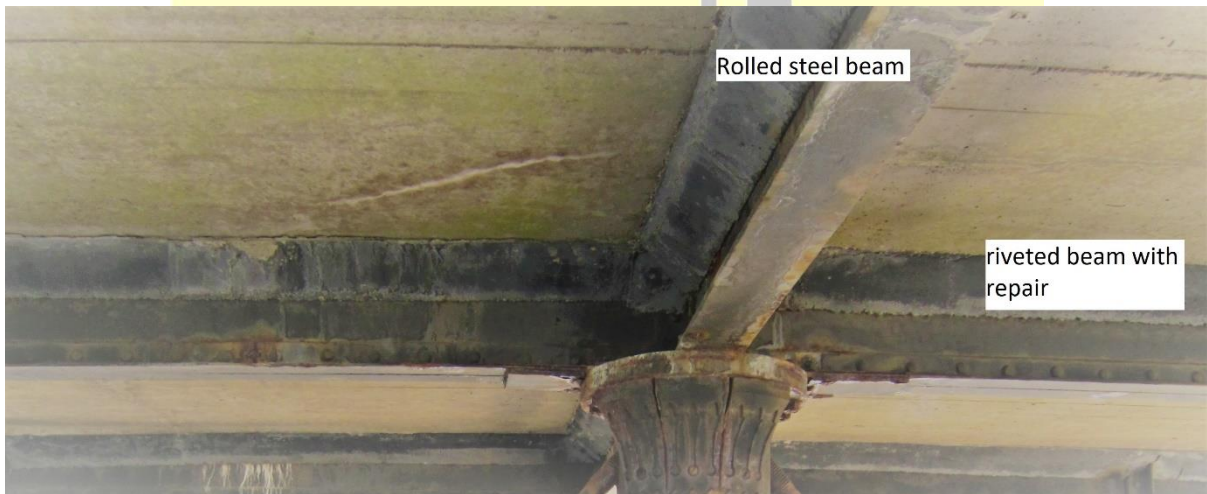
The riveted beams have had welded plate repairs done to the ends as they go on to piles and the top flanges covered in concrete to protect and strengthen corrosion in the past. The repairs have seen better times and are covering up continuing corrosion. The concrete coving and plate repairs are wide spread. Corrosion continues at normal rates.

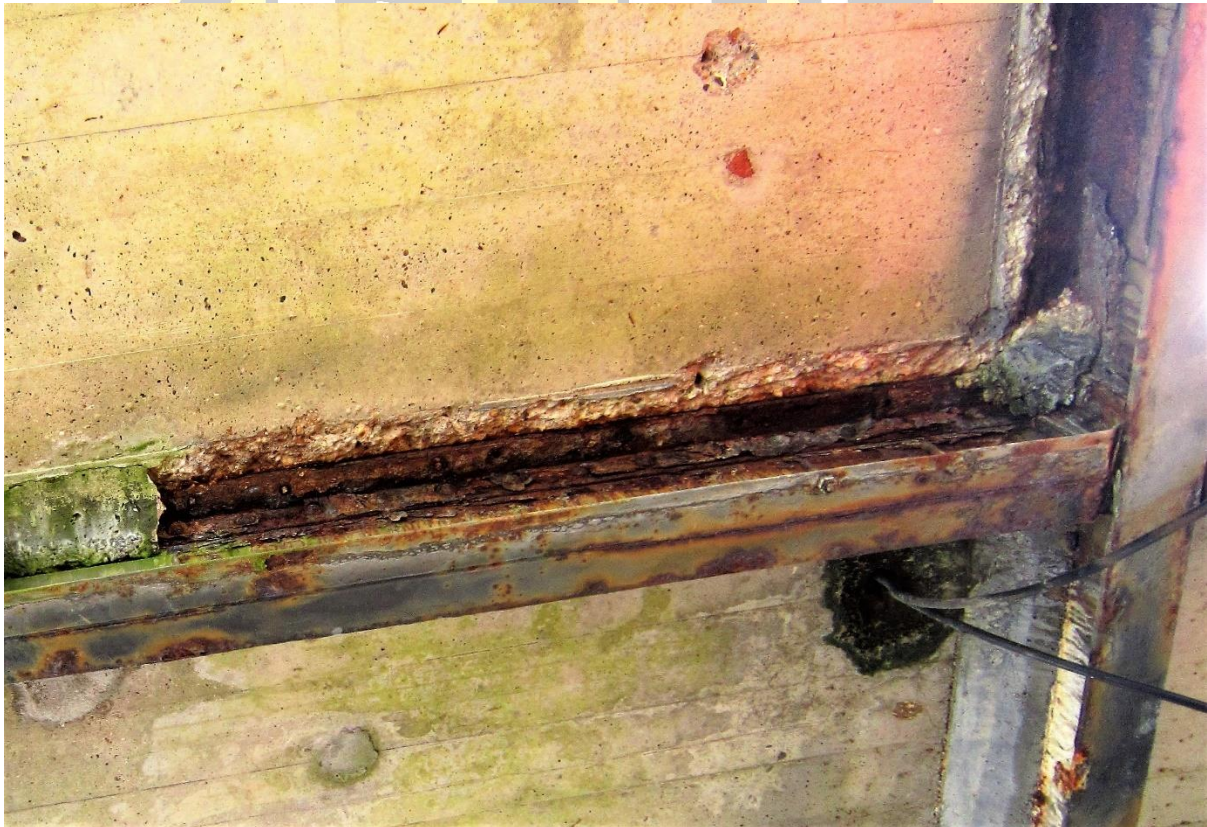
Note corrosion under coving where corrosion has blown coving. This is likely to be similar under majority of coving.

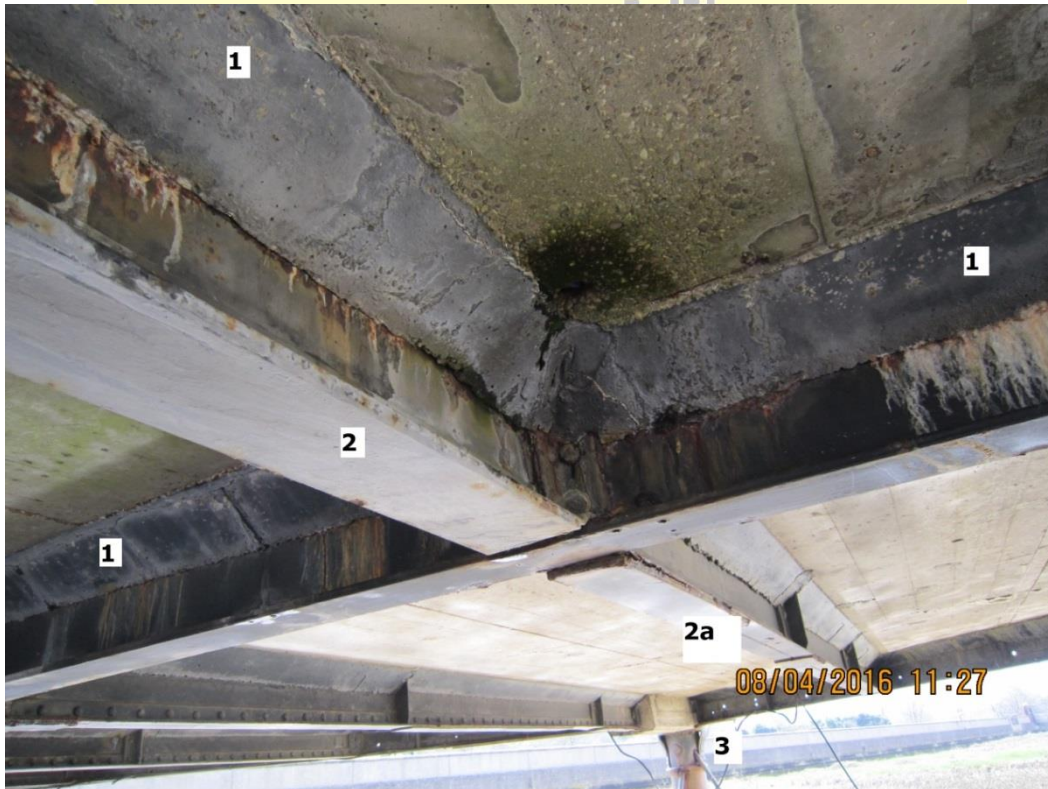
- 1 Concrete coving that has blown due to water ingress, original corrosion, continues and rust is pushing concrete away. Staining running down web of beams shows rust, alkali leaching and water ingress.
- 2 Welded plates to strengthen corroded flanges, showing rust marks and staining.
- 2a Welded plate strengthening has split welds and is corroding between flange and plate, this undermines strength.
- 3 Beam boxed in with concrete, welded plate repair to flange was carried out first and boxed in. the corrosion has blown the concrete see picture below.

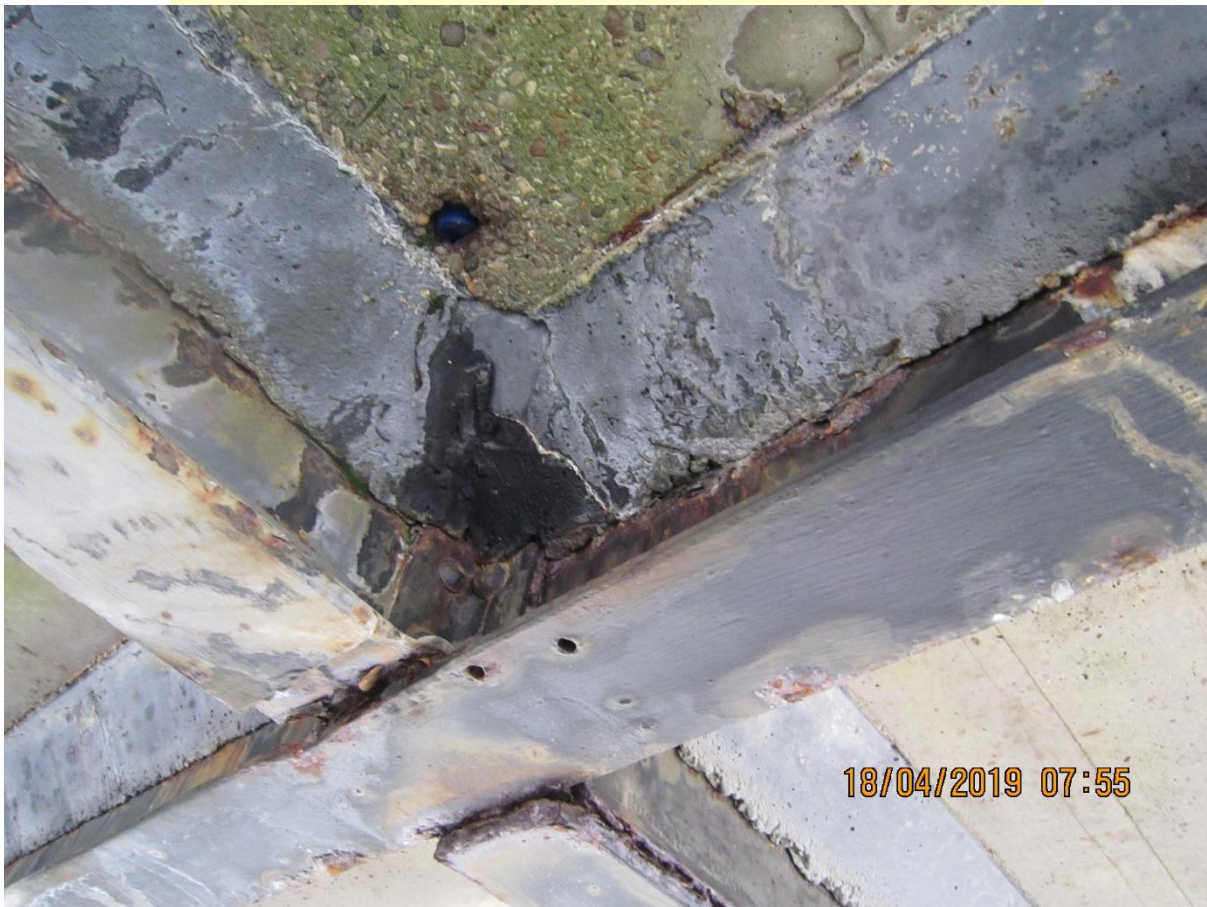
Photo from 2019 of same area. Corrosion continuing and repairs are becoming redundant.

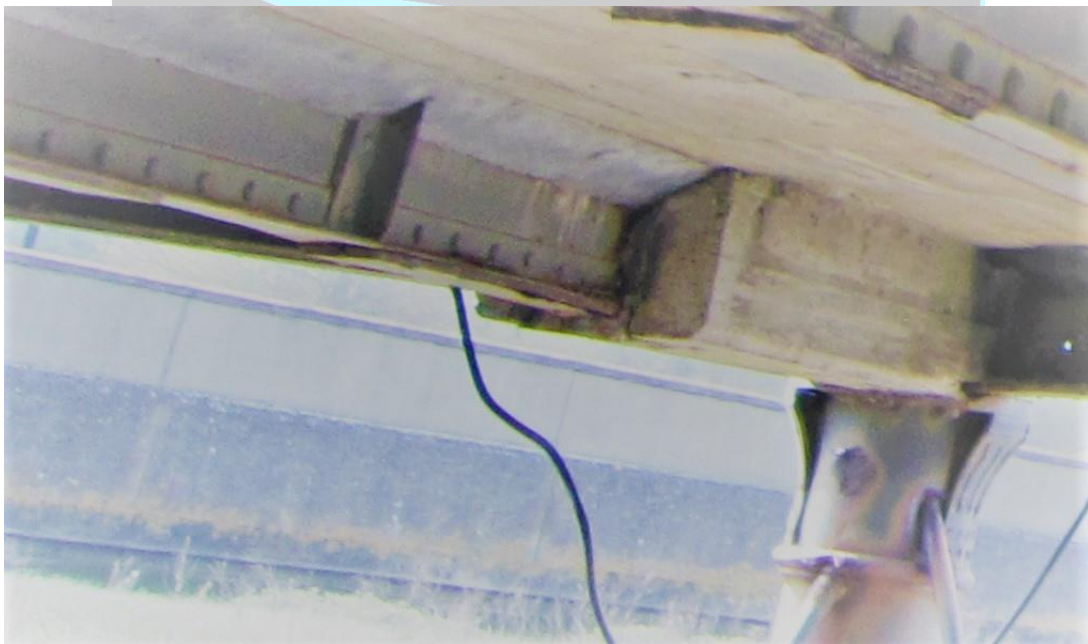
2019 photo blown concrete patch crack has expanded and will eventually fall away.

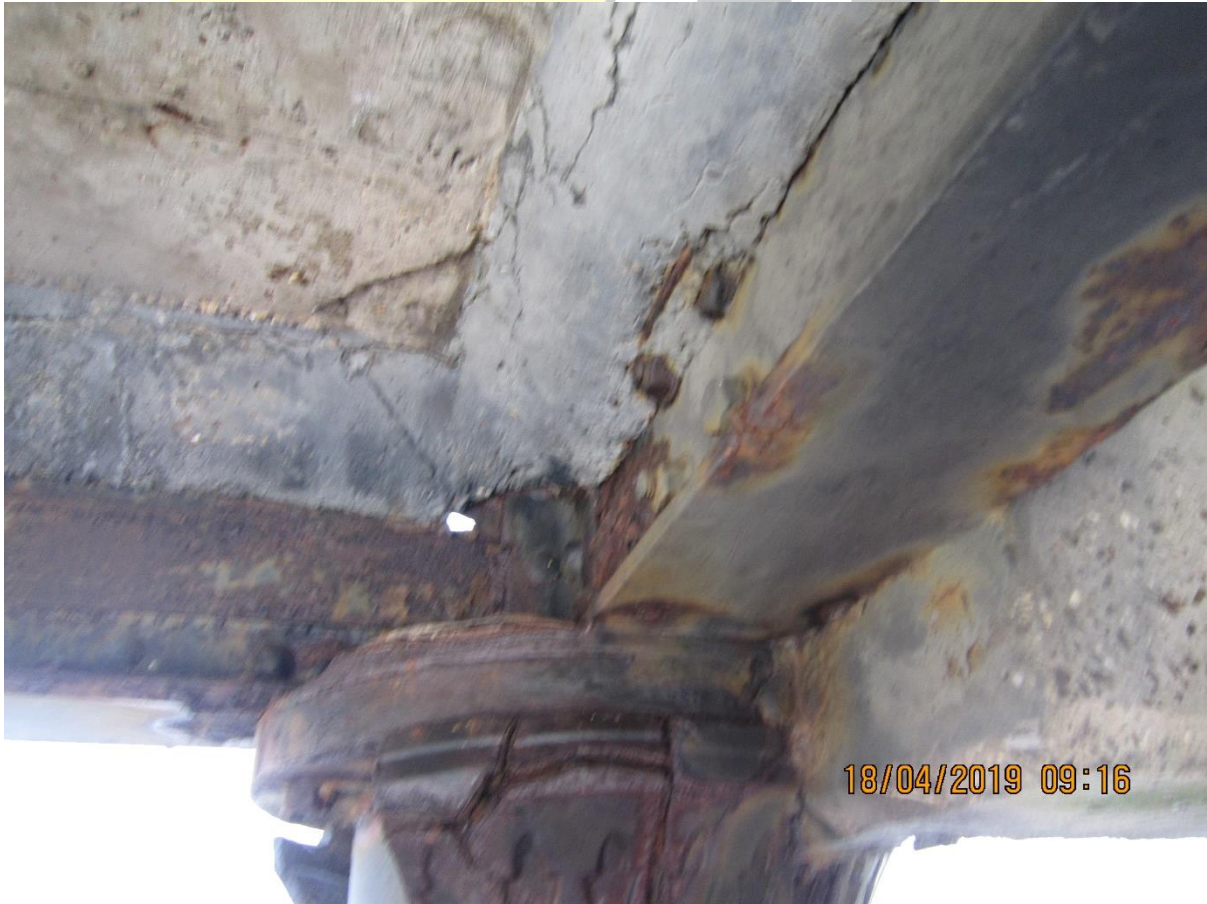
The following photograph shows all forms of the above corrosion and a hole in the web.

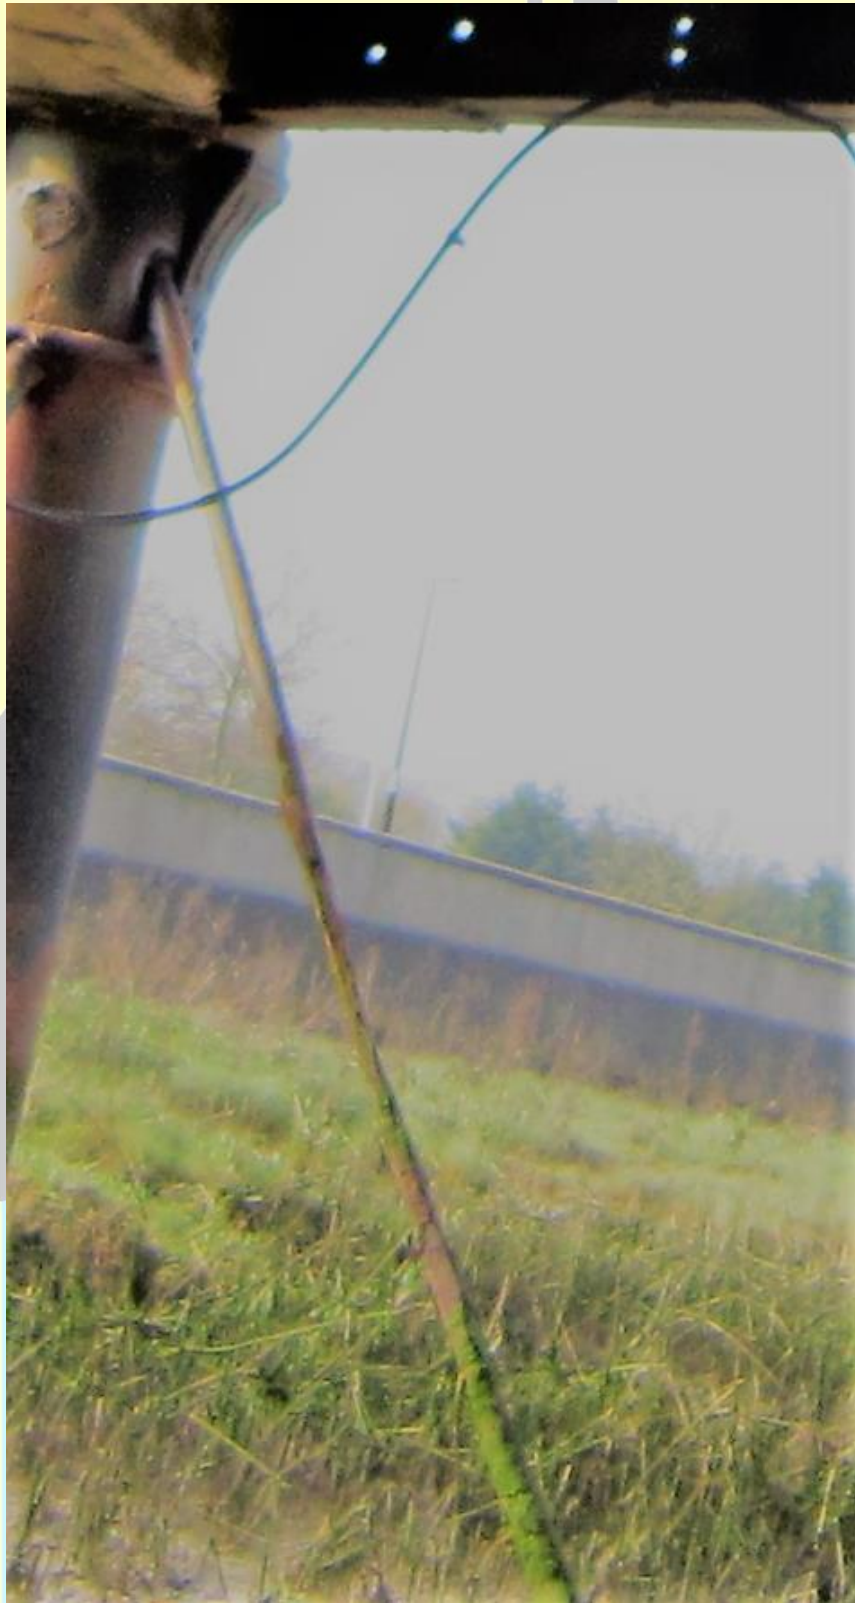
The cross-bracing ties between piles are approx. 38mm diameter, 35/45% are between 35/50% wasted and require maintenance. 20% would normally be the safety factor.

This one is nearer 70% wasted.

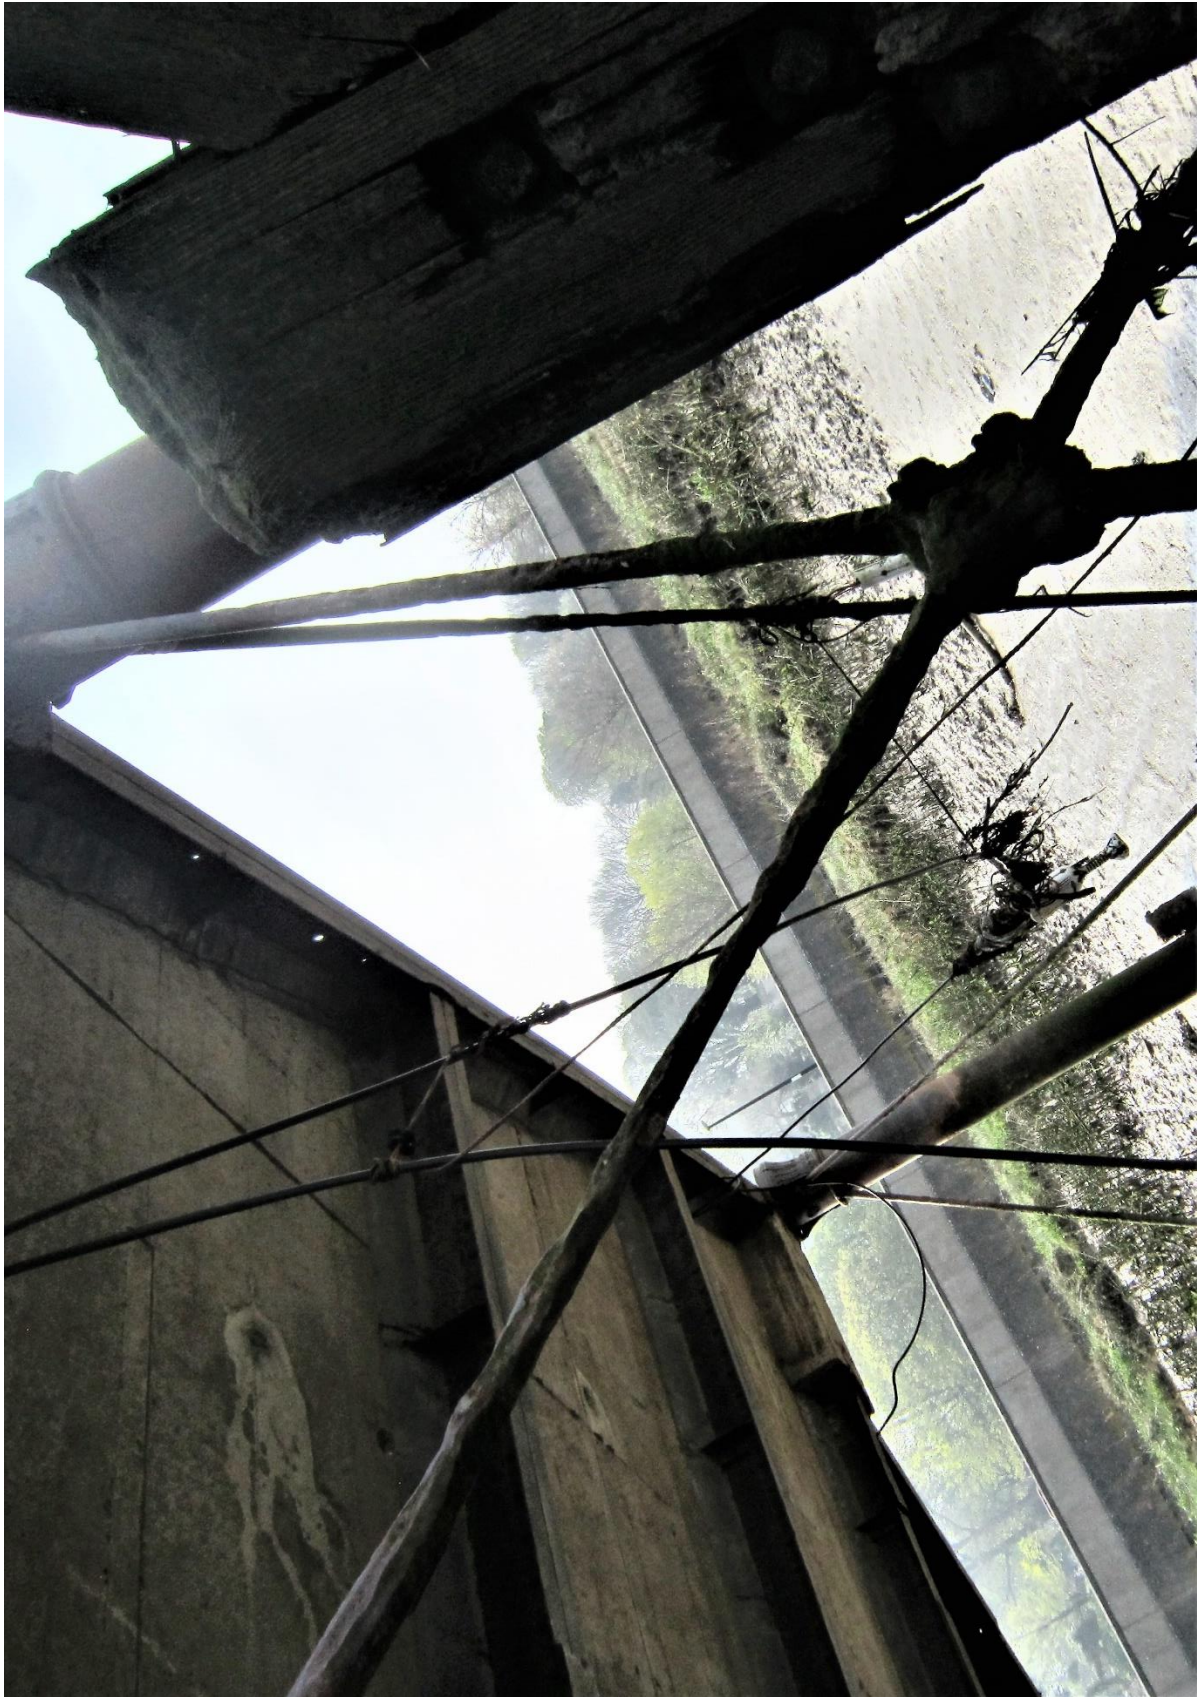
These two are 25% and 60% wasted.

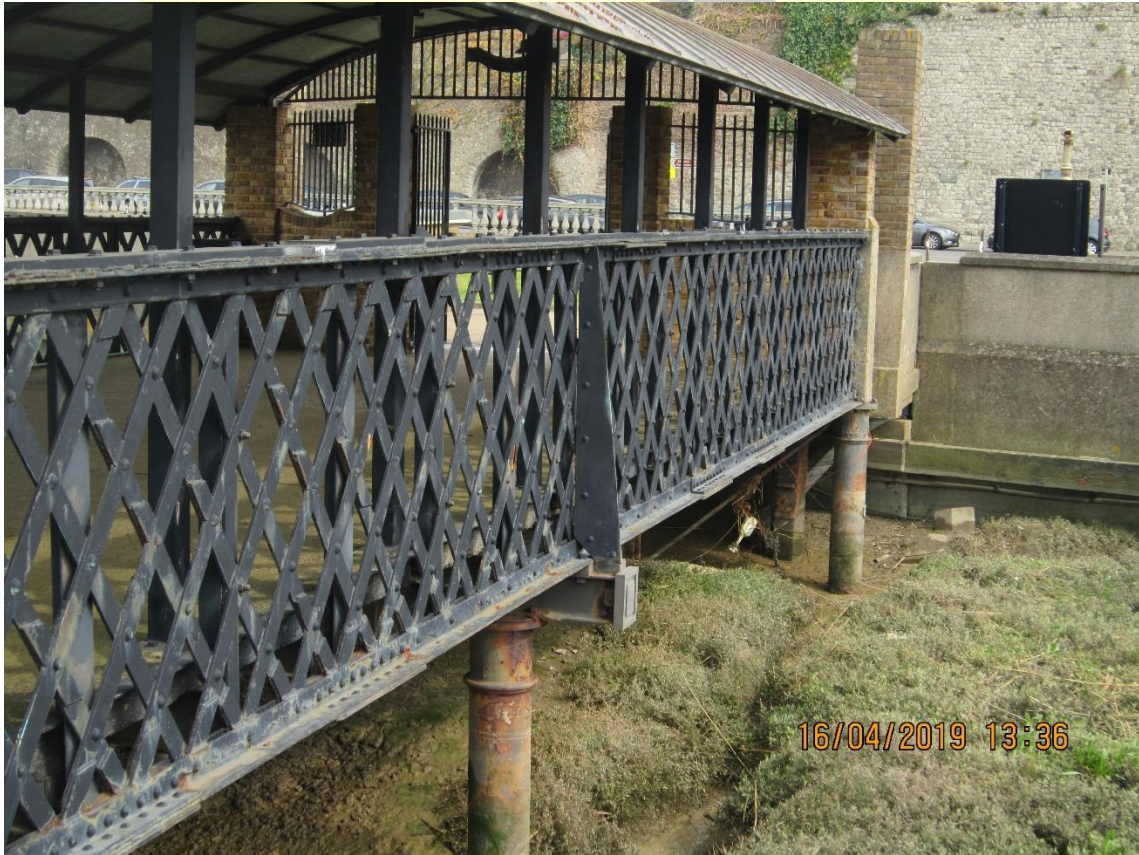
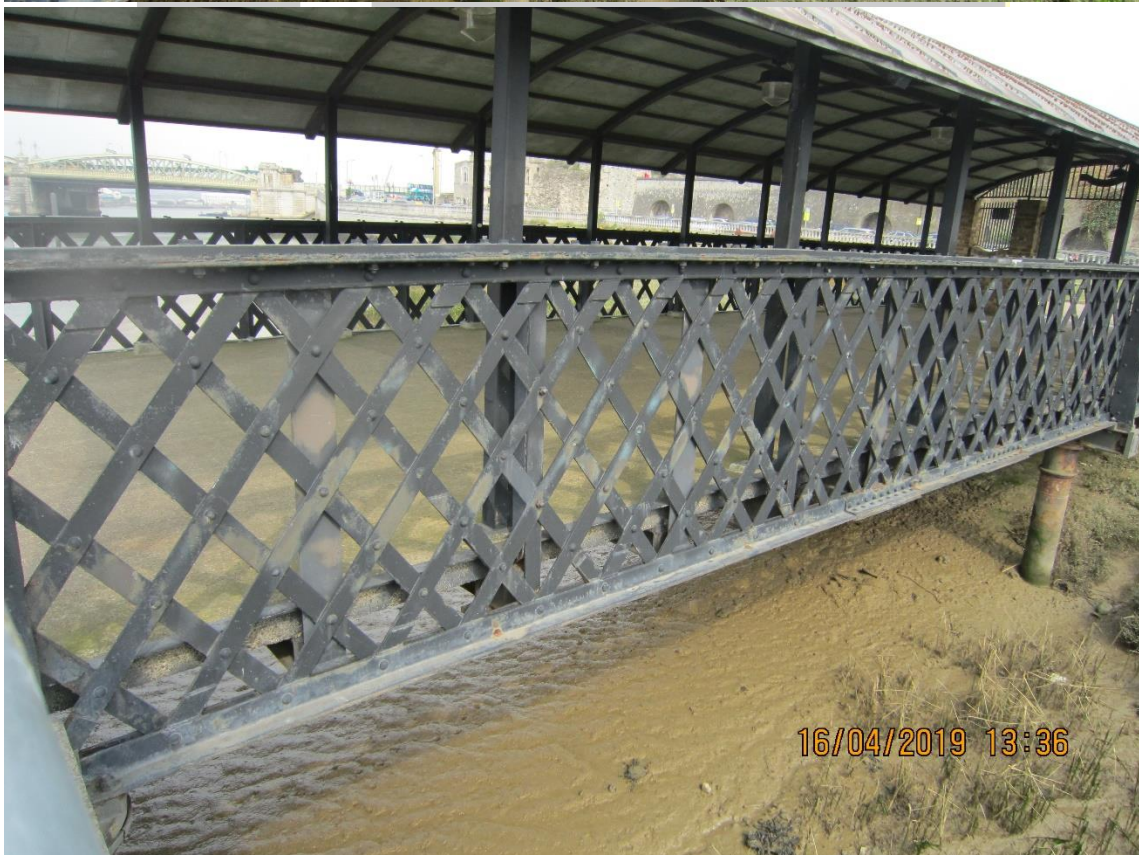
The approach handrails are generally in good condition. However, they require protective coating maintenance.

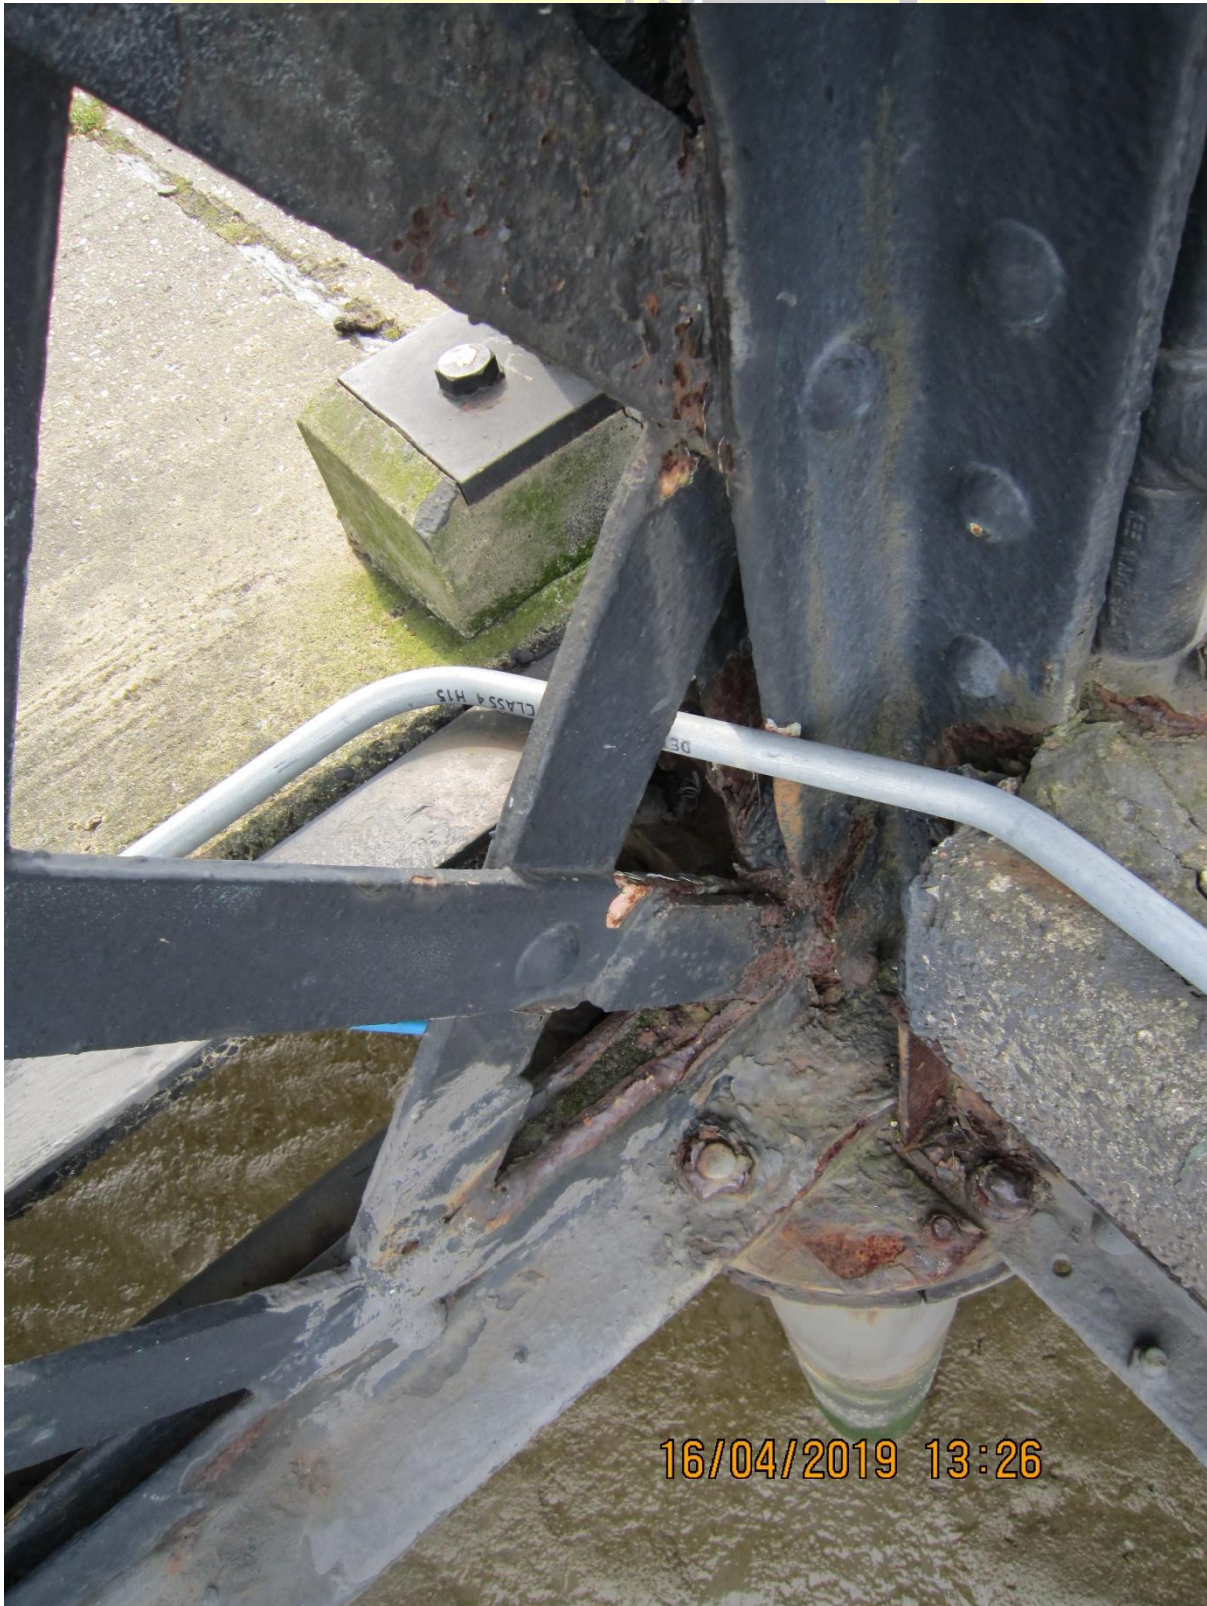
However, more attention and further investigation of areas where bridge is supported is required. These areas are crevice traps and accelerate corrosion, as they hold dirt and moisture with good supply of oxygen. They are also the prime load bearing points. Remedial repairs to steel in these areas is expected.

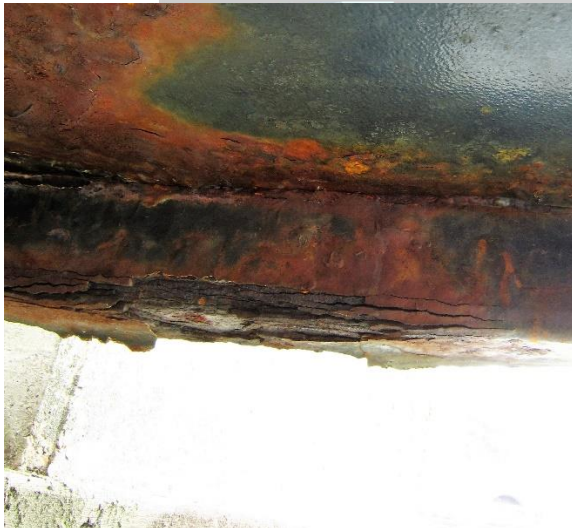
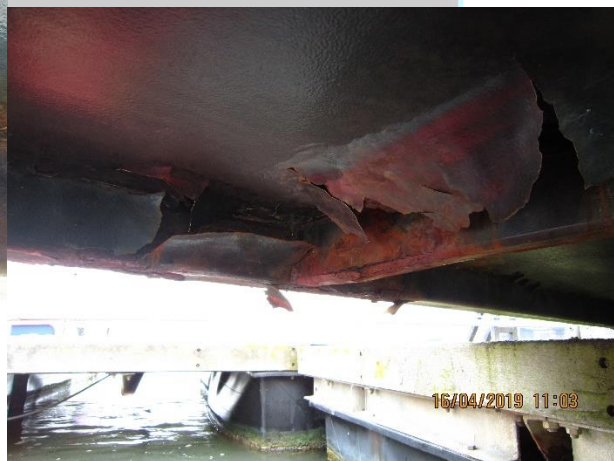
There are numerous areas where the paint has lifted and corrosion taken place. The majority of the corrosion is surface corrosion but there are 9No. Areas that are between 25/40% wasted.

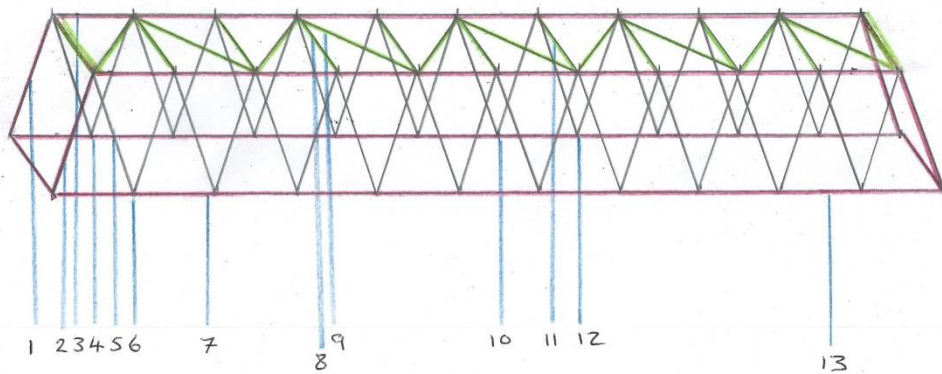
FIG.1.

- Item 1. Thickness taken through paint 8.3mm 100 x 100 x 8mm RHS
- Item 2. Paint lifted and thickness taken 7.5mm 100 x 100 x 8mm RHS
- Item 3. Top stringer outside radius of box 6.4mm 100 x 100 x 8mm RHS
- Item 4. Bottom stringer thickness 5.6mm 100 x 100 x 8mm RHS

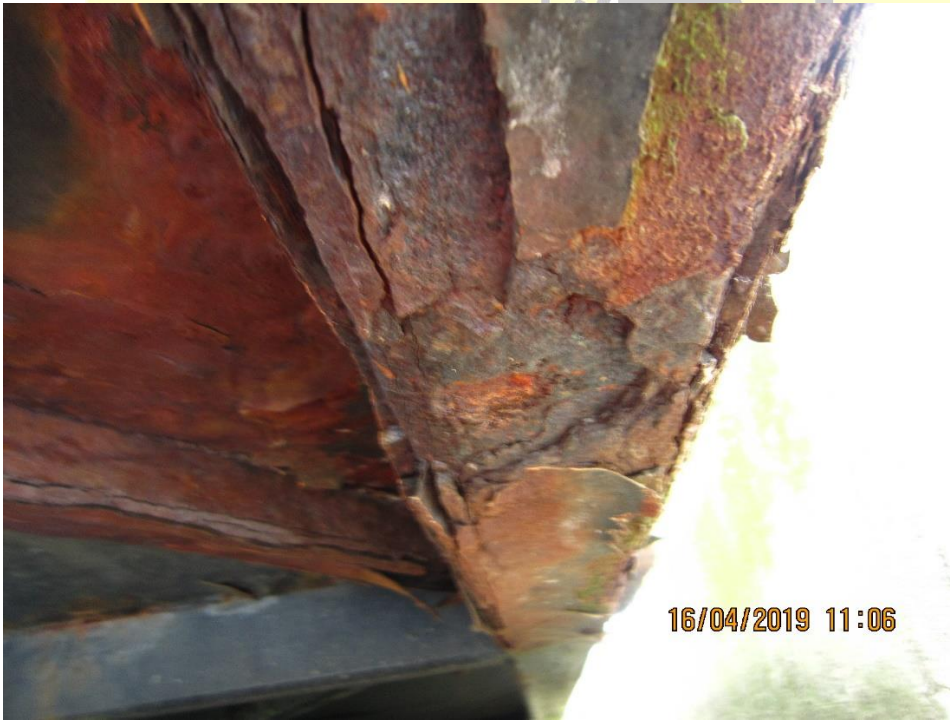
item 4.

- Item 5. Thickness through paint 6.7mm 100 x 50 x 6mm
- Item 6. Bottom stringer thickness 6.1mm 100 x 100 x 8mm RHS

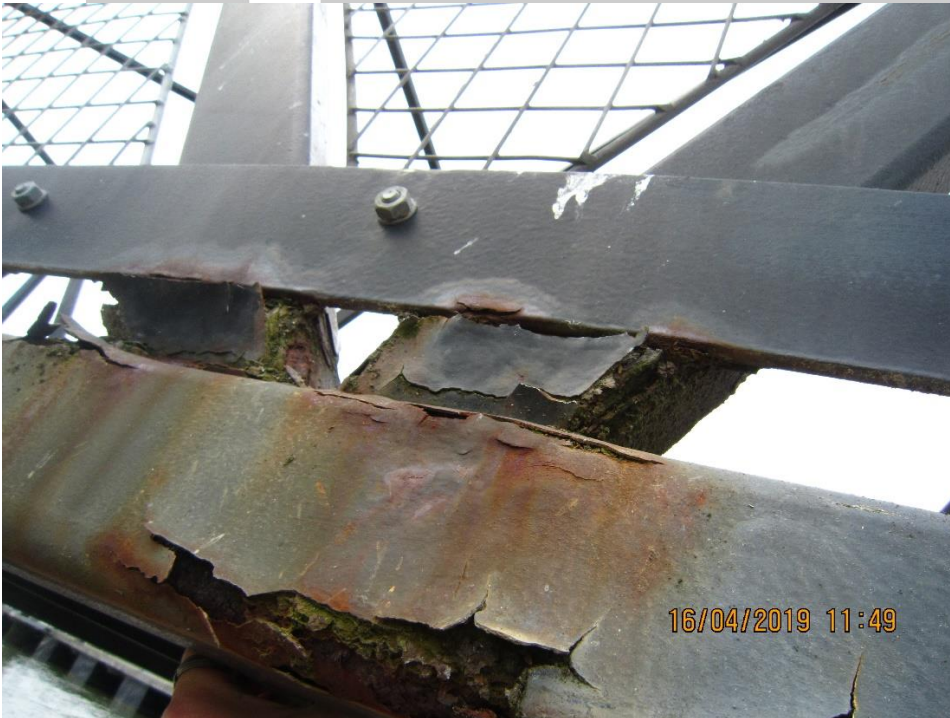
item 7.

- Item 7. Bottom stringer thickness 5.6mm 100 x 100 x 8mm RHS
- Item 8. Perpendicular tie thickness through paint 5.6mm
- Item 9. Diagonal tie thickness 4.0mm

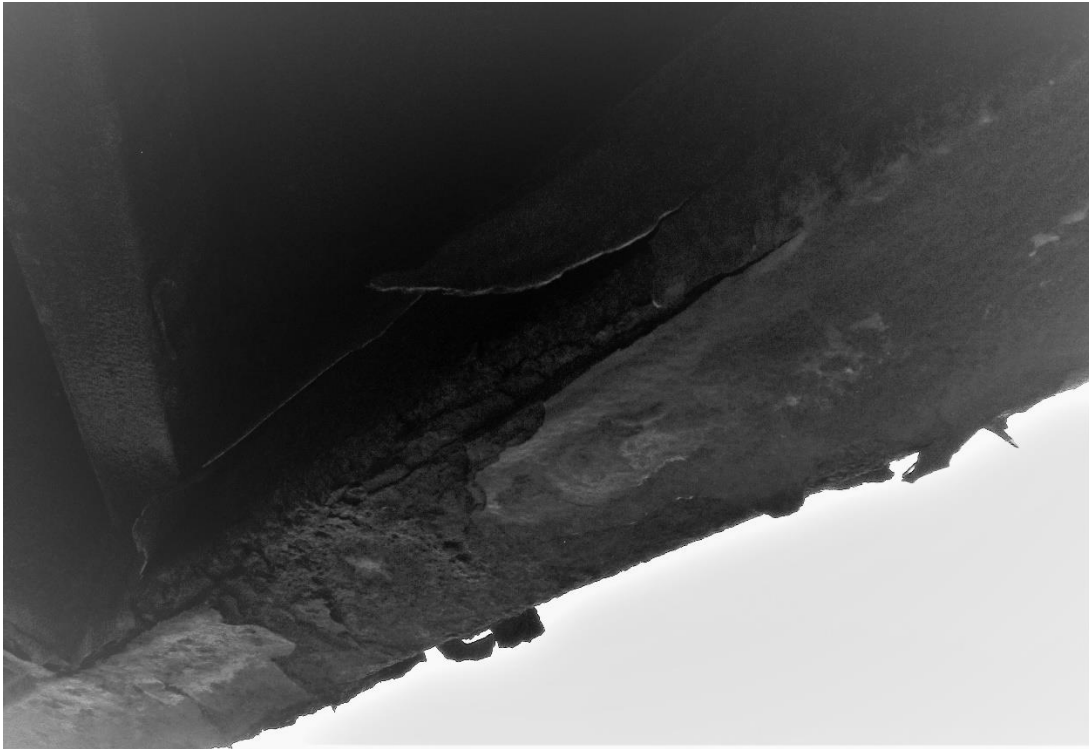
item 10

- Item 10. Bottom stringer thickness 5.4mm
- Item 11. Perpendicular tie thickness 3.6mm
- Item 12. Bottom apex thickness 4.7mm

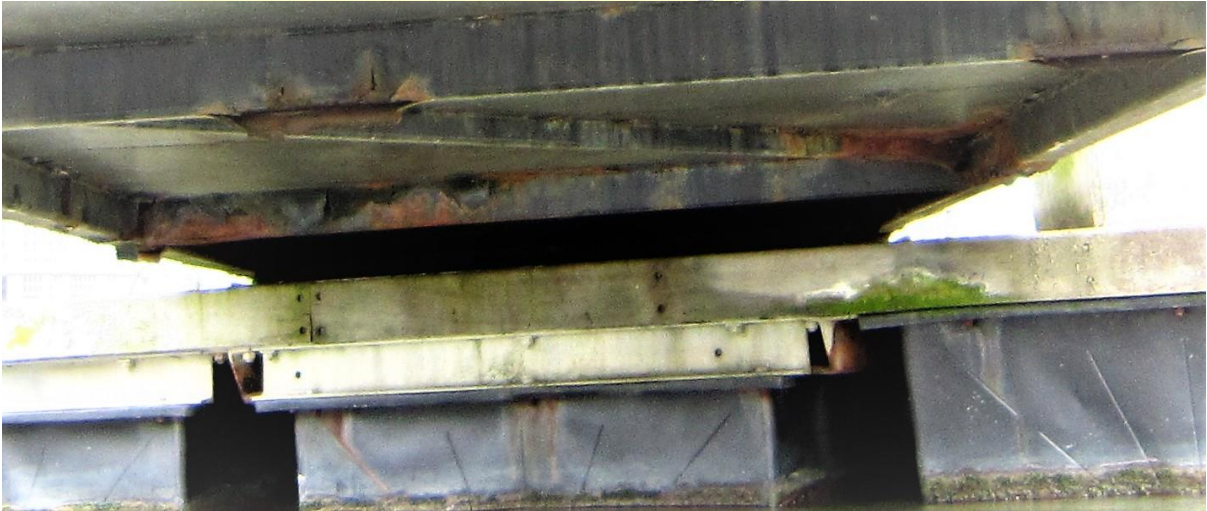
The damaged paint is extensive see photos below;
