# Survey Report

Rochester Pier, Medway Towns

Condition of jetty structure, pontoon and Brows

## Introduction

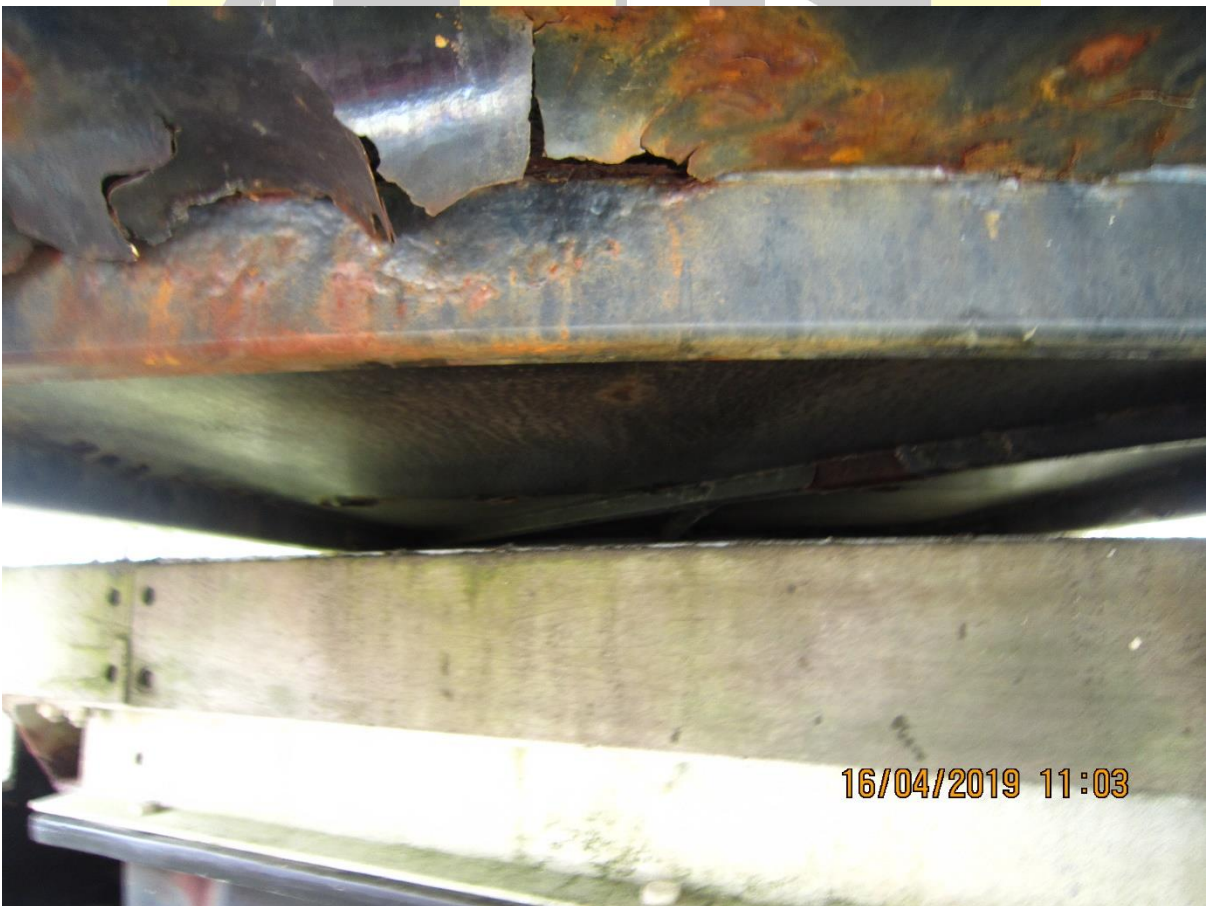
Corrosion at this first apex from pontoon is being influenced by stress loads, splash zone and impact with pontoon in rough weather. Thickness items

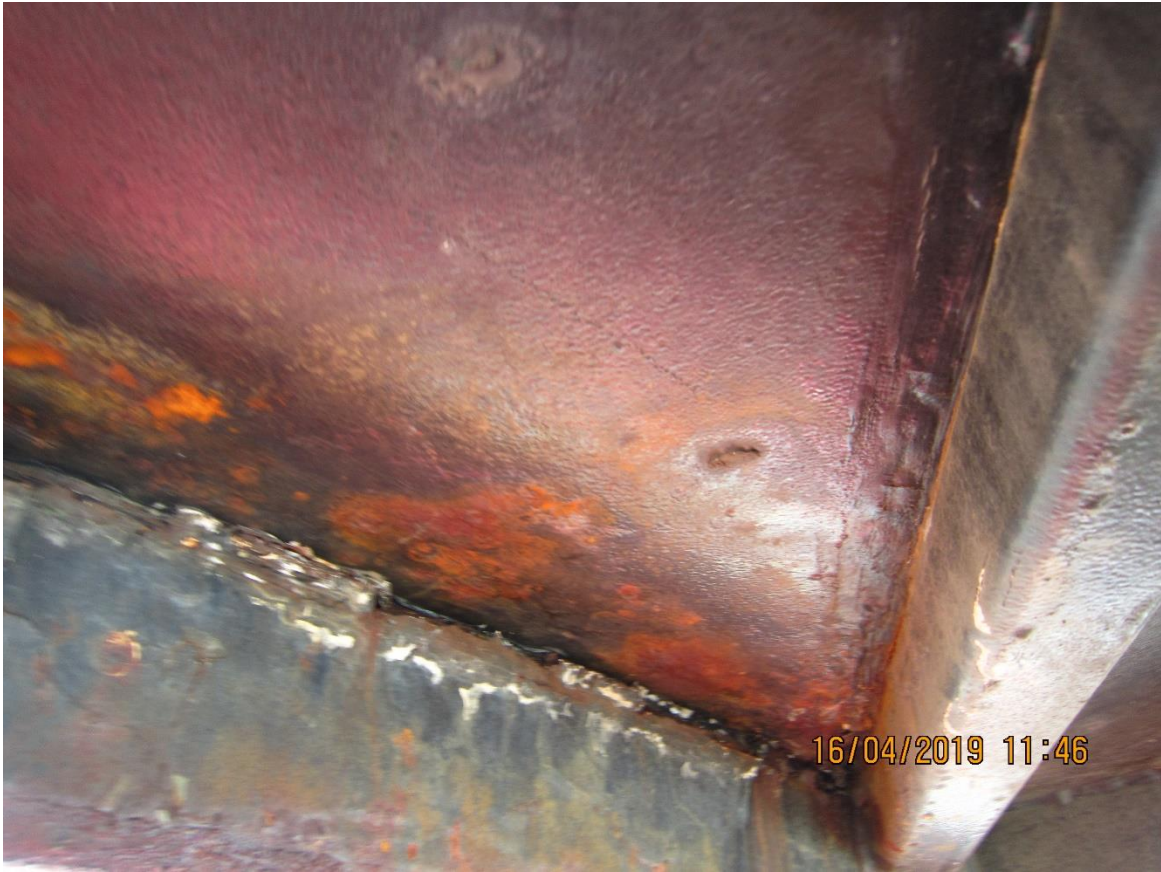
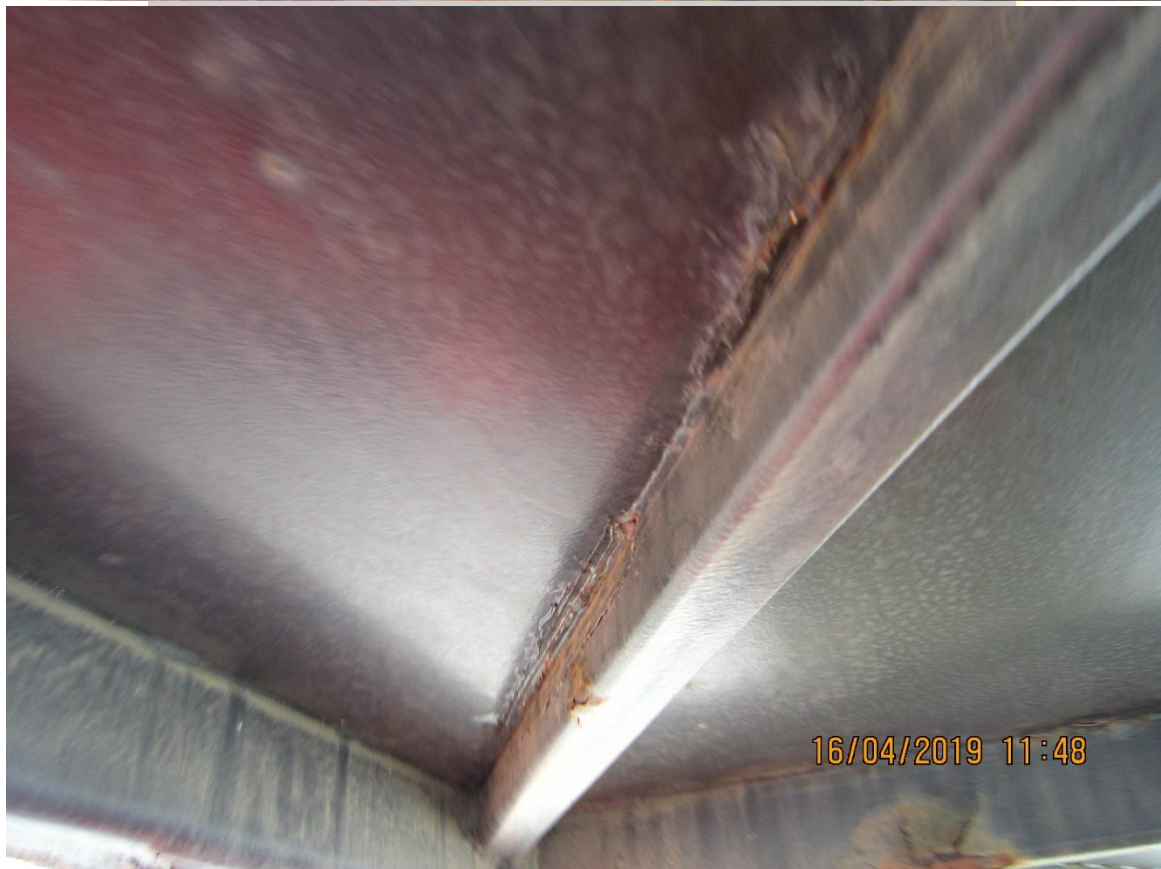
These are all water traps between deck and bottom stringer, where deck is stitch welded.

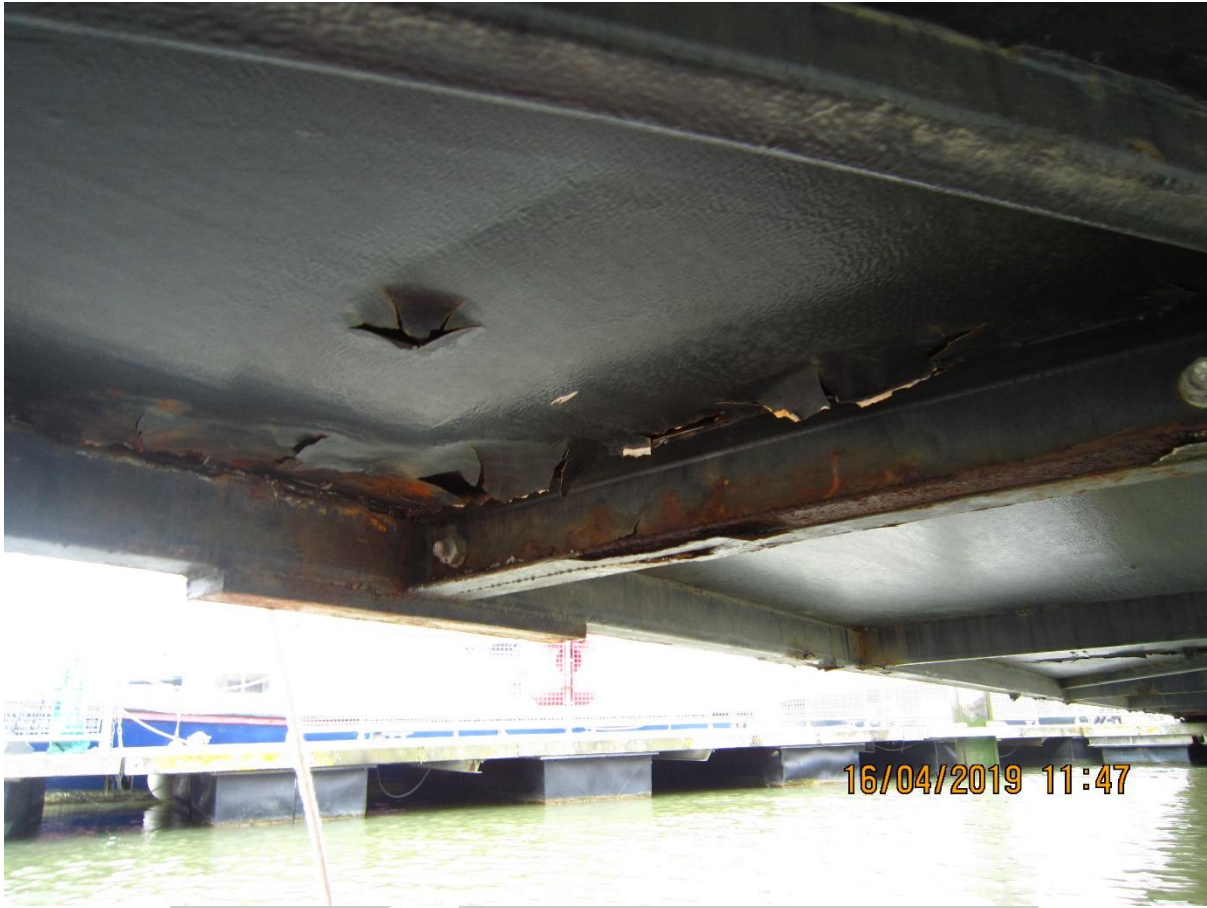
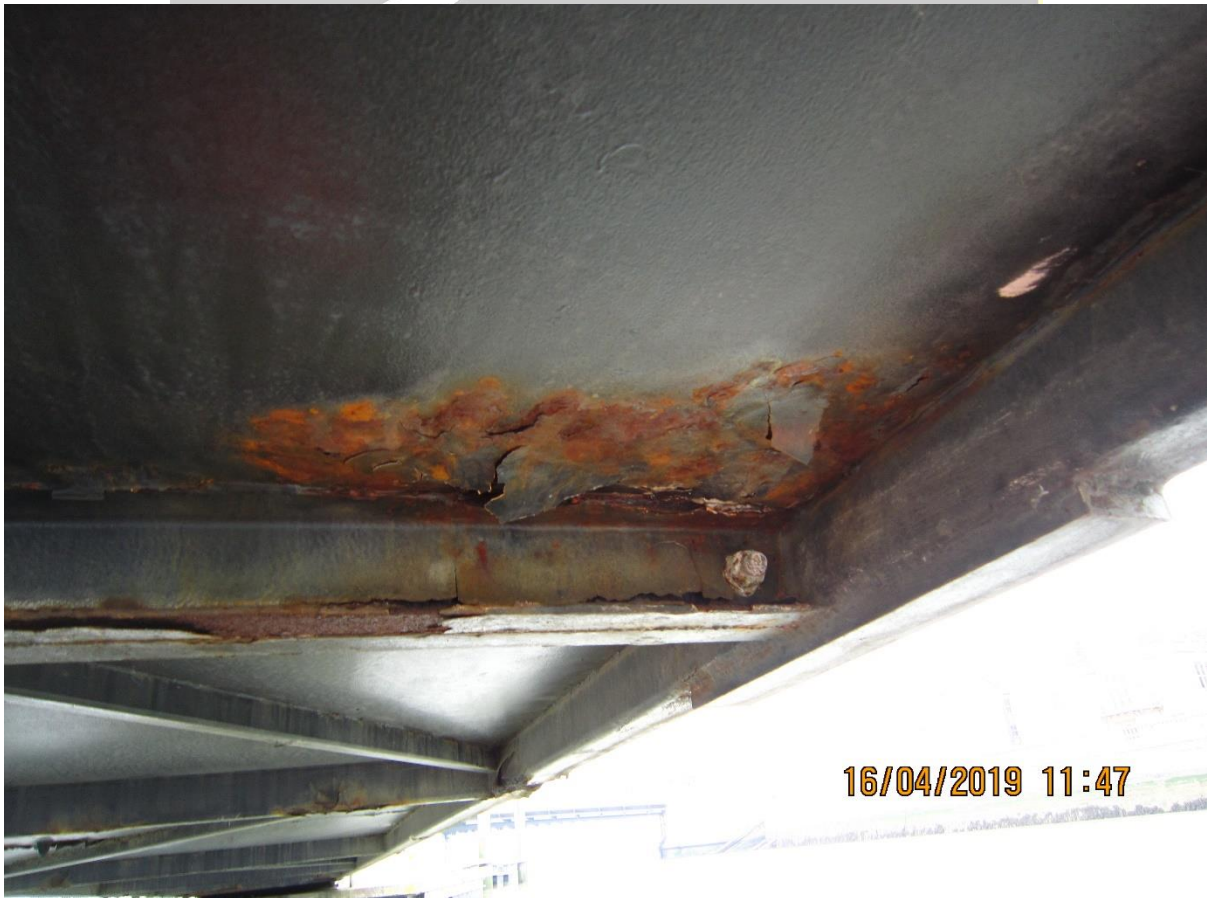
Channel joint, in middle of brow where brow was joined after fabrication and road haulage.

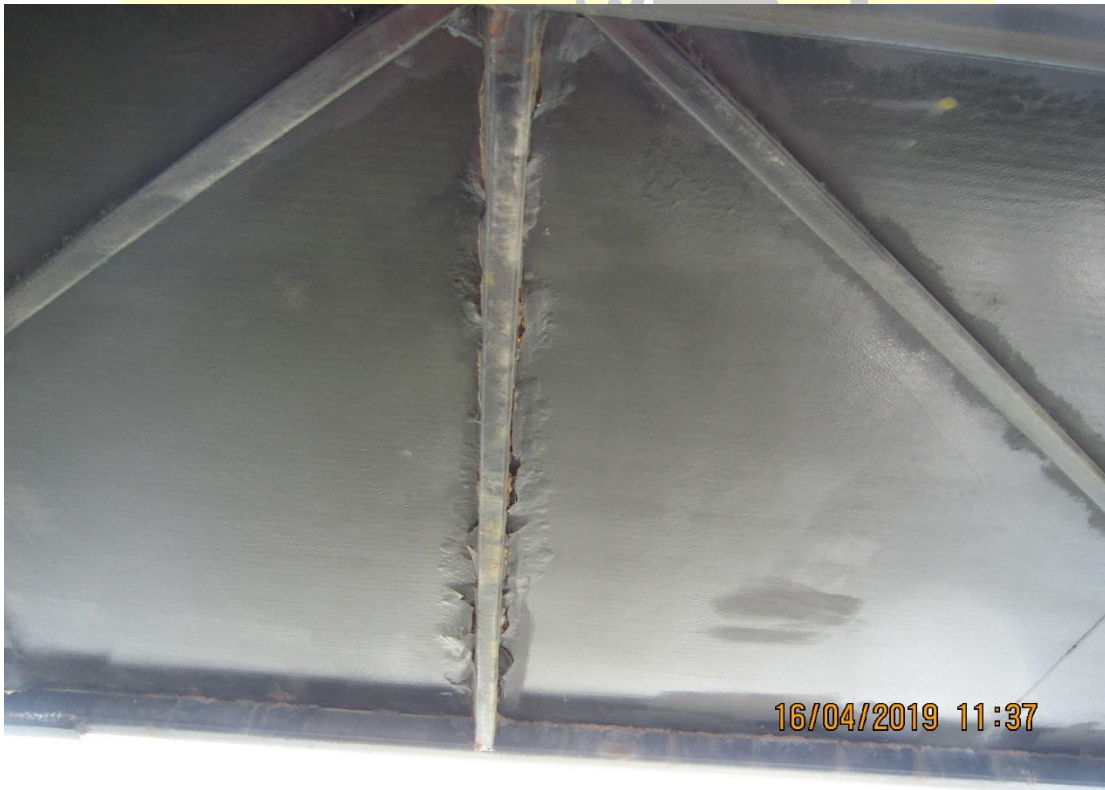
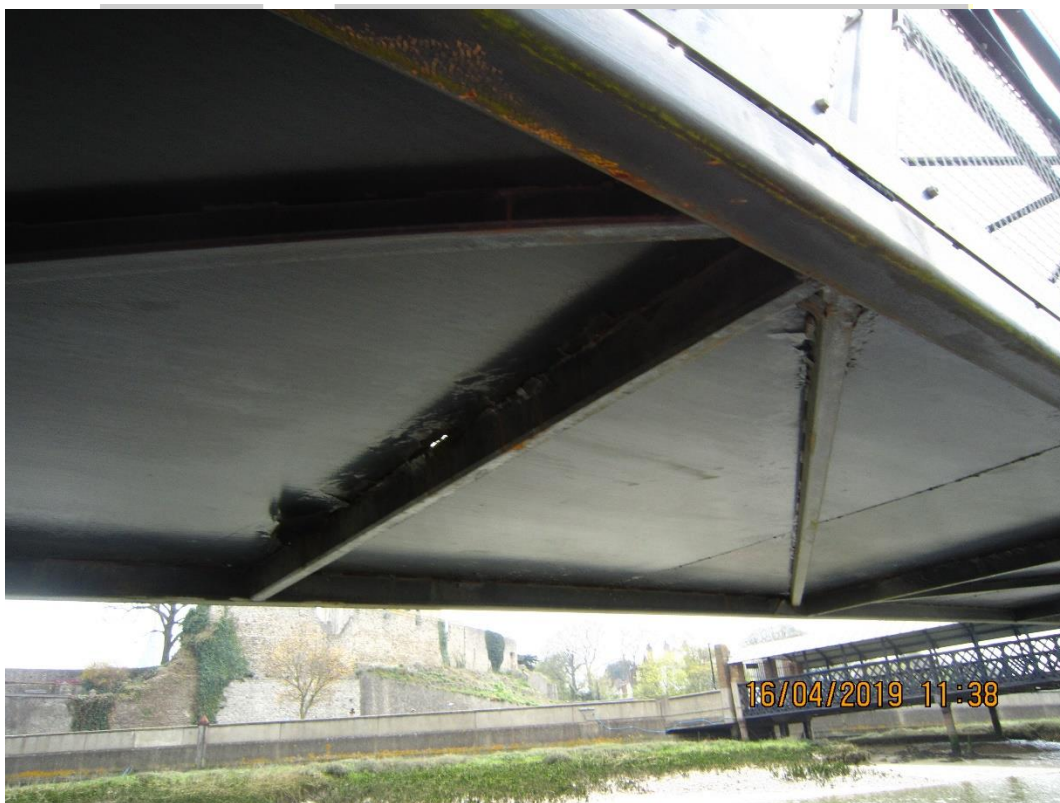
Generally in a much better condition with regard corrosion, the paint is similar, see photos below.

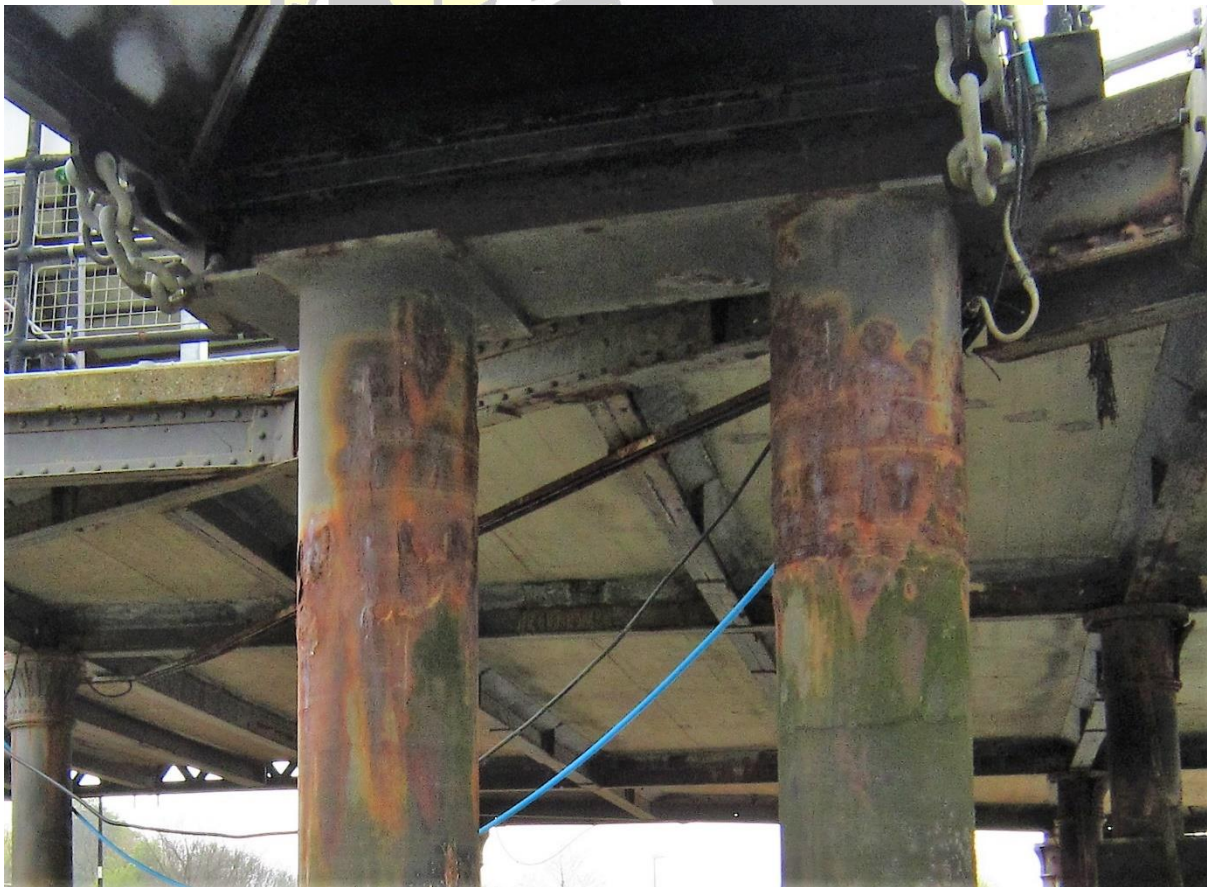
The piles are in good condition generally but have lost paint protection in the tide splash zone, thus corrosion is evident.

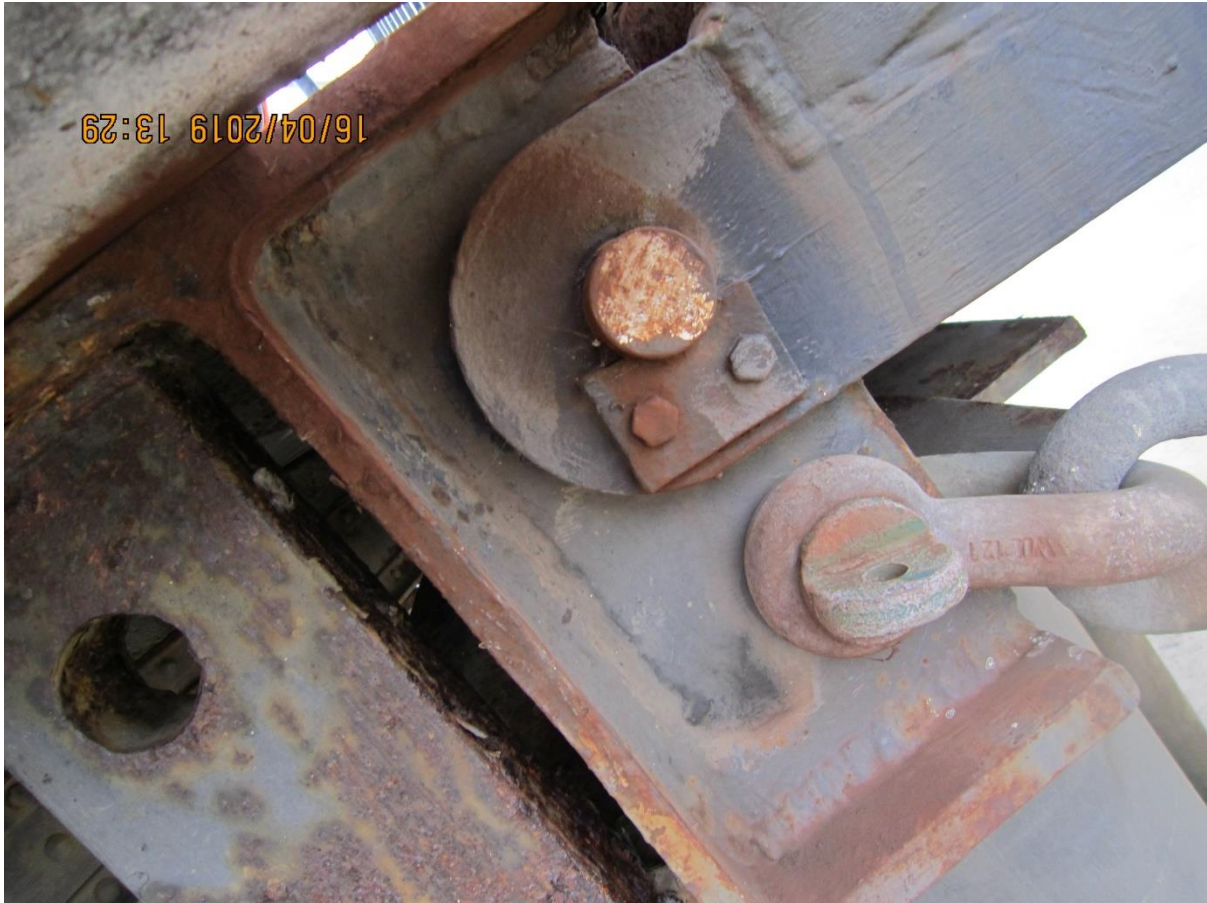
The pins are locked in place and the safety chains are in good condition. Due to construction type of pin and housing there is no way to inspect pin its self for wear. They need to be removed for inspection.

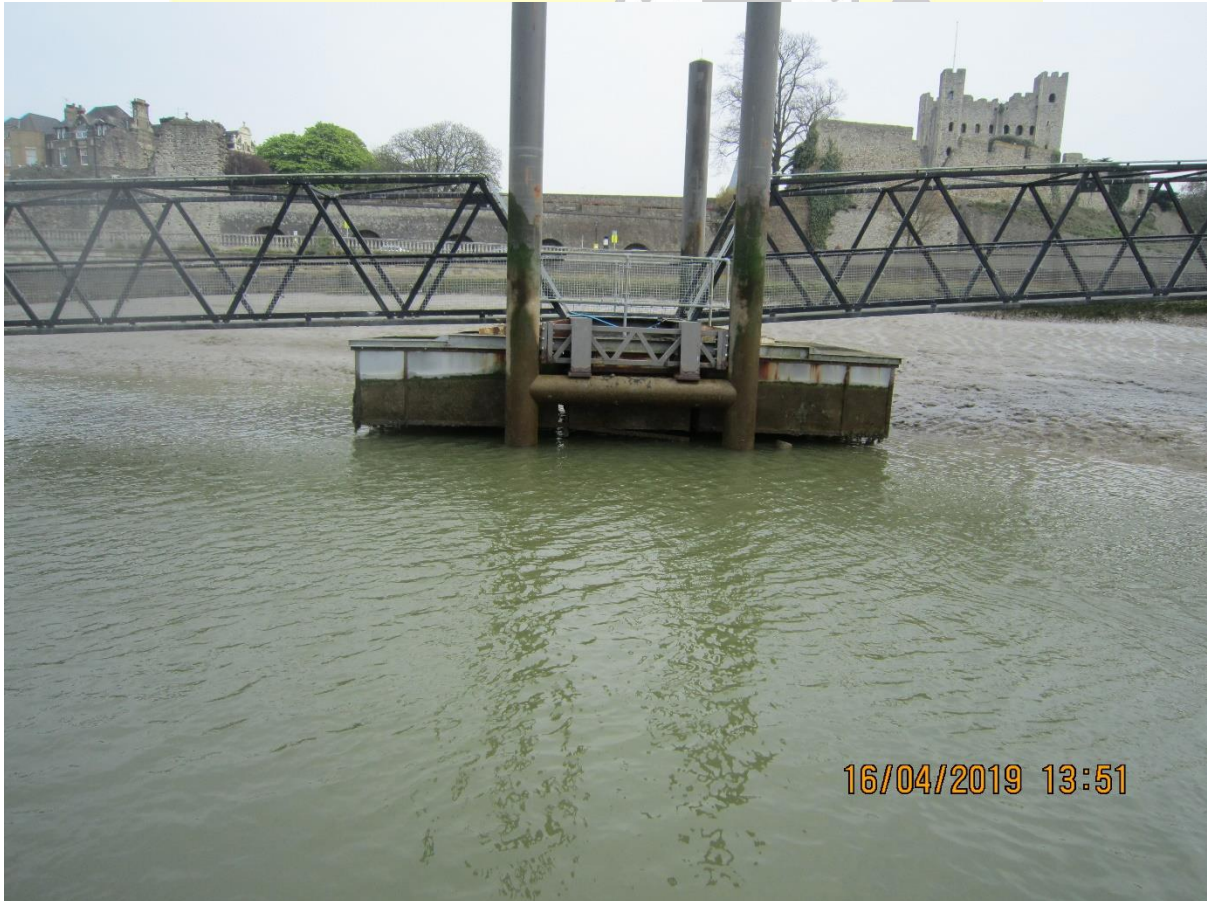
Piles are generally in good condition with protective paint coating in need of maintenance in the high tide splash zone.

The frame of the pontoon has had repairs carried out in the past, the horizontal main beam has broken at the point of cantilever for the overhanging pontoons up and down river.

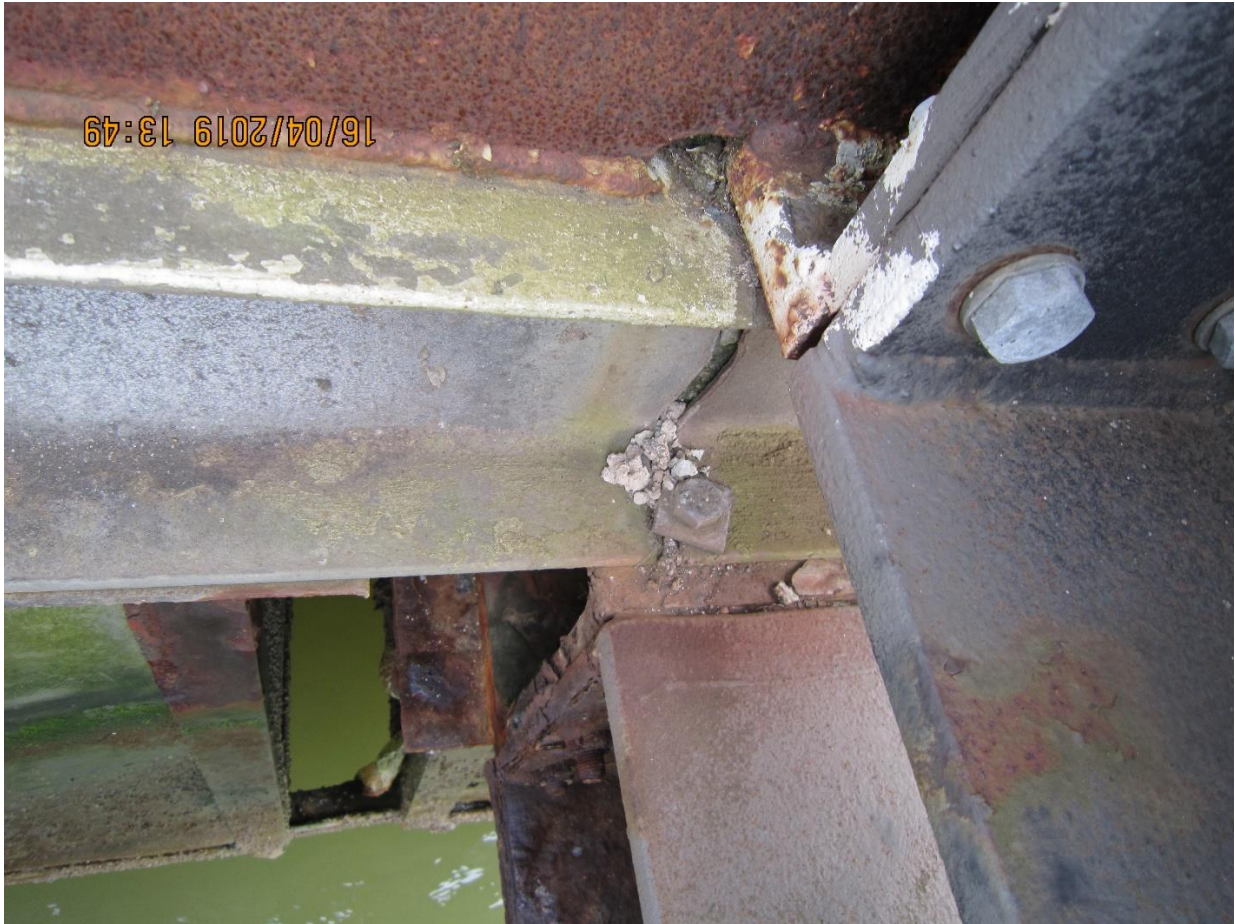
down river out-shore low tide.

Note. Gap opens and closes in split with tide change. The bolts above split can be turned with your fingers. The pontoon is moving the bolted joint every change of tide. All bolted connections require bolts tightening and/or replacing.

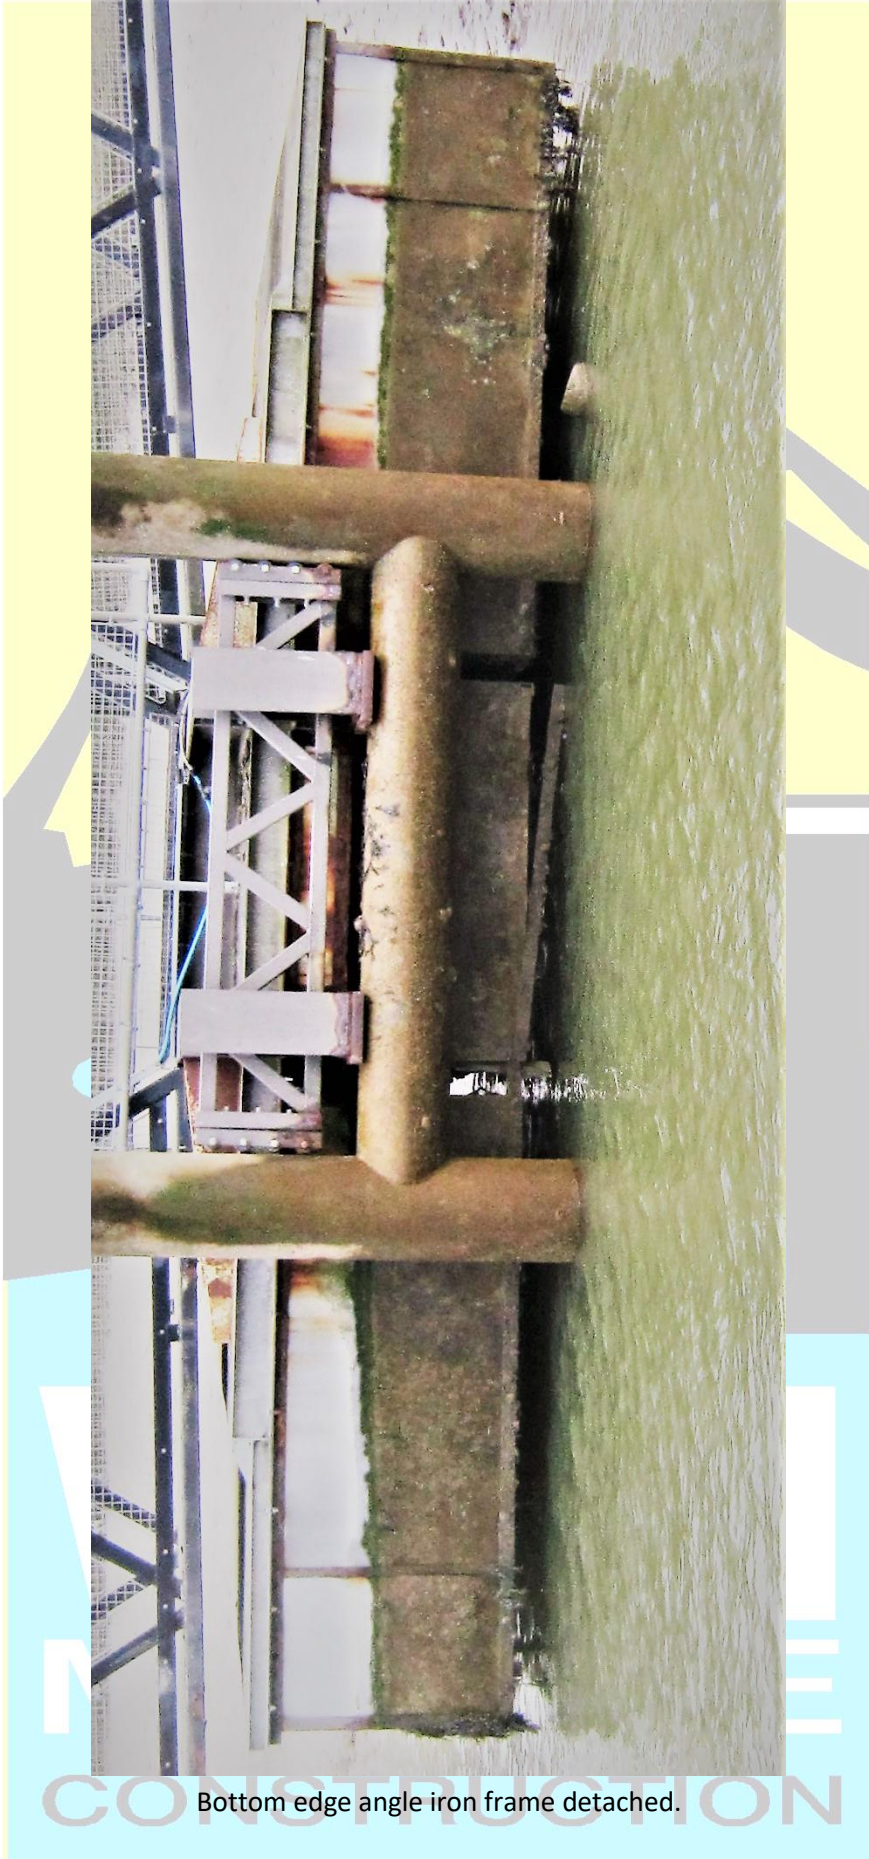
Also note the condition of the angle iron frame work that holds the pontoons in place. There is only currently one area of damage as photo below, but remainder are at the end of life stage.

Bottom edge angle iron frame detached.

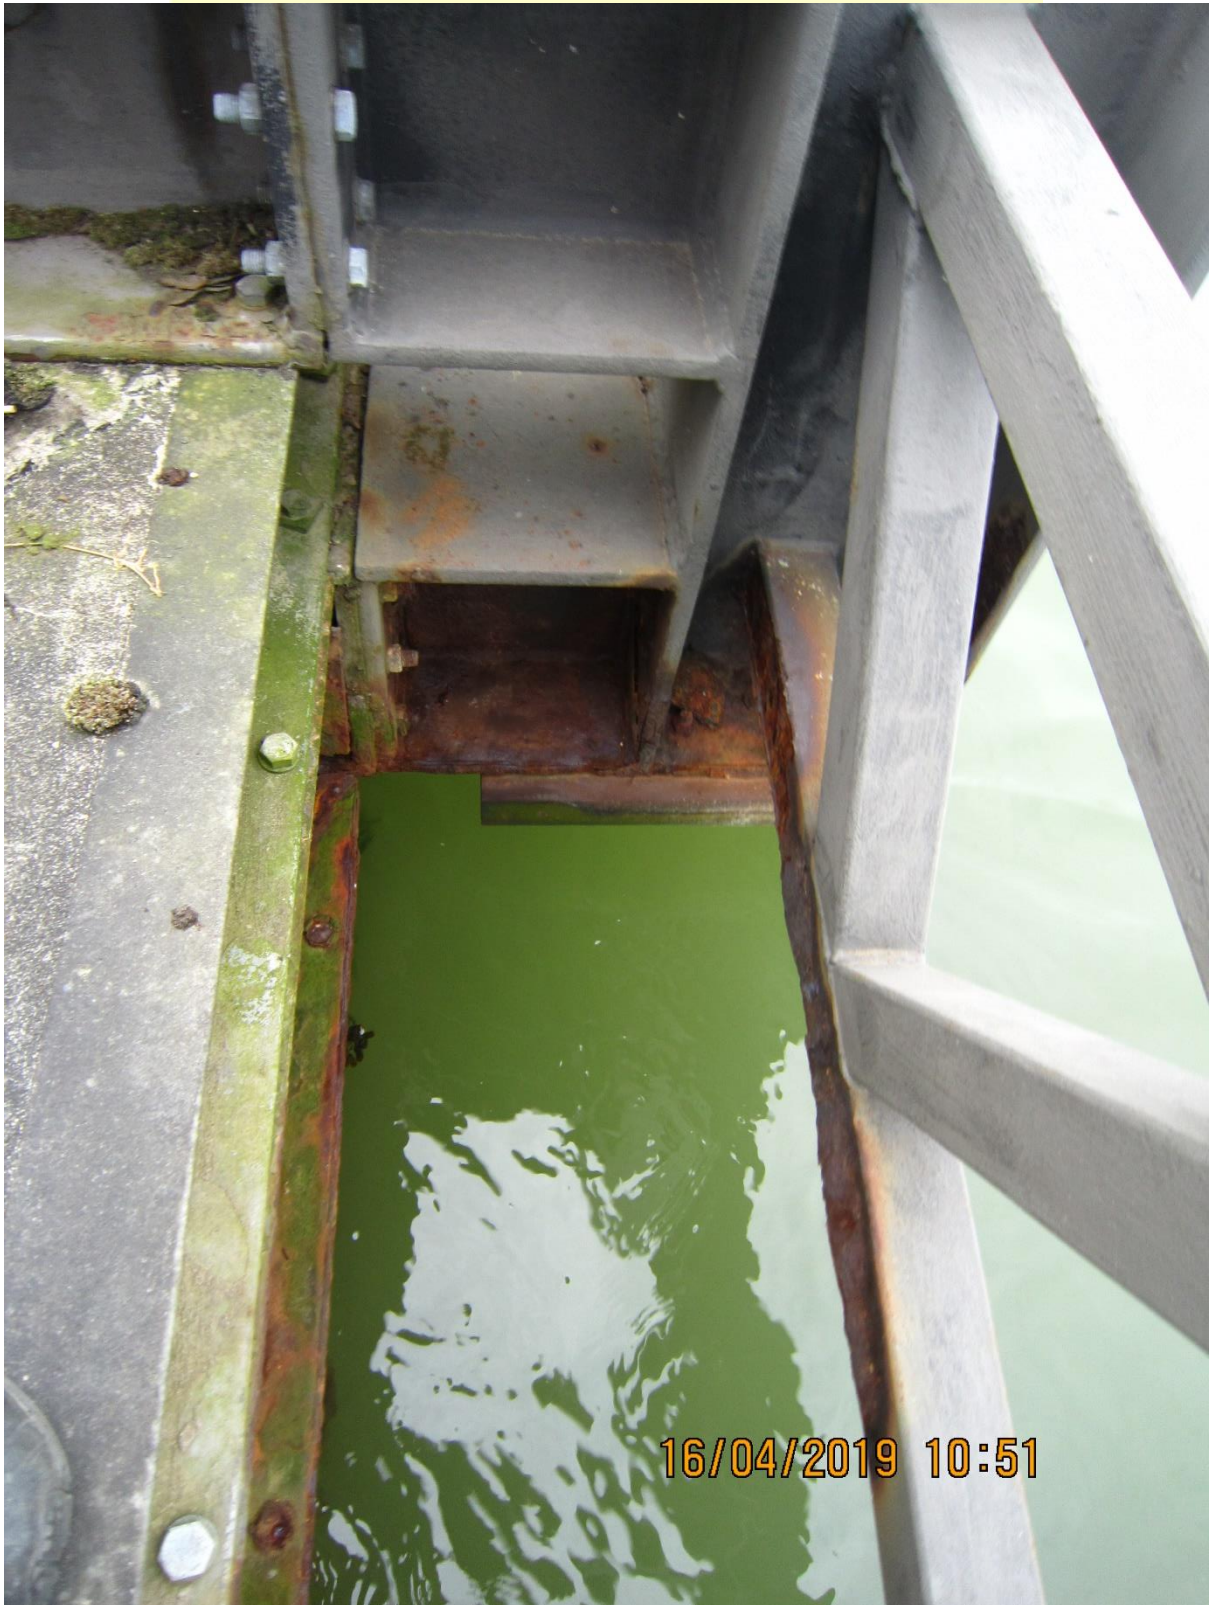
Protective paint coating on the lower frame requires maintenance.

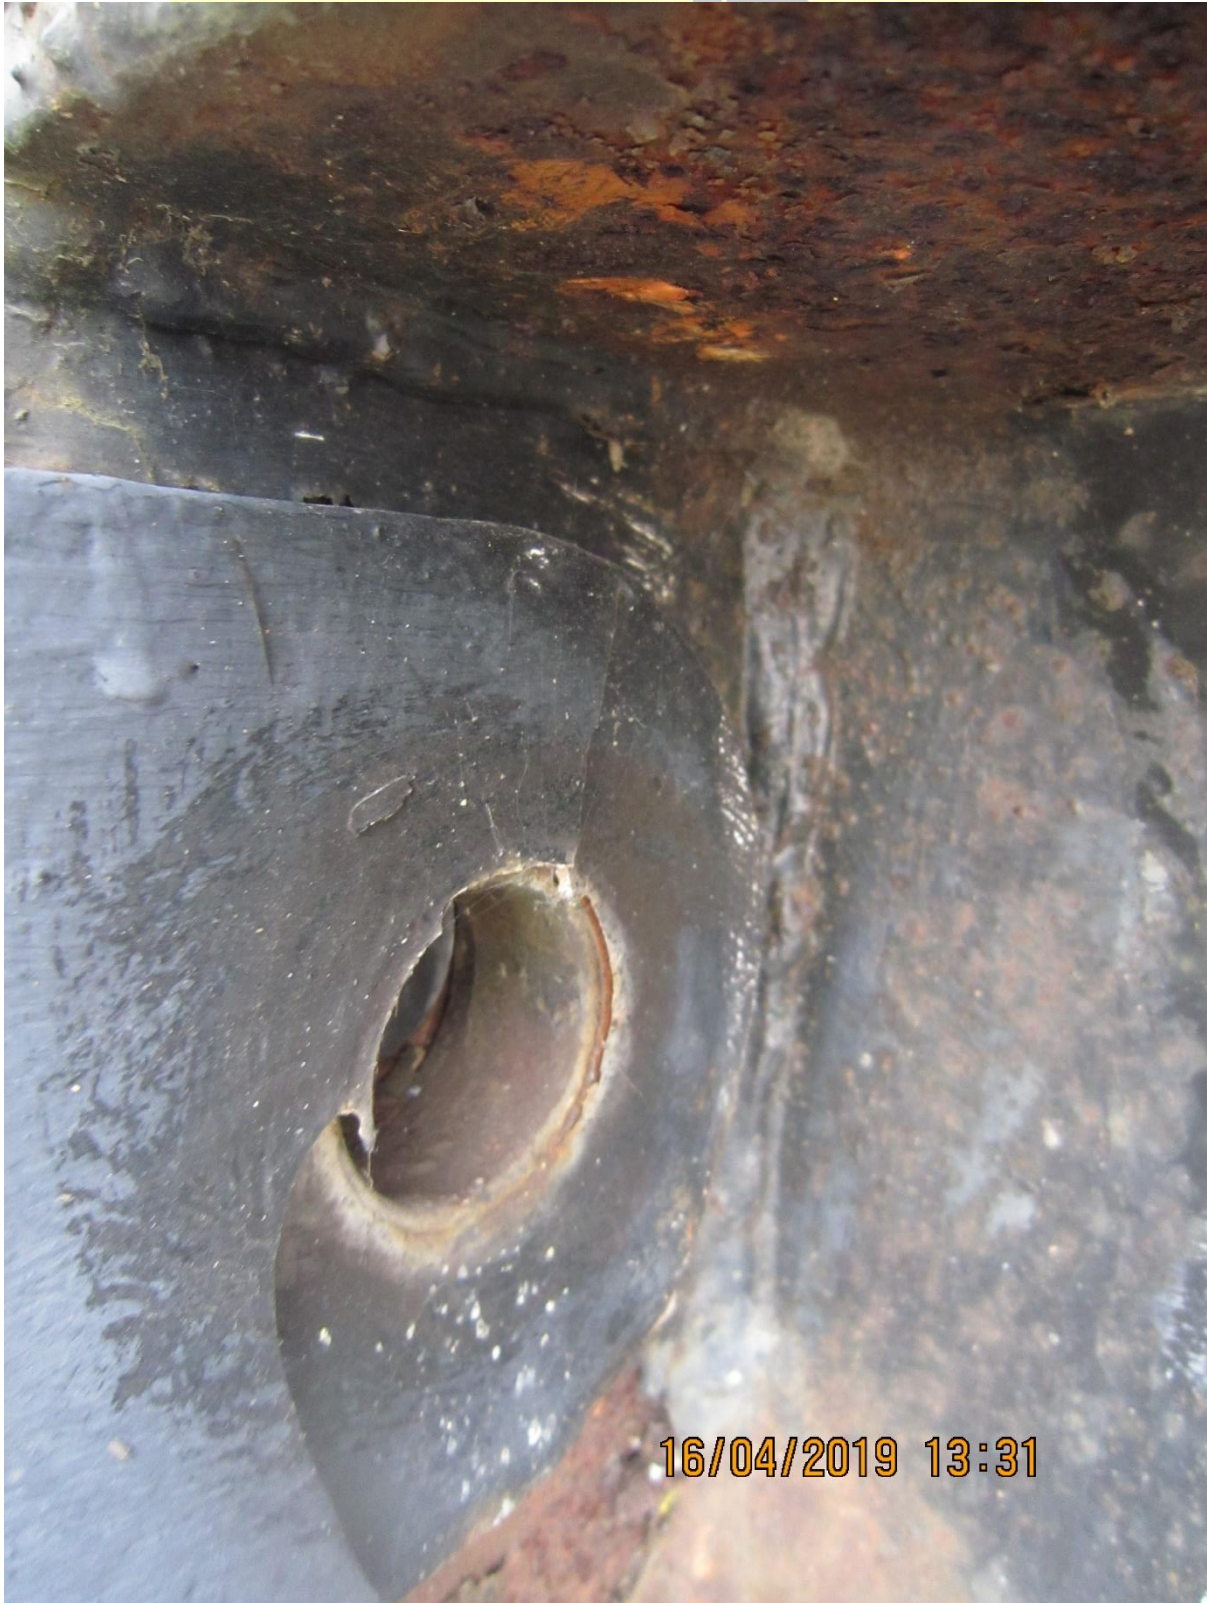
The pin to the lower brow in shore is in and locked. However, but the out-river side pin is free of its locking plate and only partially in working its way out. Only got 50% strength left and may come out at any time.

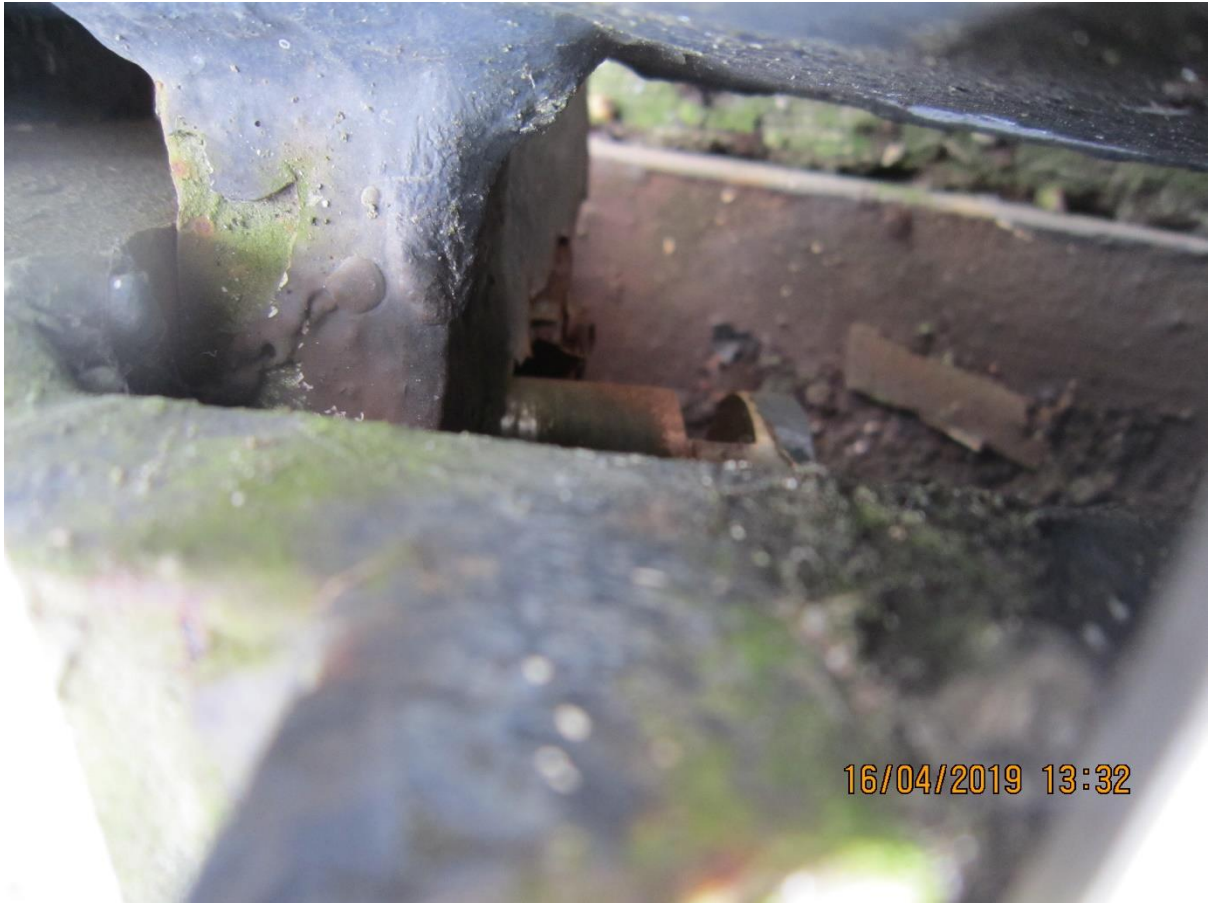
The locking plate to pin is missing a bolt. Wear on the pins can't be checked due to construction type need to be removed to check.

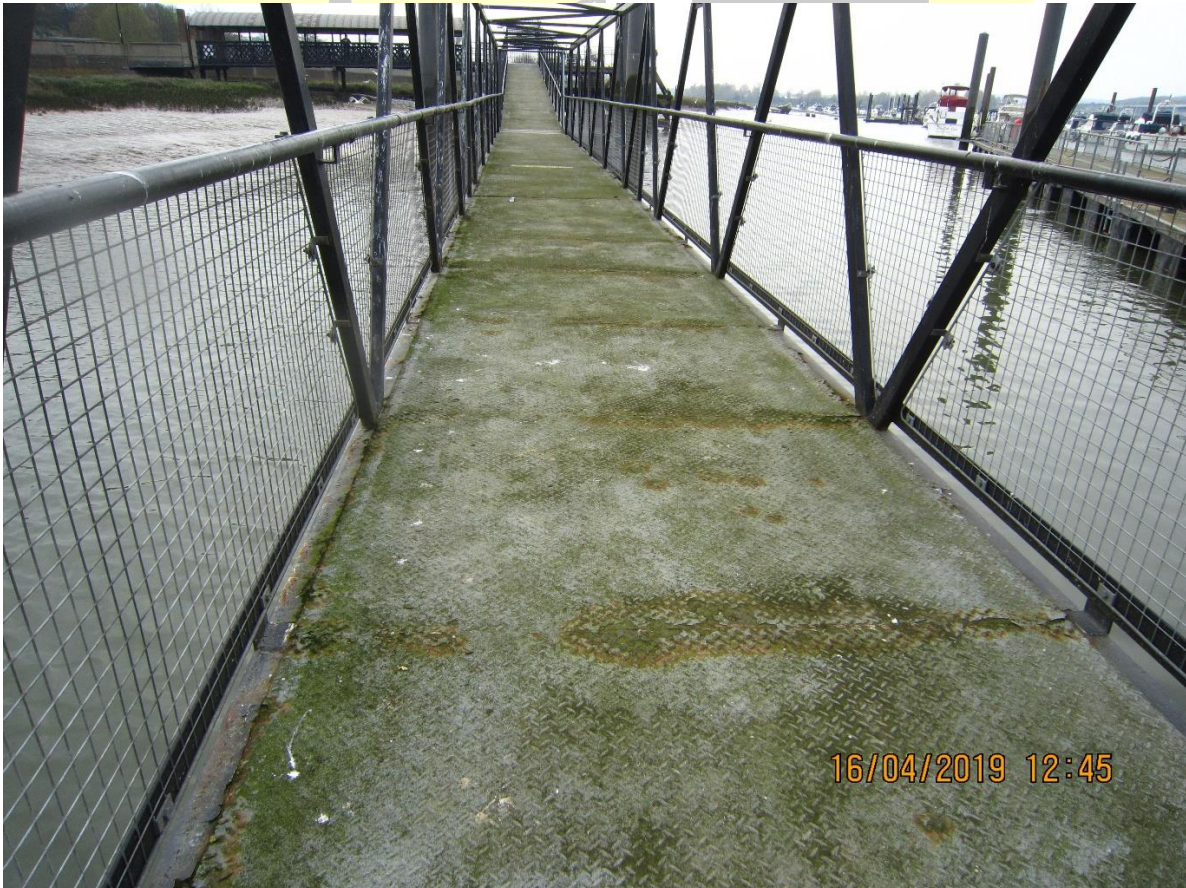
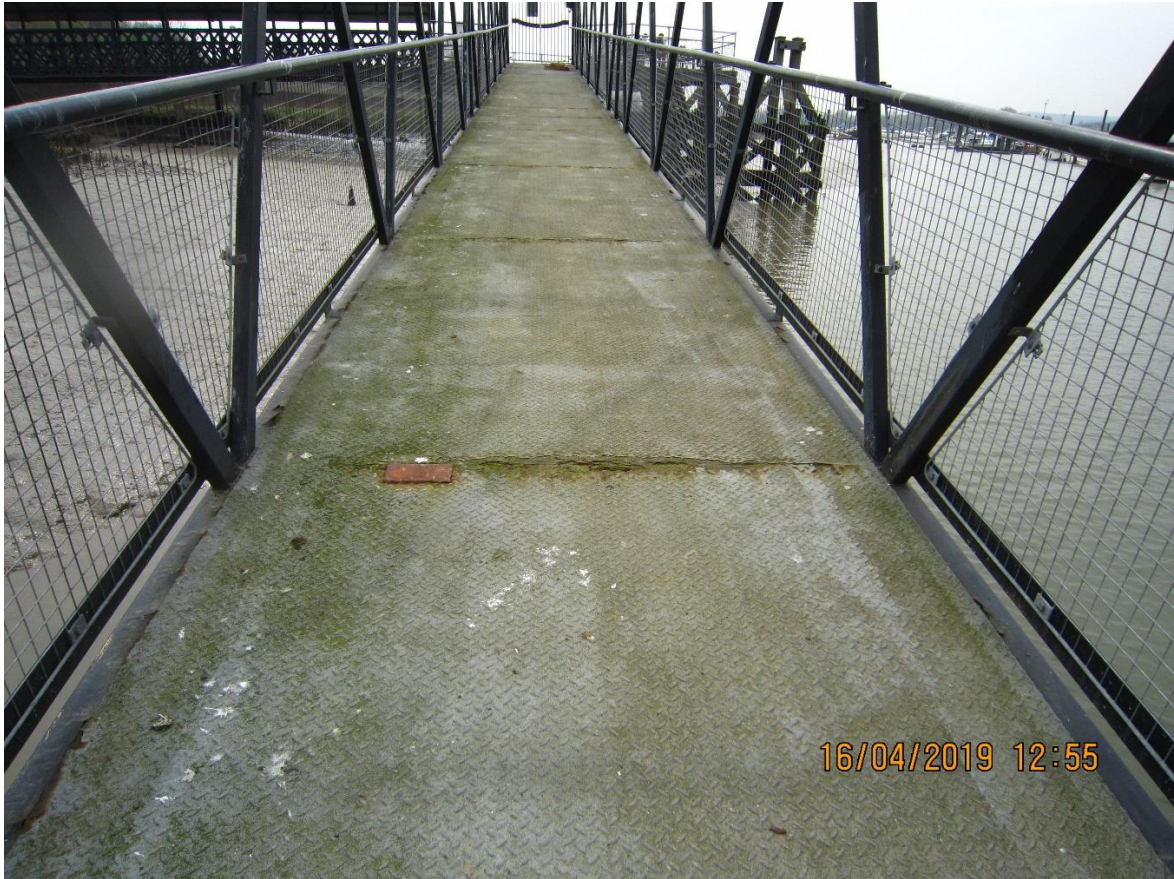
Every stitch welded area is corroding to a greater or lesser extent and the fully welded joints on lower brow in particular are also starting to corrode.

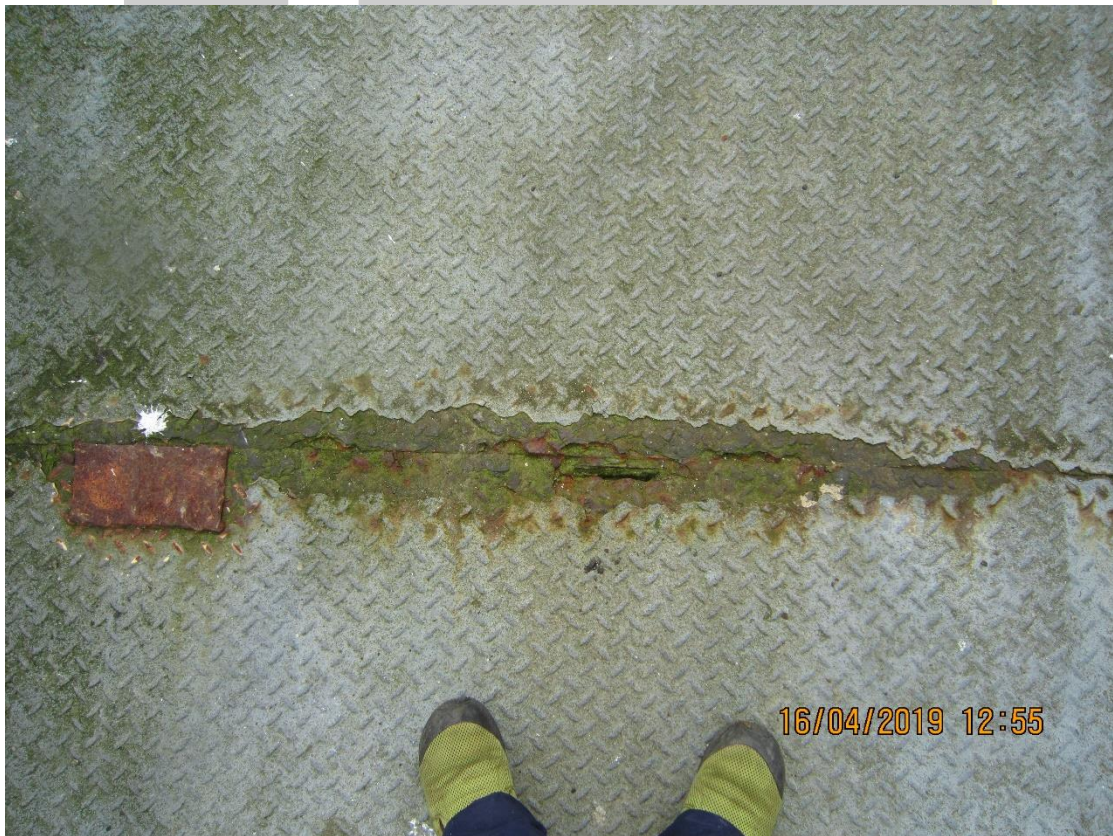
There are repairs of areas, areas with deck cut out and plate welded over cut out and patches welded over holes and holes. 2No. visible holes as of survey.

view of patch and hole.

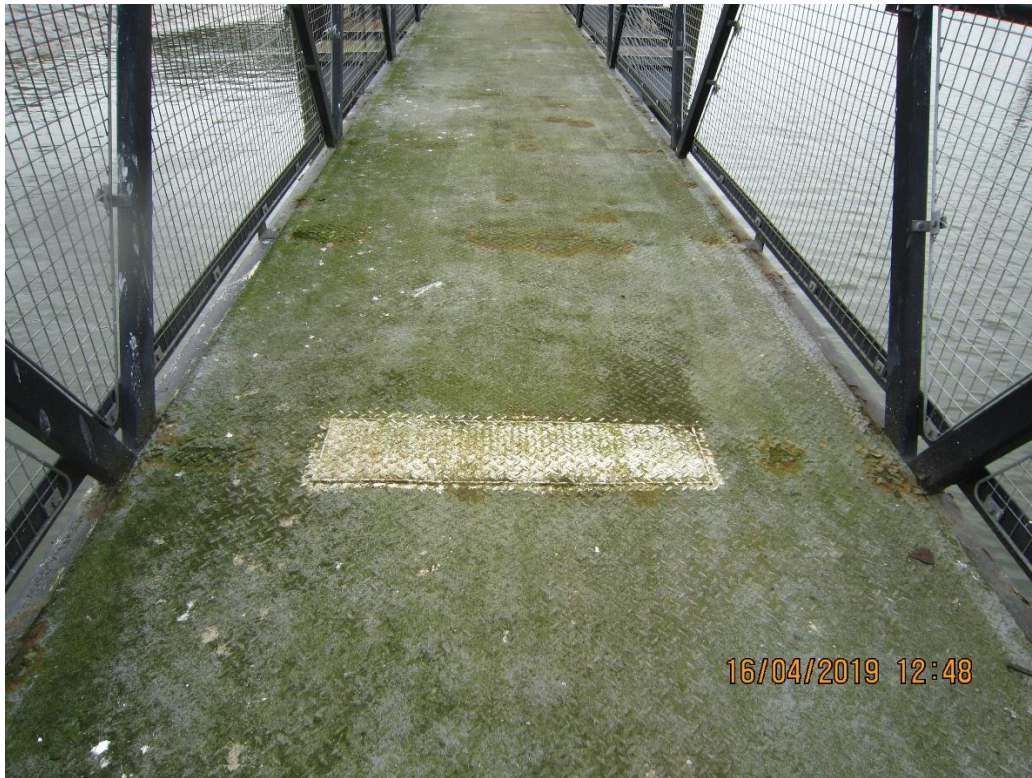
Cut out and plated over.
