# Survey Report

Rochester Pier, Medway Towns

Condition of jetty structure, pontoon and Brows

## Introduction

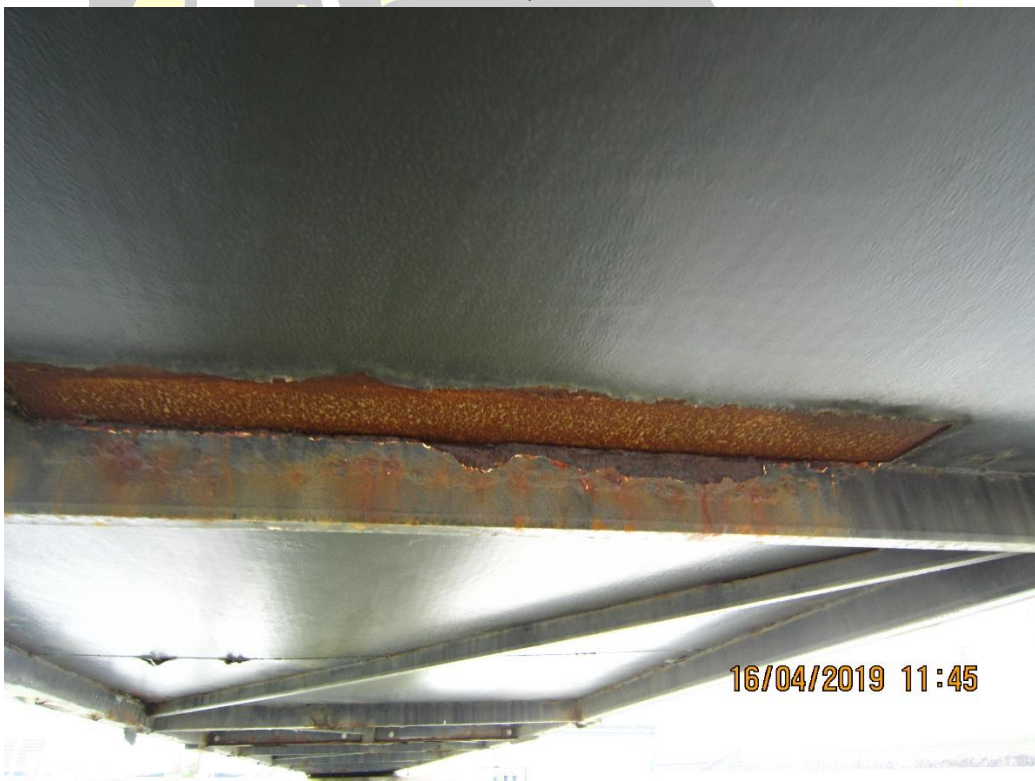
View from underneath

Underside of plate not corrosion protected (painted), area where old plate cut out (box section or plate edges) not cleaned and painted. The over lap of plate to box is a water trap and will corrode rapidly. This area requires very regular monitoring as structural member of bridge. These types of repair patching and cutting in require good corrosion prevention practises or they will cause corrosion to accelerate. This is a sticky plaster to hide the problems.

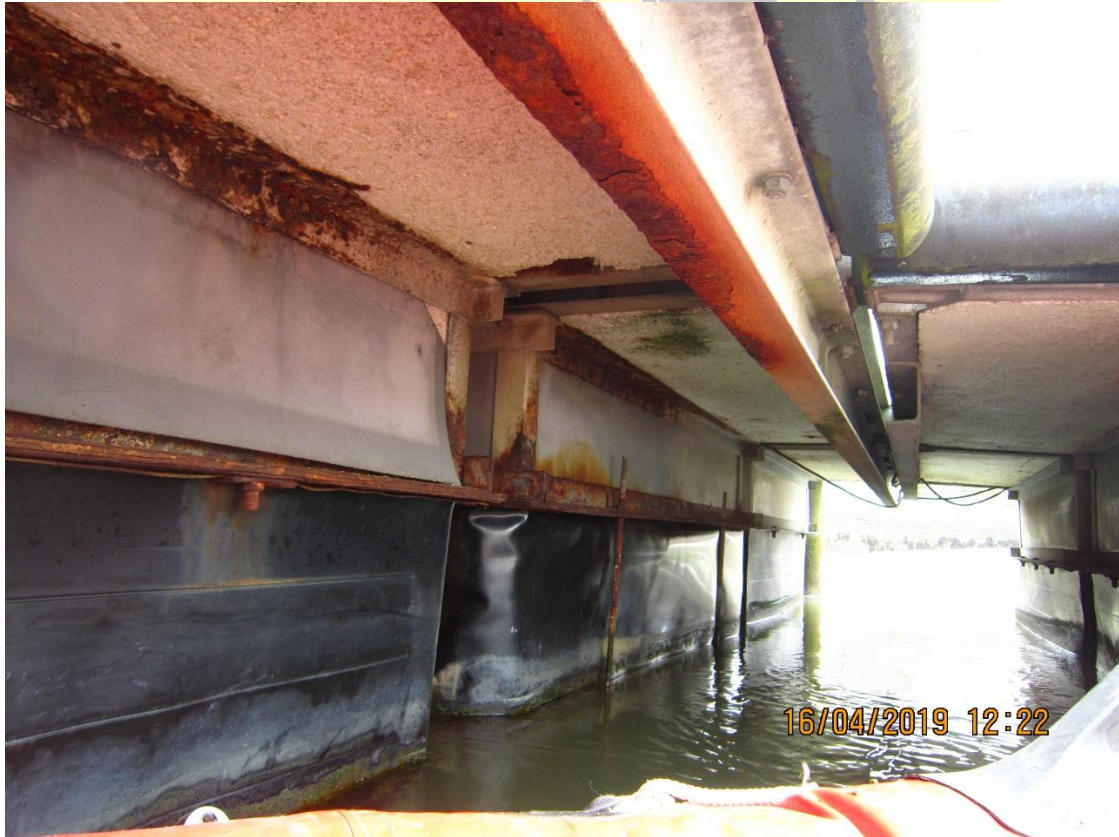
There is corrosion to galvanising on the frames below deck, predominately to front face but also to areas where rain water or river water drain through deck. Due to vessel wash/splash and environmental exposure from open water.

View through front to back. Note corrosion heaviest at front and non-existent at rear.

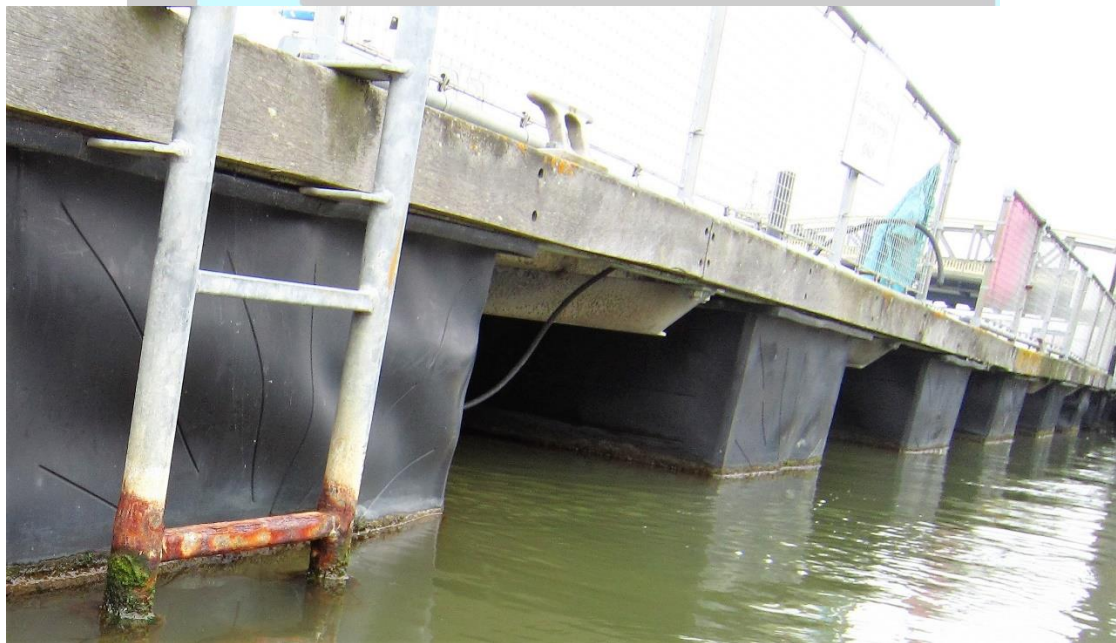
View to rear, shows less corrosion.

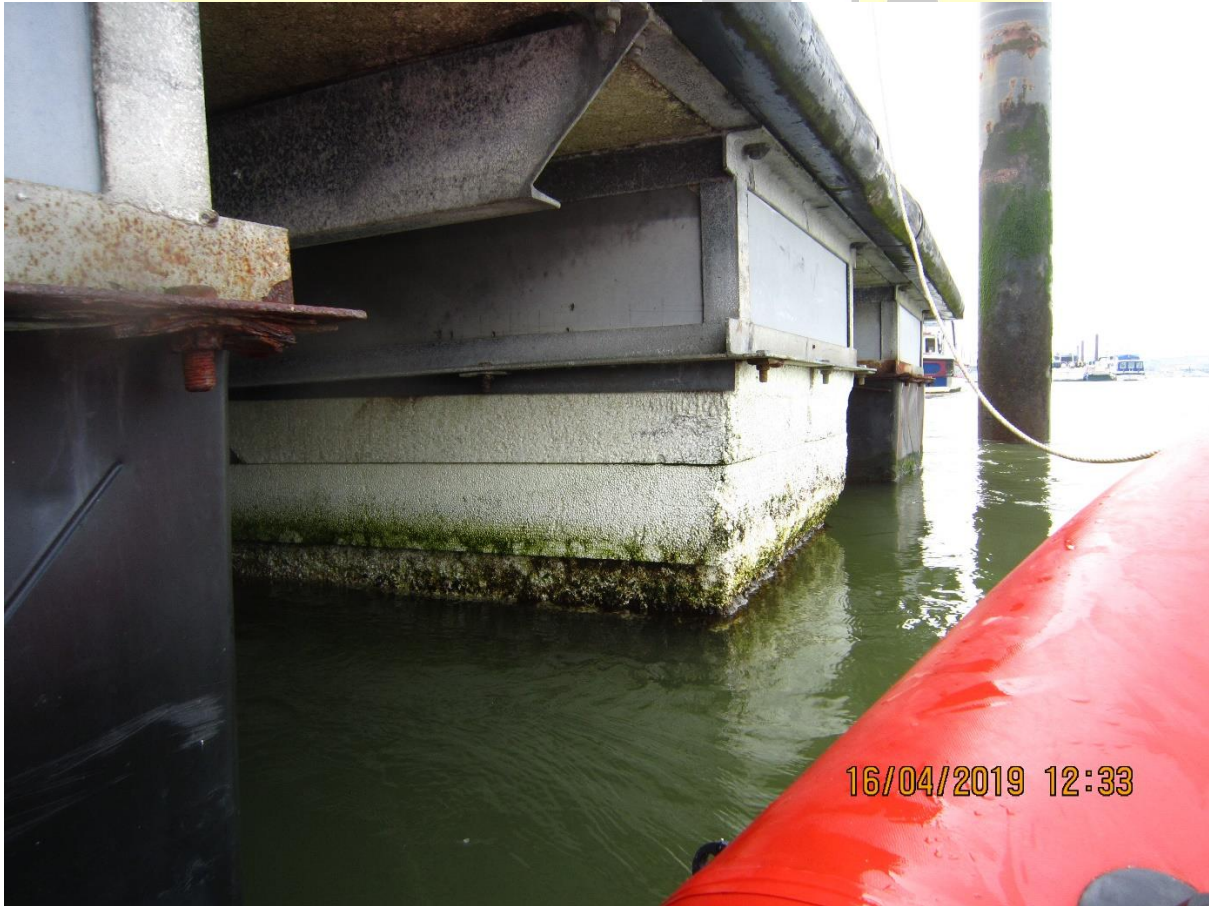
There are 2No. floats with missing plastic tanks one to face of lower pontoon and one to face of raised area. There is no evidence that these have been ripped out and the washers and bolts are tight to frame no gap where plastic has been removed. Would suggest that these were never fitted.

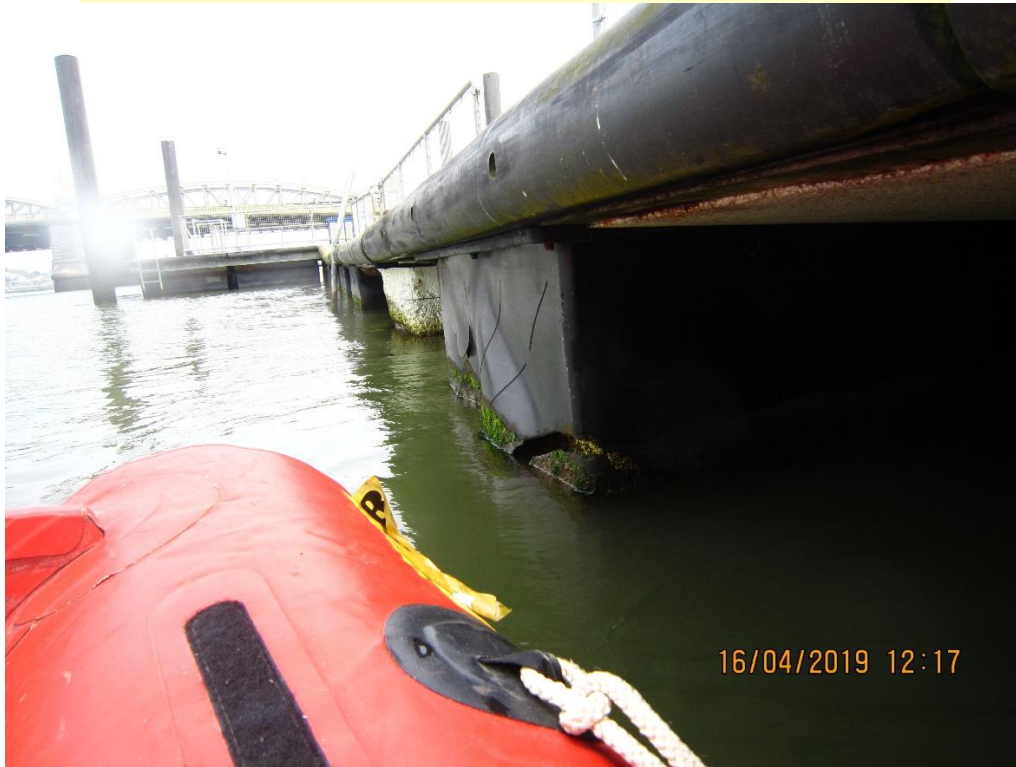
There are also 4No. tanks that are split.

We would recommend monitoring these with no action at present, as they are functioning correctly.

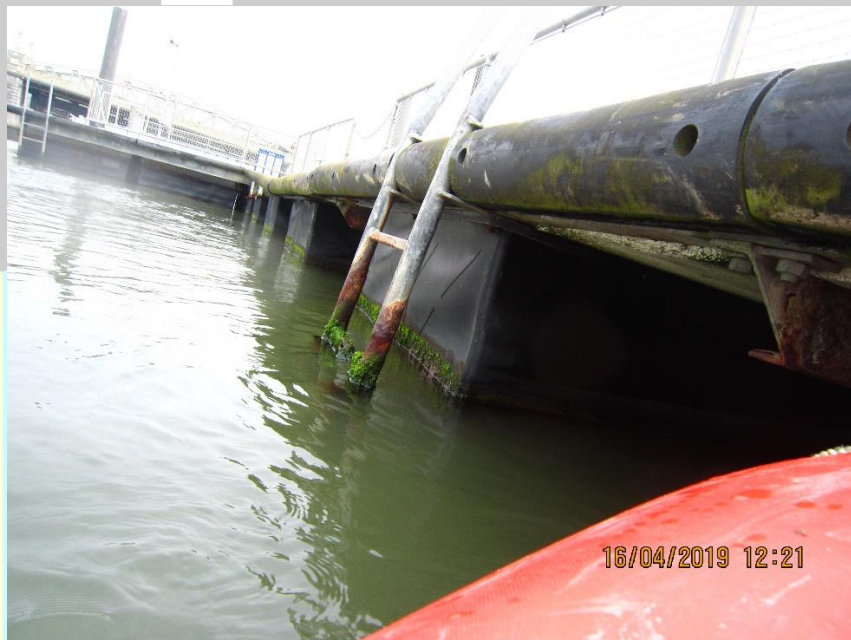
There are 7No. escape ladders around pontoon all of which need replacing, as rungs are missing.  
Individual unbolt bolt on.
