# Survey Report

Rochester Pier, Medway Towns

Condition of jetty structure, pontoon and Brows

## Introduction

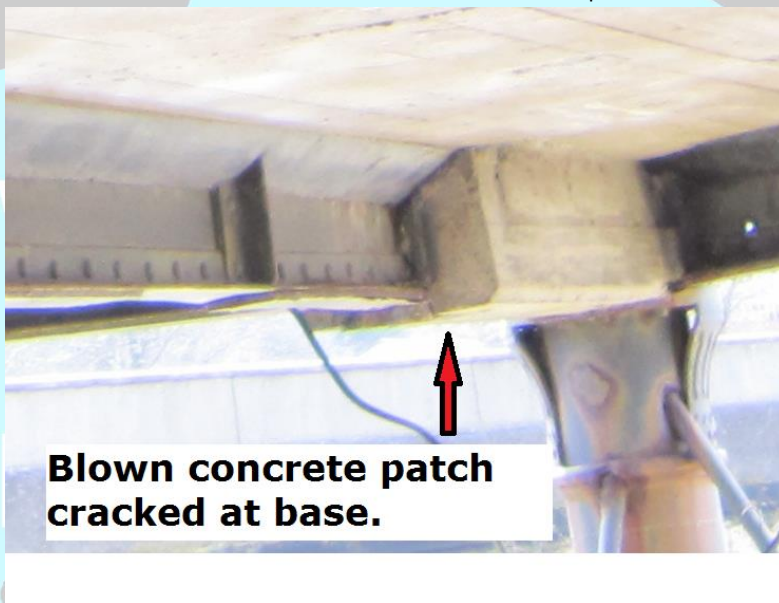
- 1 Concrete coving that has blown due to water ingress, original corrosion, continues and rust is pushing concrete away. Staining running down web of beams shows rust, alkali leaching and water ingress.
- 2 Welded plates to strengthen corroded flanges, showing rust marks and staining.
- 2a Welded plate strengthening has split welds and is corroding between flange and plate, this undermines strength.
- 3 Beam boxed in with concrete, welded plate repair to flange was carried out first and boxed in. the corrosion has blown the concrete see picture below.

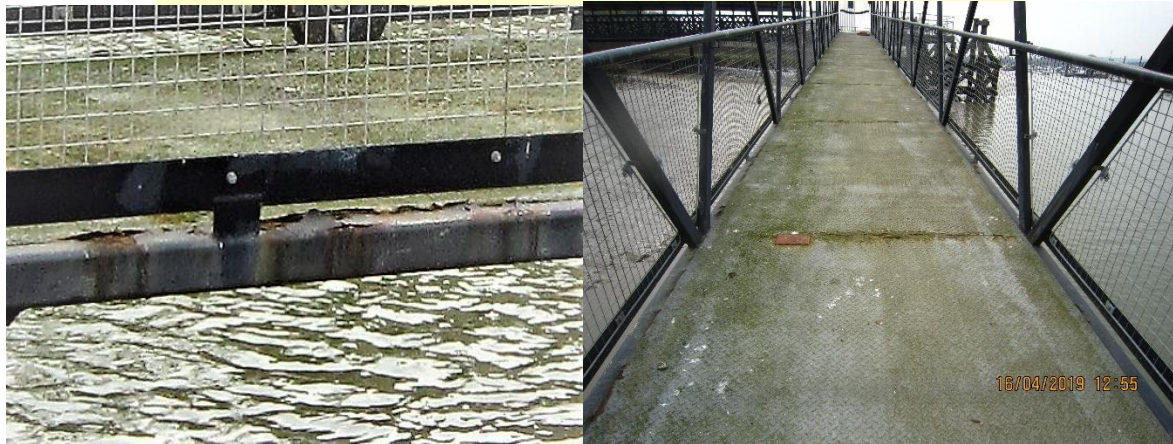
Lower brow

The chequer plate deck has been fully welded on joints between apexes and stitch welded where they join over perpendicular 100 x 50 x 6mm ties between stringers. The majority of corrosion is on the stitch welded joints and where the plates are stitch welded to stringers along sides. These are the supports for the deck plate, with only one diagonal tie underneath a three meter span.

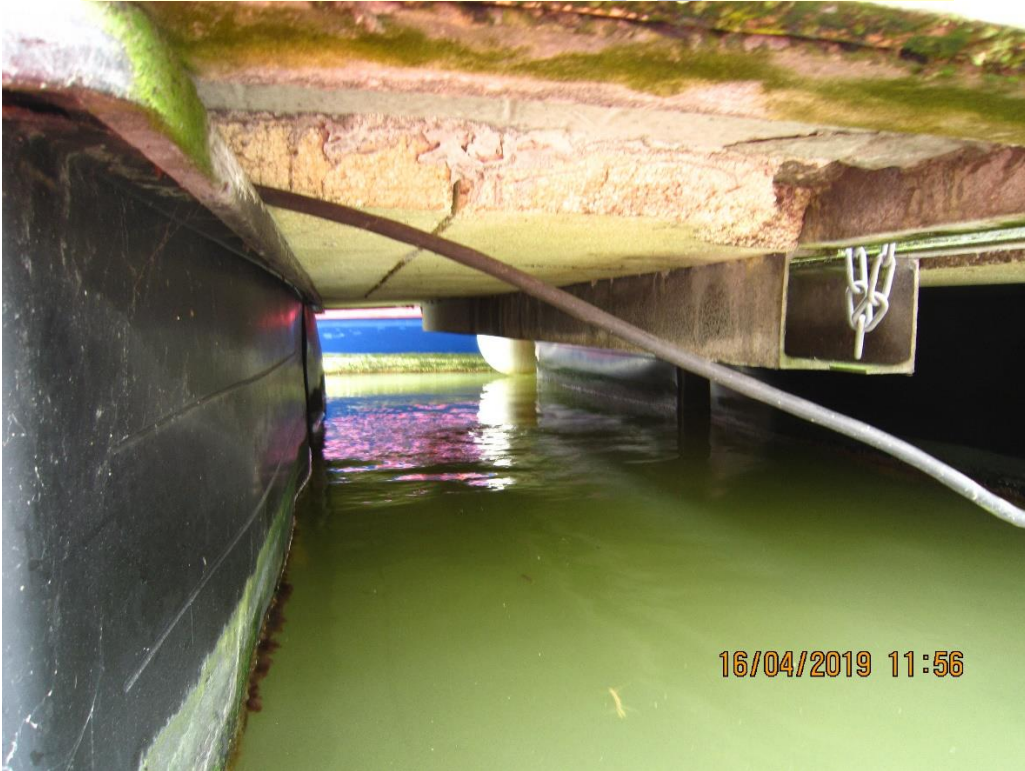
The frames are supported on 2500 x 1200 x 900 mm polystyrene enclosed in plastic effectively a tank and lid, bolted to frame.

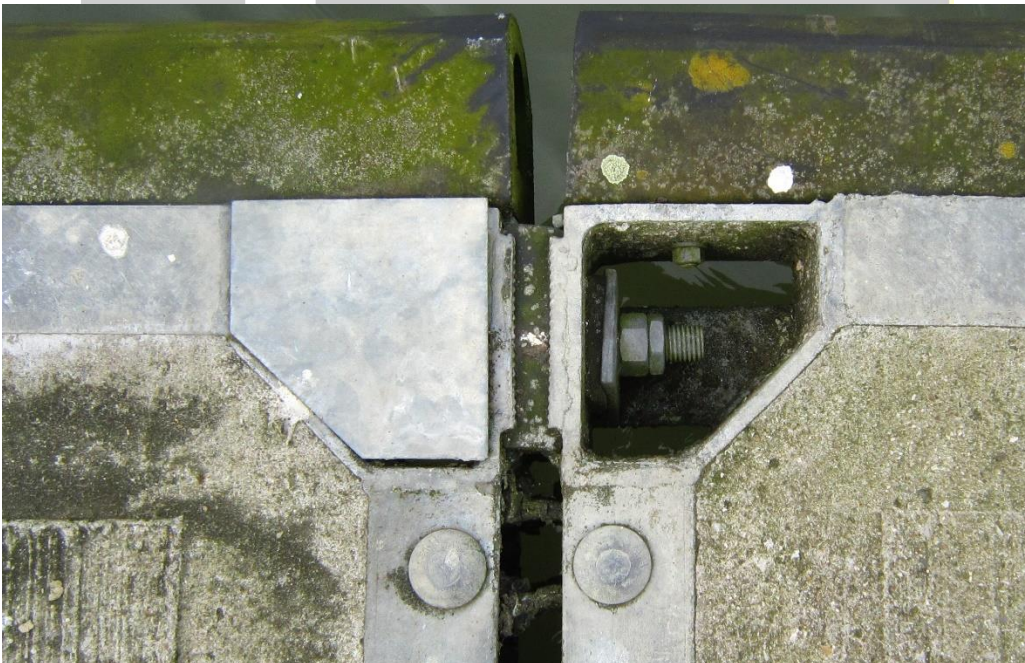
Sections of pontoon are bolted together through rubber blocks and a safety sling.

These are all in good condition. D section rubber fenders to front face good.
