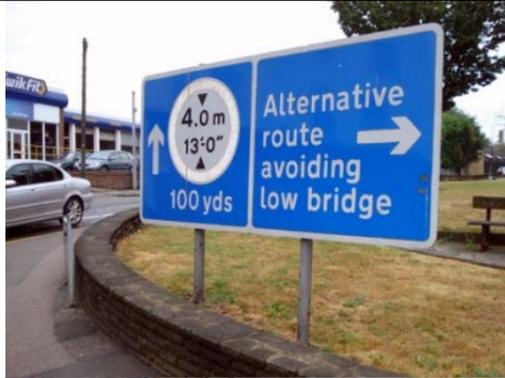
Chainage (m)	Street Furniture	Description	Size (mm)	Reduction Applicable	Legally Correct	Condition	Material	X Height (mm)	Additional restriction/furniture required?	Safety implications if removed	Recommendations/ reasons	Picture Reference	
	Road	High St, Southbound						Assessor				Date	
0	Sign	First Panel Bridge with restricted height 100 yards ahead	1.2mx2.6m	Yes	No	Poor	Metal	110	Map type sign	None	Renew left hand panel. Positively sign the HGV route Dispense with the right hand panel, correct the distance to 150 yards to replicate the sign opposite (See Below)

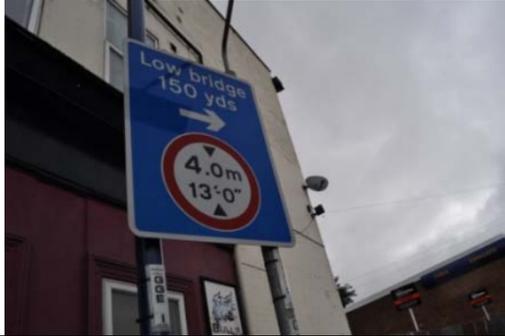
SE Kerbline of Gun Lane	Second Panel Direction to avoid the low bridge	750 (r)	Yes			Metal		None	None	Smaller x height on both

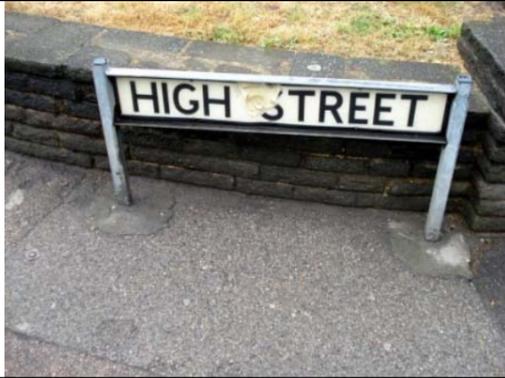
5.2	Street Name Plate	'High Street'		No	Yes	Poor	Metal	100	New Street Name Plate: 'High Street'	None	Replace with an enamel sign, and attach to the wall.

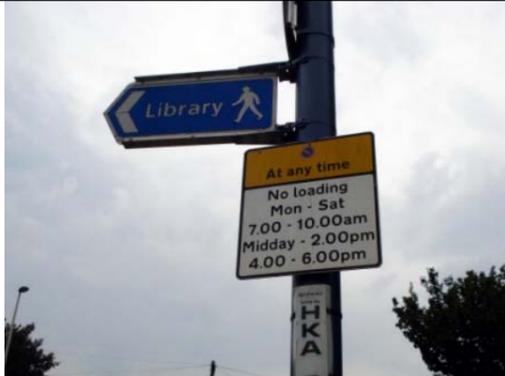
6.8	Pedestrian Sign	'Library' Sign on L/C HKA2	550 (w) 250 (h)	Yes	Yes	Adequate	Metal	40	None	None	Remove

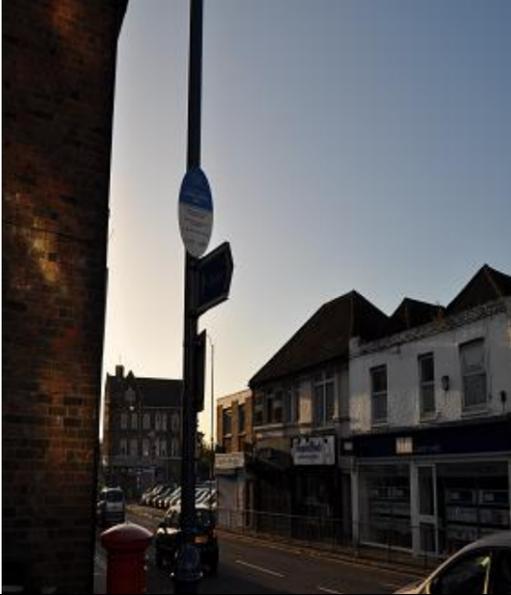
Chainage (m)	Street Furniture	Description	Size (mm)	Reduction Applicable	Legally Correct	Condition	Material	X Height (mm)	Additional restriction/furniture required?	Safety implications if removed	Recommendations/ reasons	Picture Reference
6.8	Sign – Not Official	'Drink Aware' Sign on L/C HKA2	450 (h) 350 (w)	Yes	N/A	Good	Metal		None	None	Reduce number of signs through High Street, Strood. Determine the minimum number of signs required.

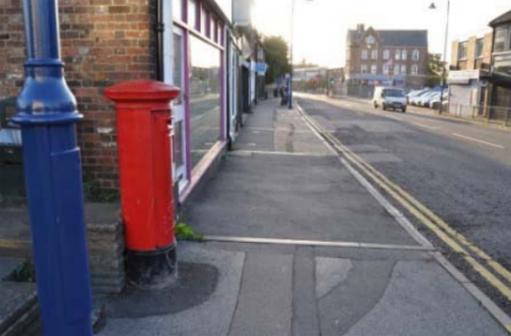
8.4	P.O Box			No	Yes	Adequate	Metal	N/A	None	None	Keep

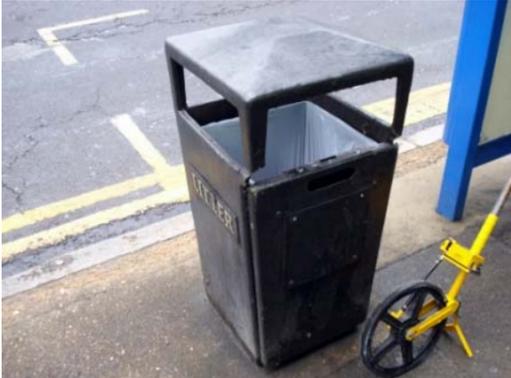
50.6	Litter Bin	Litter Bin adjacent to Bus Stop	500 x 500	Yes	N/A	Poor	Plastic	N/A	New Litter Bin	None	Replace with new and attach to lamp column north of the bus stop.

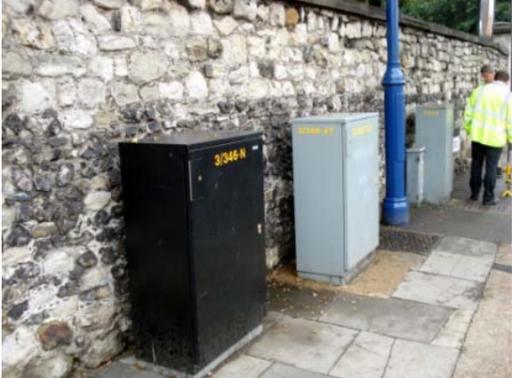
Chainage (m)	Street Furniture	Description	Size (mm)	Reduction Applicable	Legally Correct	Condition	Material	X Height (mm)	Additional restriction/furniture required?	Safety implications if removed	Recommendations/reasons	Picture Reference
69.2	3 Cabinets 2 Feeder Pillars	3/346-N 3/346-347 3/345		Yes		Adequate	Metal	N/A	No	None	Remove

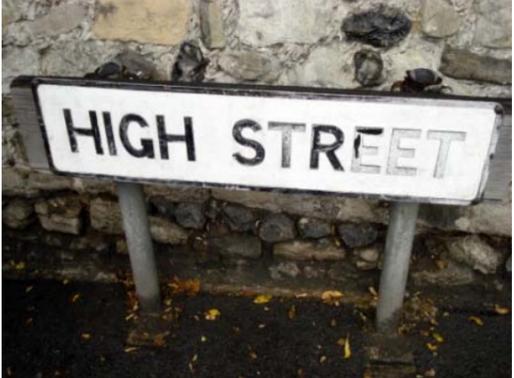
75	Street Name Plate	'High Street'	230 (h) 1m (w)	Yes	Yes	Poor	Metal	100	New Street Name Plate: 'High Street'	None	Replace with an enamel sign, and attach to the wall.

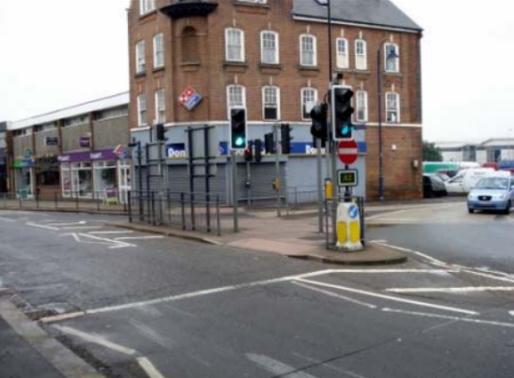
79.2	Bollard	Keep Left Bollard (Centre Island)		Yes	Yes	Poor	Plastic	N/A	New Weebol to replace existing	None	Replace existing with a Weebol

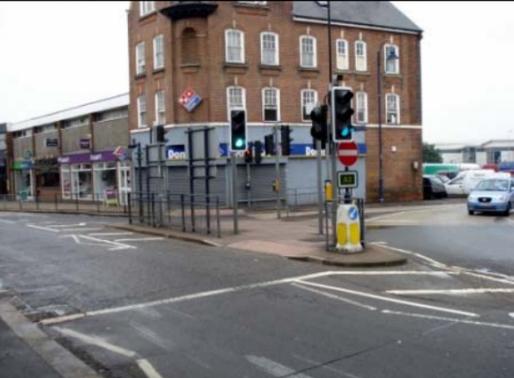
79.4	Guardrail	Around the Centre Island	17m	Yes	Yes	Poor	Metal	N/A	None	None	Remove all guardrail

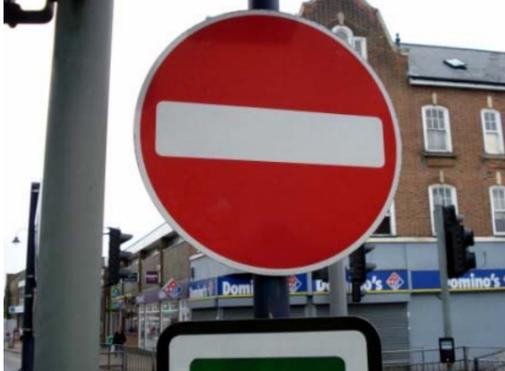
80	Road Sign	'No entry' On lit post	600 (r)	No	Yes	Good	Metal	N/A	None	None	Keep

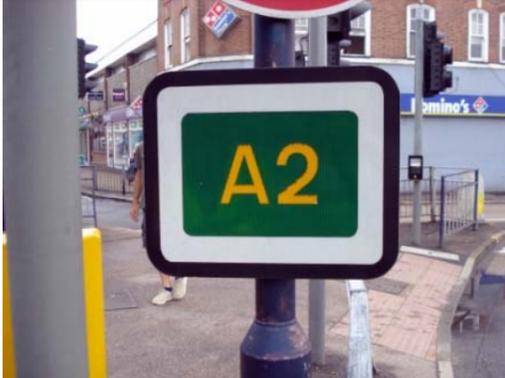
80	Road Sign	'A2' On lit post	400 (w) 380 (h)	No	Yes	Good	Metal		None	None	Remove

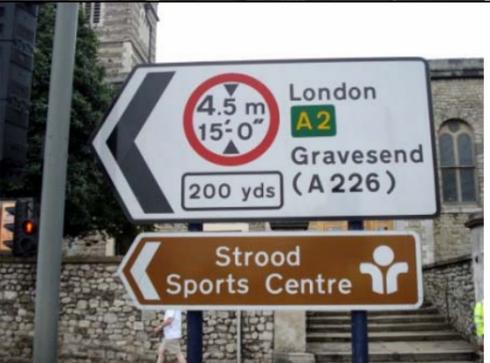
85	Road Sign (top)	Two posted direction sign on Island	970 (h) 2m (w) 550 (r)	Yes	Yes	Good	Metal	80	New Sign with smaller x height	None	Incorporate the 2 signs and replace existing sign with smaller x height.

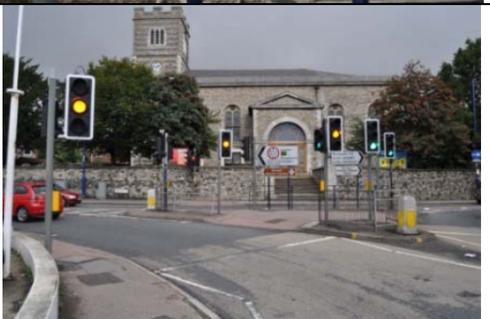
Road Sign (bottom)	Two posted direction sign on Island	430 (h) 1.7 (w)	Yes	Yes	Good	Metal		New Sign without the text: 'Strood Sports Centre'	None		
86	Traffic Signals	(4) On Island Pedestrian Head Push Button Unit

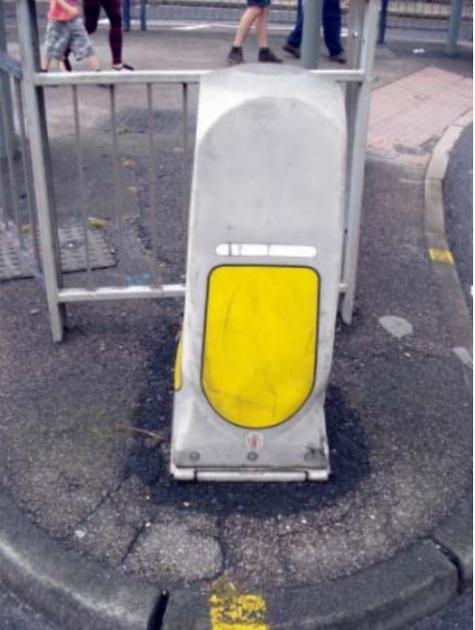
Chainage (m)	Street Furniture	Description	Size (mm)	Reduction Applicable	Legally Correct	Condition	Material	X Height (mm)	Additional restriction/furniture required?	Safety implications if removed	Recommendations/ reasons	Picture Reference
88	Bollard	Plain face Bollard on island		Yes	Yes	Poor	Plastic	N/A	New Weebol to replace existing	None	Replace with new Weebol

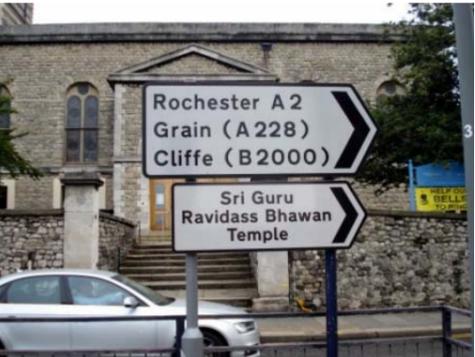
88	Road Sign	Direction Sign on Island (Top)	660 (h) 1.6m (w)	Yes	Yes	Good	Metal	80	New sign to replace existing	None	Smaller x height

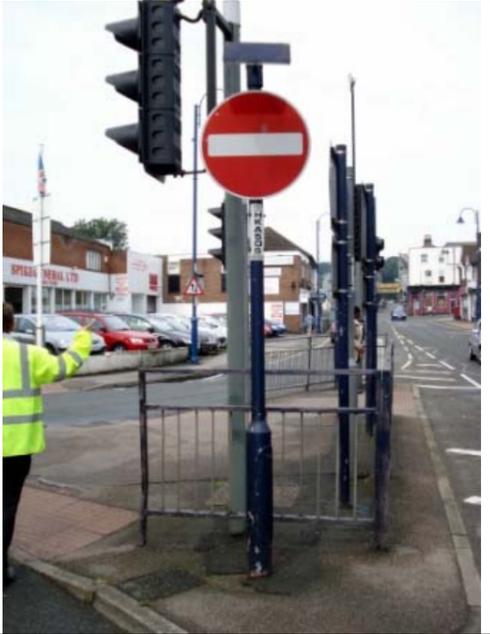
90.5	Road Sign	'No Entry' Sign on HKA505 - Lit		Yes	Yes	Adequate	Metal	N/A	None	None	Remove

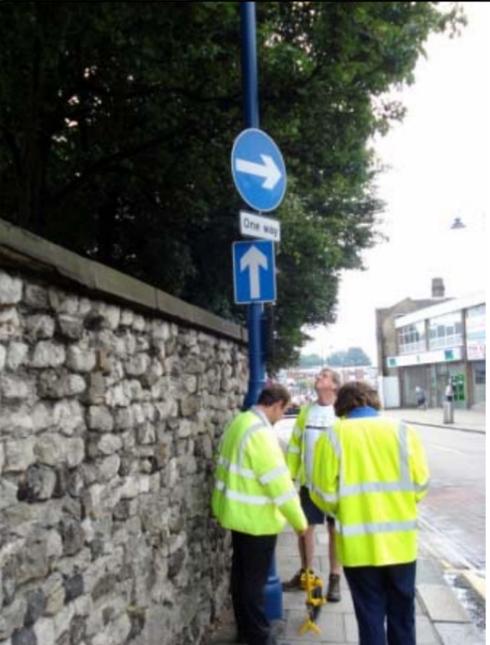
100.4	Road Sign	One Way sign on HKA7	600 (r)	No	Yes	Adequate	Metal	62	None	None	Keep

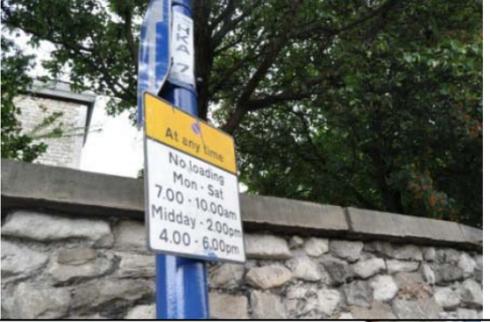
Chainage (m)	Street Furniture	Description	Size (mm)	Reduction Applicable	Legally Correct	Condition	Material	X Height (mm)	Additional restriction/furniture required?	Safety implications if removed	Recommendations/ reasons	Picture Reference
100.4	Loading Plate	No Loading at any time on HKA7	370 350	Yes	Yes	Adequate	Metal	20	New Plate reading: No loading Mon – Sat 7.00 – 10.00am Midday – 2.00pm 4.00 – 6.00pm	None	Remove and replace with a new loading plate

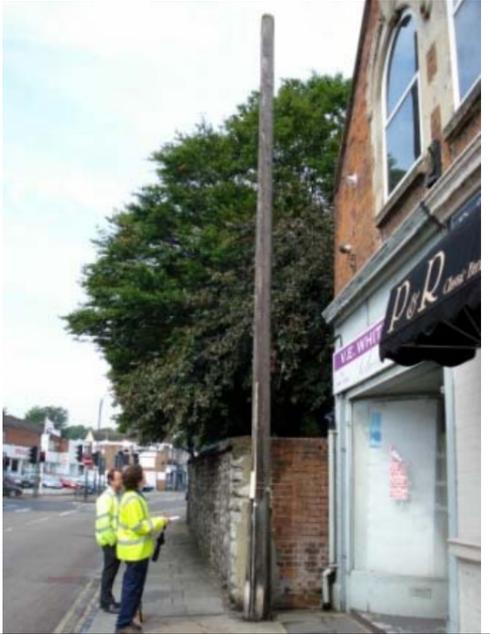
126.4	Telegraph Pole 30-83 IFCV63			No		Poor	Wood	N/A	None	None	Keep

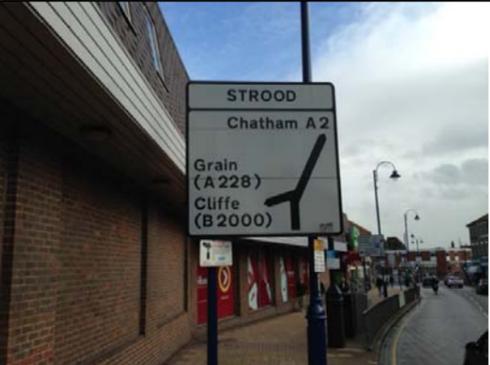
148.8	Road Sign	Two posted direction sign on HKA9	1.9 (w) 1.9 (h)	Yes	Yes	Adequate	Metal	100	None	None	Remove

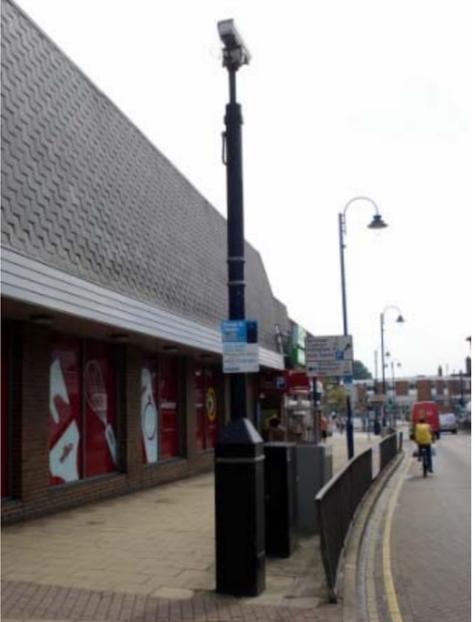
156.8	CCTV camera	CCTV Camera outside Wilkinsons	400 x 400	Yes		Adequate	Metal	N/A	None	None	Retain

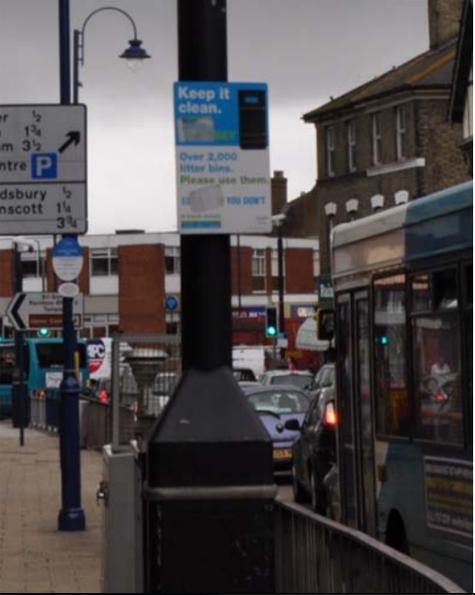
Chainage (m)	Street Furniture	Description	Size (mm)	Reduction Applicable	Legally Correct	Condition	Material	X Height (mm)	Additional restriction/furniture required?	Safety implications if removed	Recommendations/ reasons	Picture Reference
156.8	Sign – Not Official	Keep it clean on camera sign	500 (h) 350 (w)	Yes		Good	Metal	N/A	None	None	Reduce number of signs on High Street, Strood

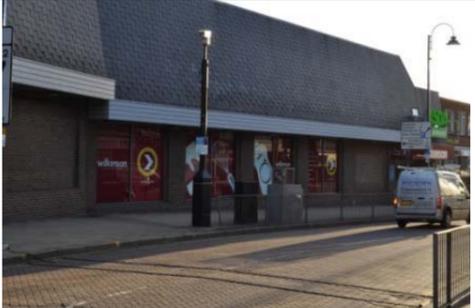
156.8	Guardrail	On north side of carriageway	24m	Yes	Yes	Poor	Metal	N/A	Deterrent needed to prevent parking	None	Remove all guardrail, but install deterrent to prevent parking outside Wilkinsons

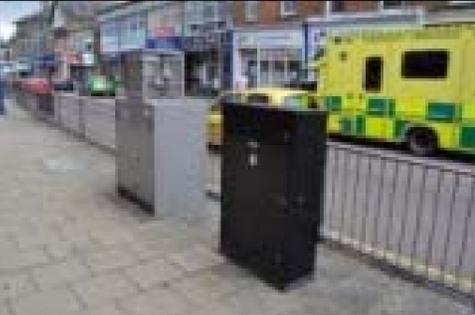
158.7	Black Cabinet	Charles Endirect Ltd	800 x 350	Yes	Yes	Adequate	Metal	N/A	None	None	Remove or Relocate in liaison with traffic signal team

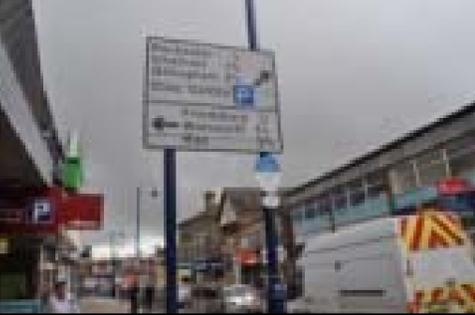
174	Direction Sign	Direction sign on L/C HKA 10	1.35 (h) 1.65 (w)	Yes	Yes	Adequate	Metal	80	Additional Sign mounted on L/C HKA 11	None	Sign to be removed. "Rochester 1/2" and "P" to be relocated to L/C HKA 11

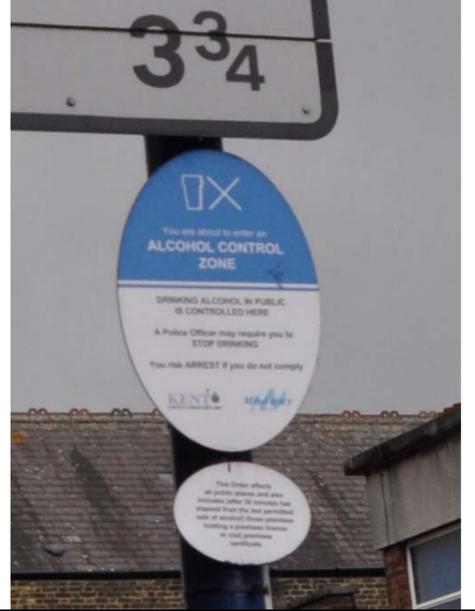
174 on L/C	Sign – Not Official	'Drink Aware' Sign on L/C HKA2	450 (h) 350 (w)	Yes	N/A	Good	Metal	N/A	None	None	Reduce number of signs through High Street, Strood.

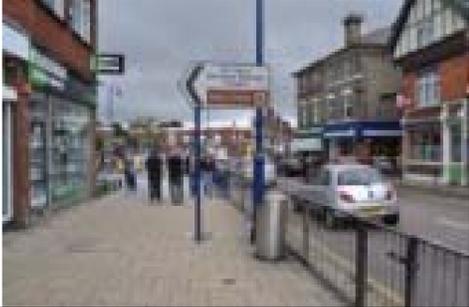
Chainage (m)	Street Furniture	Description	Size (mm)	Reduction Applicable	Legally Correct	Condition	Material	X Height (mm)	Additional restriction/furniture required?	Safety implications if removed	Recommendations/ reasons	Picture Reference
190.6	Guardrail	Start of	37m	Yes	Yes	Poor	Metal	N/A	None	None	Remove full length

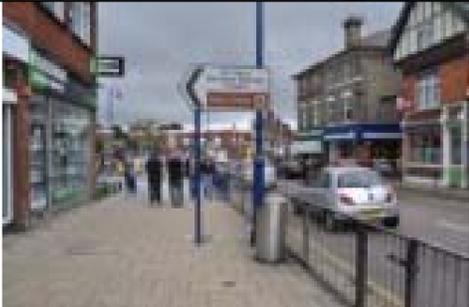
198.1	Litter Bin	Litter Bin next to L/C HKA 11		No	Yes	Adequate	Metal	N/A	None	None	Keep and locate on lamp column.

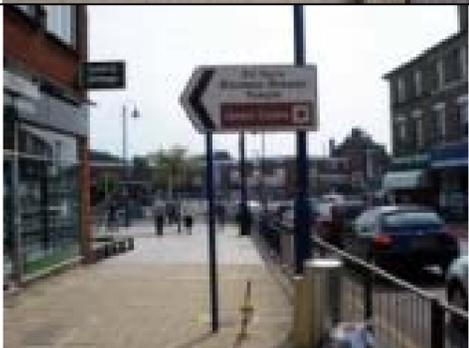
199.2	Direction Sign	One posted Direction Sign on L/C HKA 11	1.5 (w) 780 (h)	Yes	Yes	Adequate	Metal	65	Use the same sign at the junction with North Street	None	Remove sign and install replicate sign on island at North Street

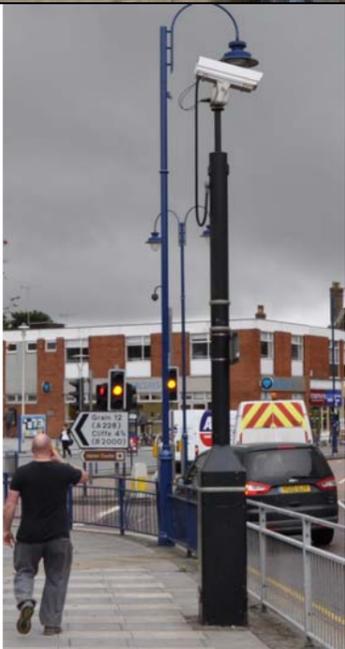
215.7	CCTV camera	CCTV Camera next to statue	400 x 400	Yes	Yes	Adequate	Metal	N/A	None	None	Reduce number of CCTV Cameras throughout

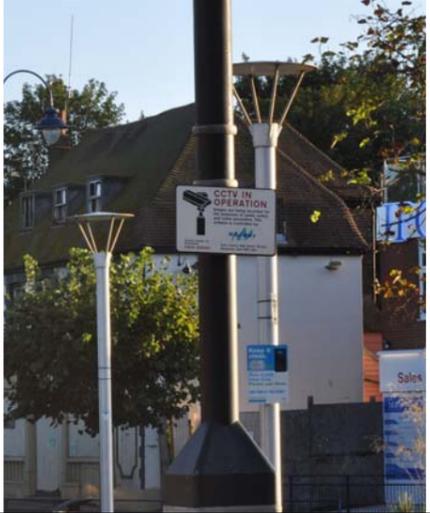
Chainage (m)	Street Furniture	Description	Size (mm)	Reduction Applicable	Legally Correct	Condition	Material	X Height (mm)	Additional restriction/furniture required?	Safety implications if removed	Recommendations/ reasons	Picture Reference
215.7	CCTV in operation	Depth Width	300 500	Yes	Yes	Adequate	Metal	N/A	None	None	Determine if the sign is a legal requirement, if not remove.

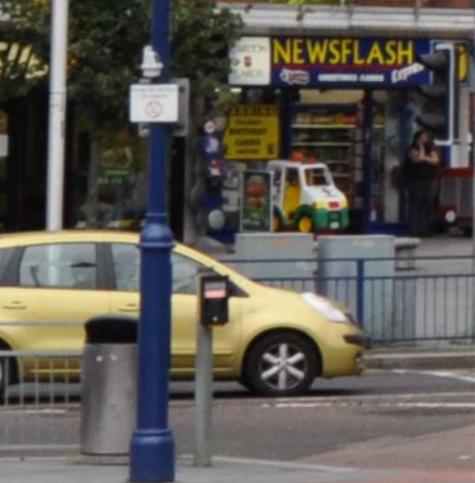
0.3	Litter Bin	Litter Bin next to L/C HKA 11		No	Yes	Adequate	Metal	N/A	None	None	Keep and relocate on L/C NDI 1

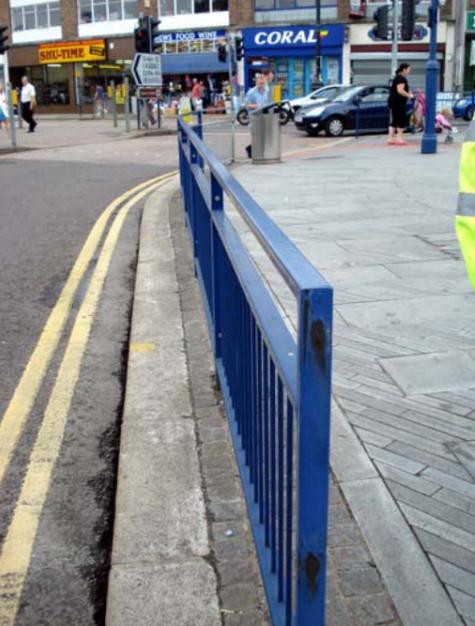
0.4	Guardrail	Start of	12m	Yes	Yes	Poor	Metal	N/A	None	None	Remove

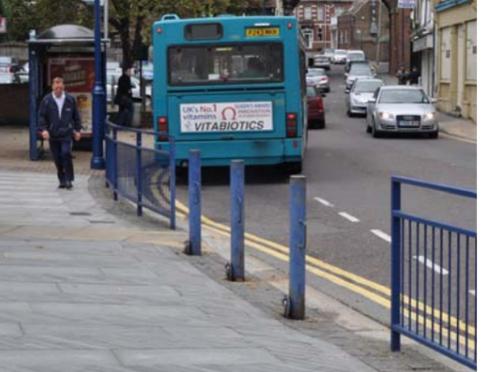
Chainage (m)	Street Furniture	Description	Size (mm)	Reduction Applicable	Legally Correct	Condition	Material	X Height (mm)	Additional restriction/furniture required?	Safety implications if removed	Recommendations/ reasons	Picture Reference
13.5	Bollard (1)	Removable Bollard		Yes	Yes	Poor	Metal	N/A	None	None	Remove

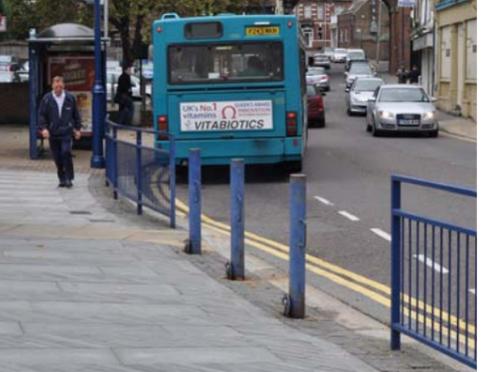
15.2	Bollard (2)	Removable Bollard		Yes	Yes	Poor	Metal	N/A	None	None	Remove

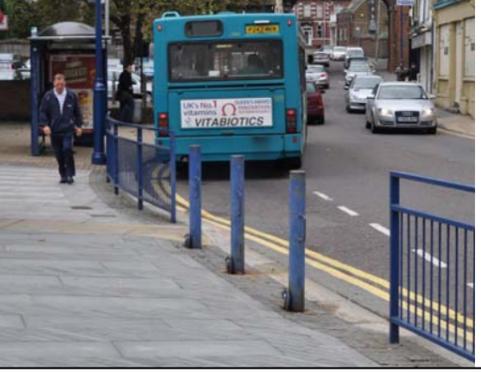
16.9	Bollard (3)	Removable Bollard		Yes	Yes	Poor	Metal	N/A	None	None	Remove

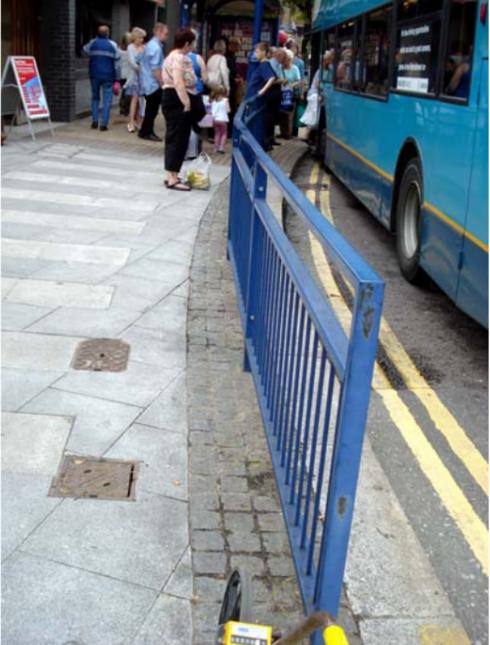
Chainage (m)	Street Furniture	Description	Size (mm)	Reduction Applicable	Legally Correct	Condition	Material	X Height (mm)	Additional restriction/furniture required?	Safety implications if removed	Recommendations/ reasons	Picture Reference
18.5	Guardrail	Outside the PO	10m	Yes	Yes	Poor	Metal	N/A	Deterrent needed to prevent parking	None	Remove all guardrail, but install deterrent to prevent parking outside the PO

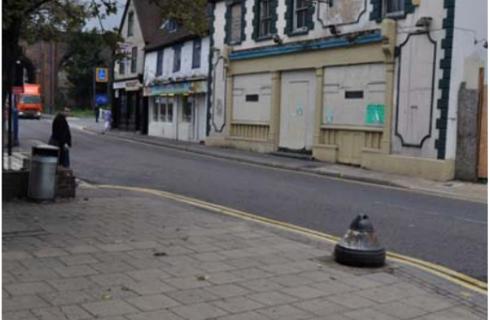
38.7	Bell Bollard	Outside the PO		Yes	Yes	Poor	Metal	N/A	Replacement bollard	None	Replace Bollard with new

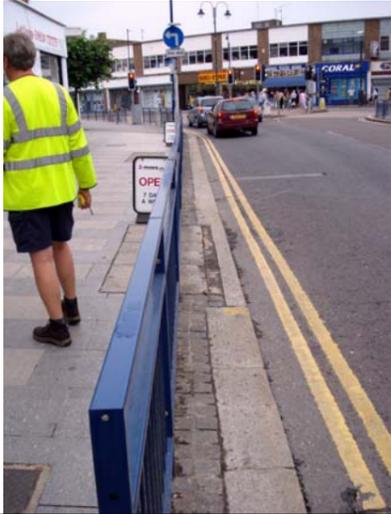
Chainage (m)	Street Furniture	Description	Size (mm)	Reduction Applicable	Legally Correct	Condition	Material	X Height (mm)	Additional restriction/furniture required?	Safety implications if removed	Recommendations/ reasons	Picture Reference
	Road						Assessor				Date	
36.3	Guardrail	Start of guardrail	42m	Yes	Yes	Poor	Metal	N/A	Deterrent needed	None	Remove all guardrail, replace with deterrent to avoid cars mounting the kerb.

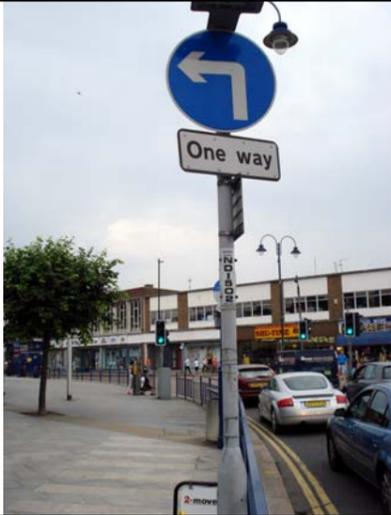
20	Road Sign	'One way' Sign on Lit post NDI 502	600 (r)	Yes	Yes	Adequate	Metal		Yes. Existing 'one way' sign to be relocated to L/C NDI 4	None	Put on L/C NDI 4

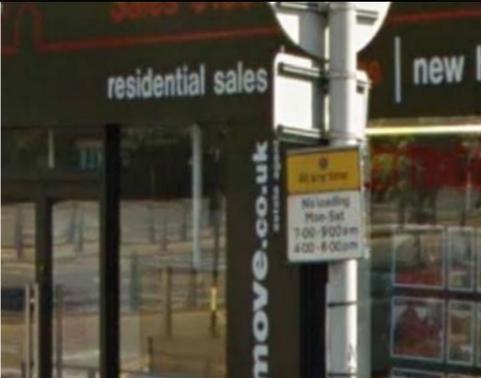
20	Loading Plate	No Loading at any time	370 350	Yes	Yes	Adequate	Metal	20	New Plate reading: No loading Mon – Sat 7.00 – 10.00am Midday – 2.00pm 4.00 – 6.00pm	None	Remove and replace with a new loading plate

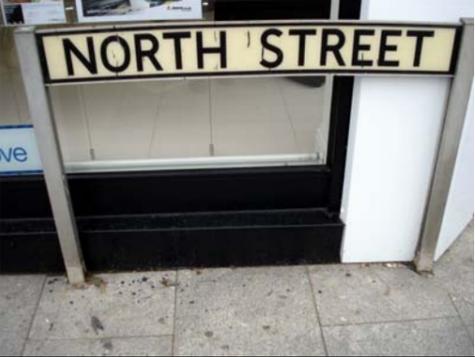
Chainage (m)	Street Furniture	Description	Size (mm)	Reduction Applicable	Legally Correct	Condition	Material	X Height (mm)	Additional restriction/furniture required?	Safety implications if removed	Recommendations/ reasons	Picture Reference
20	S.N.P	'North Street'	1.23m (w) 155 (h)	No	Yes	Adequate	Metal	100	None	None	Keep

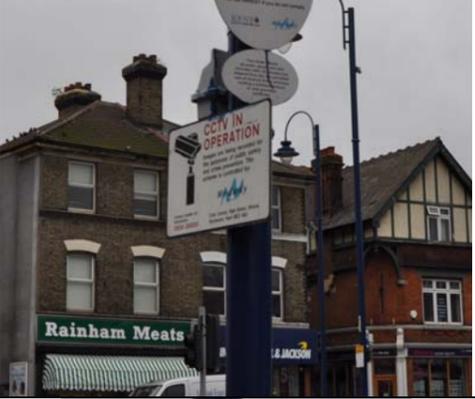
12.4	CCTV in operation	Depth Width	300 500	Yes	Yes	Adequate	Metal	N/A	None	None	Remove through liaison with Community Safety division

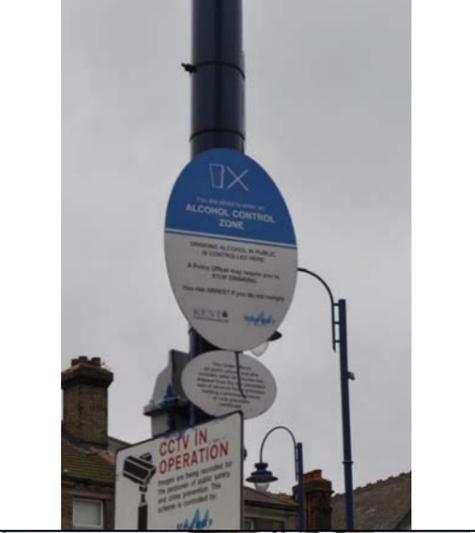
12.4	Sign – Not Official	'Drink Aware' Sign on L/C NDI 4	450 (h) 350 (w)	Yes	N/A	Good	Metal	N/A	None	None	Remove through liaison with Community Safety division

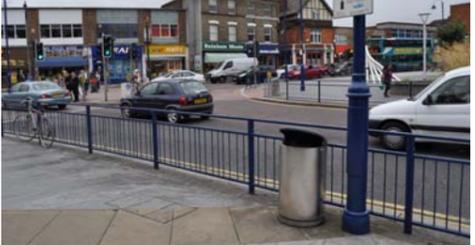
12	Litter Bin			No	Yes	Adequate	Metal	N/A	None	None	Keep and relocate on L/C NDI 4

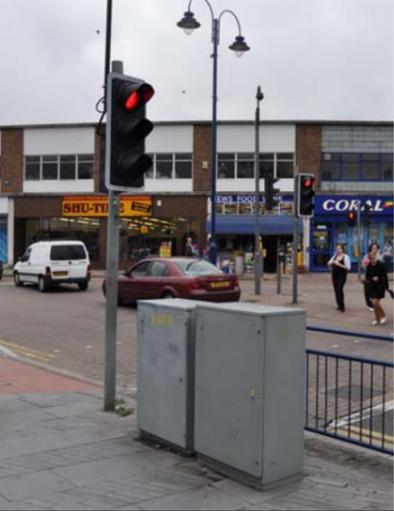
Chainage (m)	Street Furniture	Description	Size (mm)	Reduction Applicable	Legally Correct	Condition	Material	X Height (mm)	Additional restriction/furniture required?	Safety implications if removed	Recommendations/reasons	Picture Reference
0	Control Box	Siemens 3-320 3-320N		Yes	Yes	Adequate	Metal	N/A	None	None	Remove or relocate through liaison with Traffic Signals team

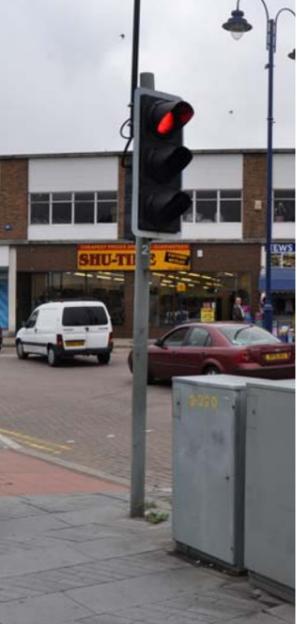
-3	Traffic Signals on path

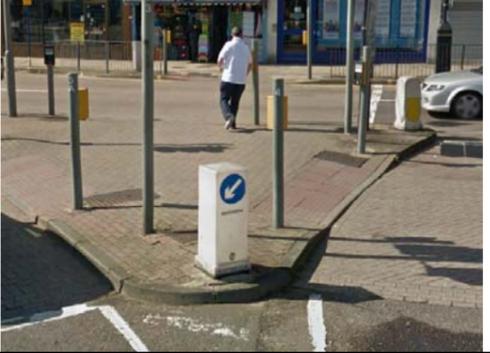
Chainage (m)	Street Furniture	Description	Size (mm)	Reduction Applicable	Legally Correct	Condition	Material	X Height (mm)	Additional restriction/furniture required?	Safety implications if removed	Recommendations/reasons	Picture Reference
240.1	Illuminated Bollard			Yes	Yes	Poor	Plastic	N/A	Replace existing with a new Weebol	None	Replace existing with a Weebol

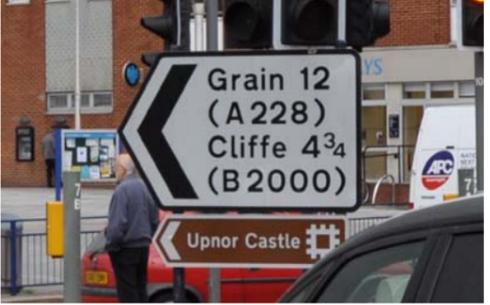
240.1	Direction Sign (Top)	Direction Sign: "Grain 12 (A228) Cliffe 4 3/4 (B2000)"	1m (h) 1.6m (w)	Yes	Yes	Adequate	Metal	100	None	None	Remove

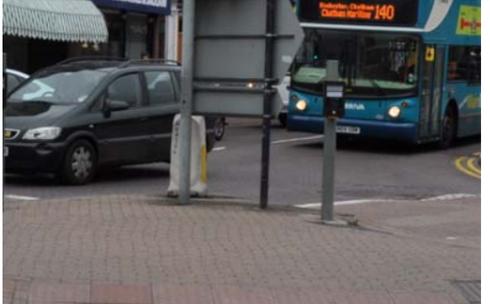
Direction Sign (Bottom)	Upnor Castle	1.3 (h) 330 (w)					65			Remove	
240.1	Illuminated Bollard	Keep left Bollard towards North Street		Yes	Yes	Poor	Plastic	N/A	Replace existing with new Weebol	None	Replace existing with Weebol

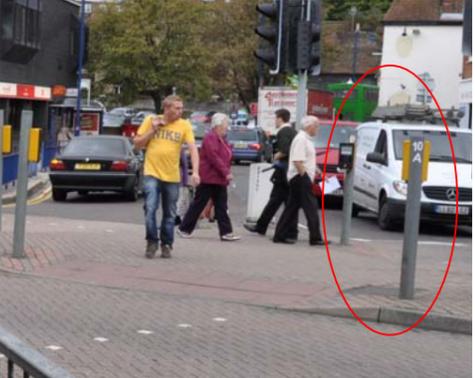
0	Guardrail	Start of Guardrail	36m	Yes	Yes	Adequate	Metal	N/A	Deterrent needed	None	Remove all guardrails and replace with deterrent to disable cars from mounting the kerb.

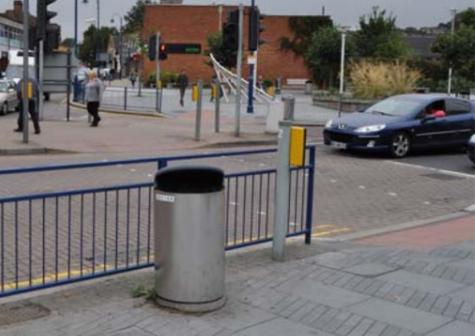
2	Litter Bin			No	Yes	Adequate	Metal	N/A	None	None	Relocate on nearby lamp column HKA 50

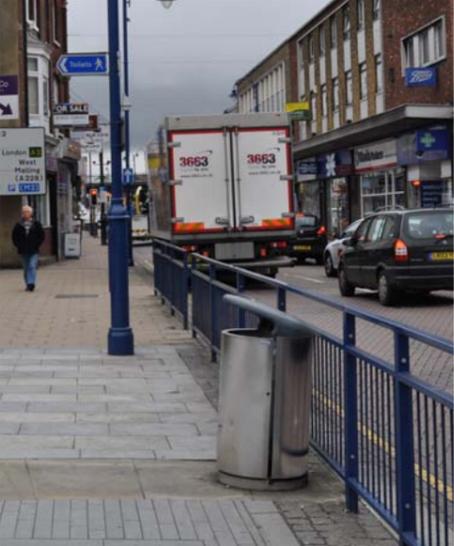
Chainage (m)	Street Furniture	Description	Size (mm)	Reduction Applicable	Legally Correct	Condition	Material	X Height (mm)	Additional restriction/furniture required?	Safety implications if removed	Recommendations/ reasons	Picture Reference
22.4	Litter Bin			No	Yes	Adequate	Metal	N/A	None	None	Relocate on nearby lamp column HKA 17

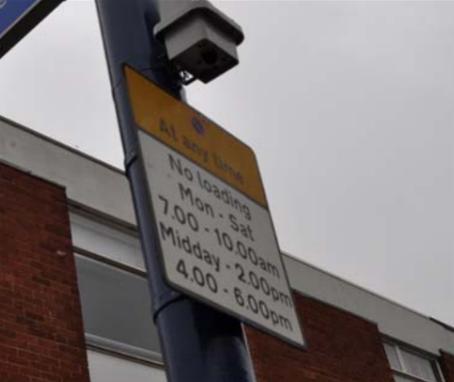
28.3	Loading Plate	No Loading at any time	370 350	Yes	Yes	Adequate	Metal	20	New Plate reading: No loading Mon – Sat 7.00 – 10.00am Midday – 2.00pm 4.00 – 6.00pm	None	Remove and replace with a new loading plate

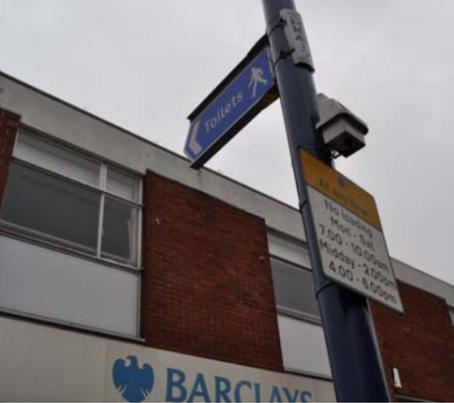
28.3	Pedestrian Sign	“Toilet” sign	250 (h)	No	Yes	Adequate	Metal		None	None	None

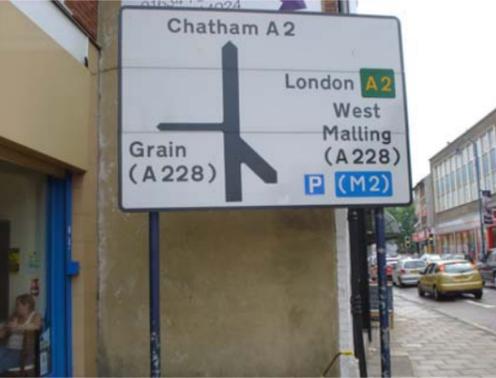
Chainage (m)	Street Furniture	Description	Size (mm)	Reduction Applicable	Legally Correct	Condition	Material	X Height (mm)	Additional restriction/furniture required?	Safety implications if removed	Recommendations/ reasons	Picture Reference
48.5	Road Sign	Two posted junction sign		Yes	Yes	Adequate	Metal		New sign to replace existing.	None	Remove 'Chatham A2' 'Grain (A228)' 'West Malling (A228)' Add Bridge restriction "London" to be in green and yellow

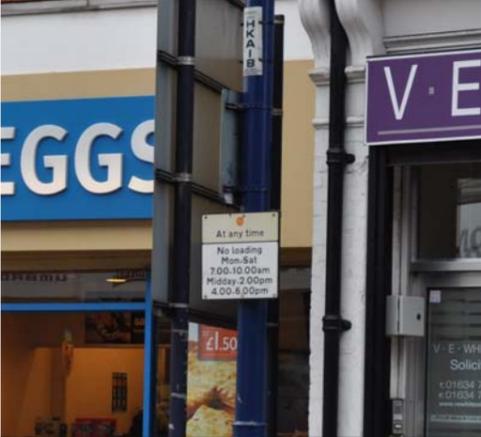
50.3	Loading Plate	No Loading at any time	370 350	Yes	Yes	Adequate	Metal	20	New Plate reading: No loading Mon – Sat 7.00 – 10.00am Midday – 2.00pm 4.00 – 6.00pm	None	Remove and replace with a new loading plate

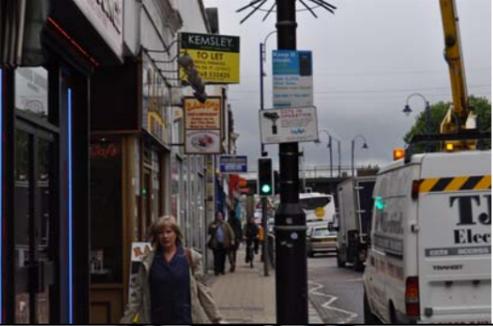
Chainage (m)	Street Furniture	Description	Size (mm)	Reduction Applicable	Legally Correct	Condition	Material	X Height (mm)	Additional restriction/furniture required?	Safety implications if removed	Recommendations/ reasons	Picture Reference
75.3	CCTV post			Yes	Yes	Adequate	Metal	N/A	None	None	Reduce number of CCTV Cameras in Strood High Street in liaison with Community Safety service.

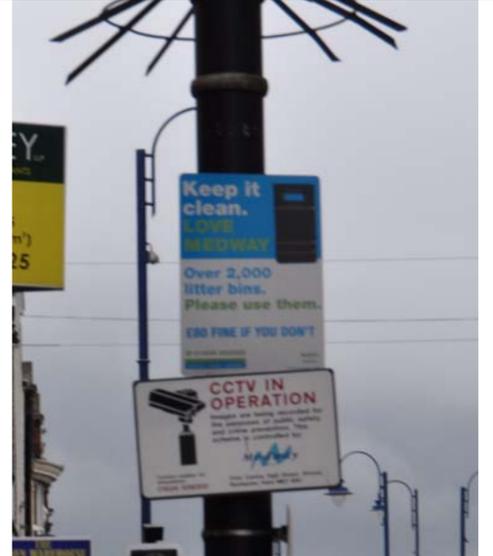
75.3	Love Medway Sign on CCTV post										Remove

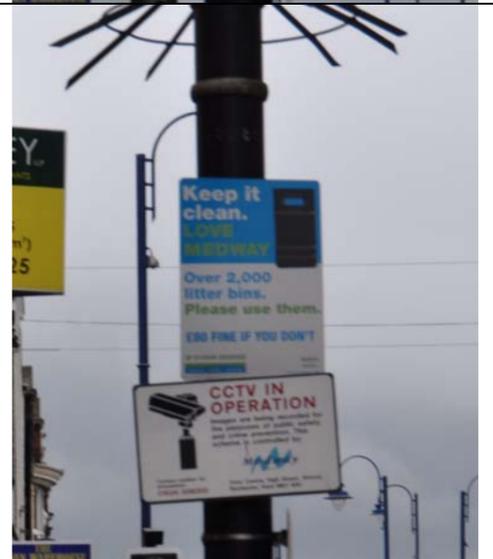
75.3	CCTV sign	CCTV in operation	300 (h) 500 (w)	Yes	Yes	Adequate	Metal	N/A	None	None	Reduce number of CCTV Cameras in Strood High Street in liaison with Community Safety service.

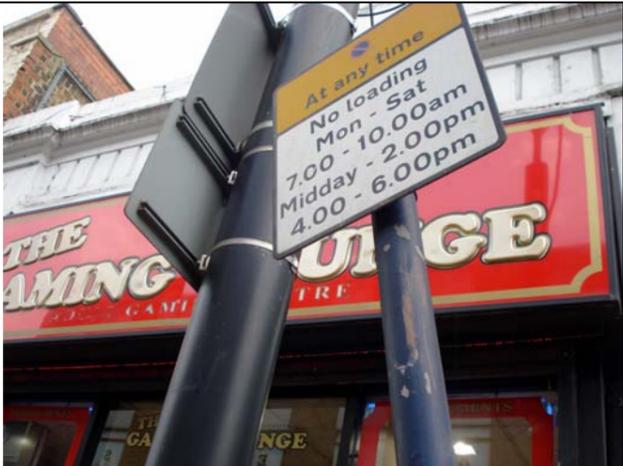
Chainage (m)	Street Furniture	Description	Size (mm)	Reduction Applicable	Legally Correct	Condition	Material	X Height (mm)	Additional restriction/furniture required?	Safety implications if removed	Recommendations/ reasons	Picture Reference
76.3	Loading Plate	No Loading at any time	370 350	Yes	Yes	Adequate	Metal	20	New Plate reading: No loading Mon – Sat 7.00 – 10.00am Midday – 2.00pm 4.00 – 6.00pm	None	Remove and replace with a new loading plate

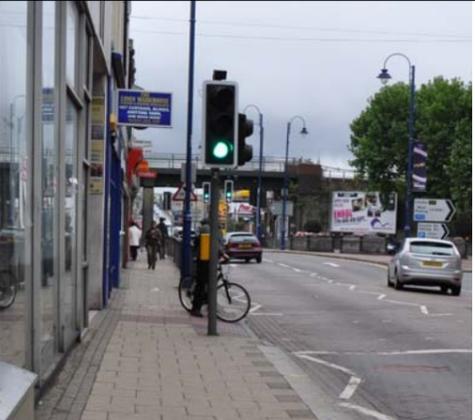
Road							Assessor				Date	
95.9	Traffic Signal										Convert to Puffin crossing

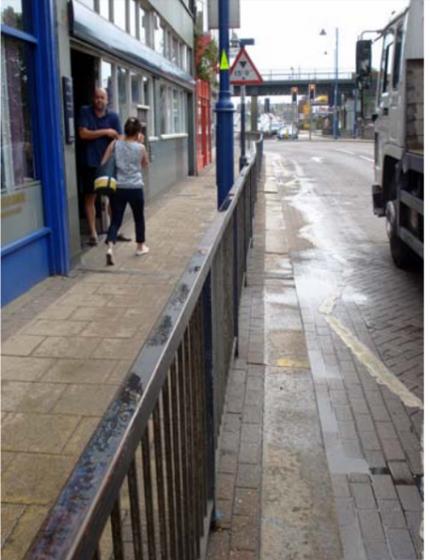
100.5	Guardrail	Start of Guardrail	36.5m	Yes	Yes	Poor	Metal	N/A	Remove guardrail	None	Remove Guardrail until chainage 137.00

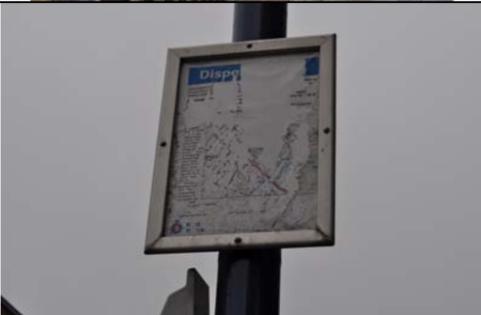
107.3	Police sign	On HKA 20		Yes	No	Poor	Plastic	N/A	None	None	Remove

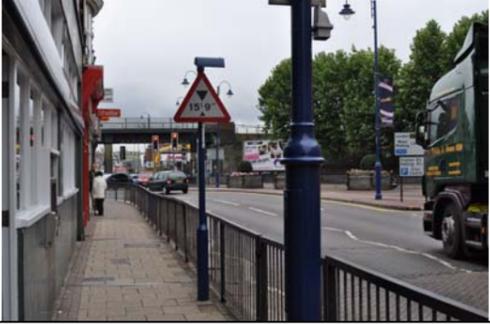
Chainage (m)	Street Furniture	Description	Size (mm)	Reduction Applicable	Legally Correct	Condition	Material	X Height (mm)	Additional restriction/furniture required?	Safety implications if removed	Recommendations/reasons	Picture Reference
111.6	Warning Sign	Lit Height warning sign on HKA 507		Yes	Yes	Adequate	Metal		None	None	Remove

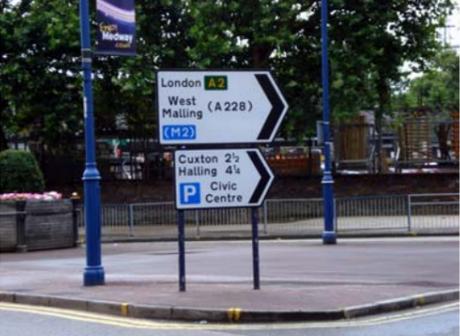
Road	High Street - Northbound						Assessor				Date	
0 Ferndale Corner	Direction Sign	'London A2' 'West Malling (A228)' 'M2' 'Cuxton 2 ½ ' 'Halling 4 ¼ ' 'P' 'Civic Centre'		Yes	Yes	Adequate	Metal		New sign to replace existing two	None	Remove: 'West Malling' 'Cuxton 2 ½ ' 'Halling 4 ¼ ' 'Civic Centre' 1 post only

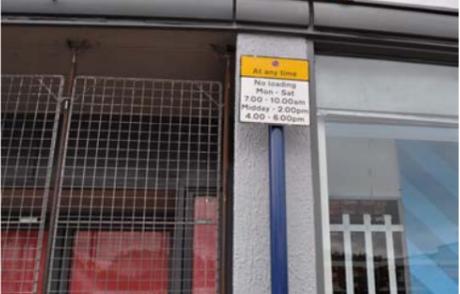
90	Loading Plate	No Loading at any time	370 350	Yes	Yes	Adequate	Metal	20	New Plate reading: No loading Mon – Sat 7.00 – 10.00am Midday – 2.00pm 4.00 – 6.00pm	None	Remove and replace with a new loading plate

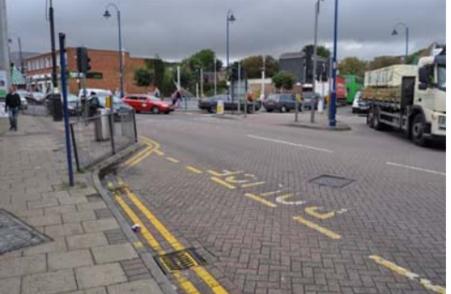
Chainage (m)	Street Furniture	Description	Size (mm)	Reduction Applicable	Legally Correct	Condition	Material	X Height (mm)	Additional restriction/furniture required?	Safety implications if removed	Recommendations/reasons	Picture Reference
104.3	Police Bay and Pole	'No stopping except Police'		No	Yes	Adequate	Metal	N/A	None	None	Renew marking

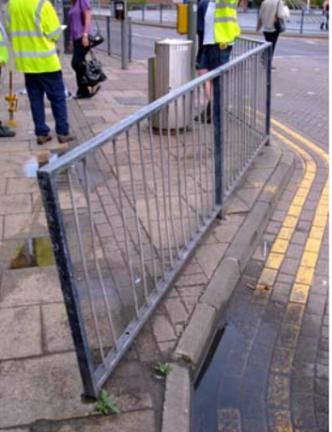
105.5	Guardrail	Start of Guardrail	6m	Yes	Yes	Poor	Metal	N/A	None	None	Remove length of guardrail

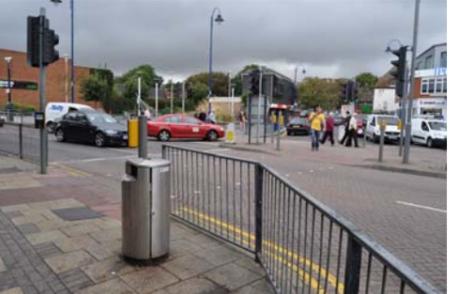
109	Litter Bin			No	Yes	Adequate	Metal	N/A	None	None	Relocate on nearby post to the south

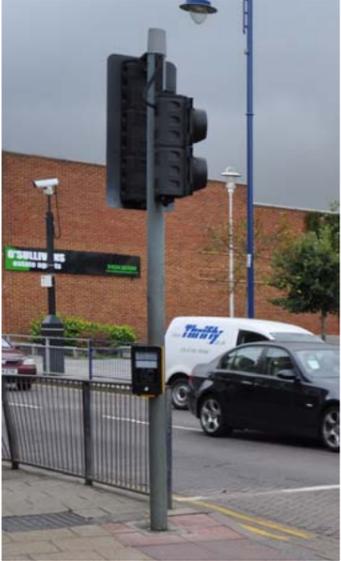
115.3	Guardrail	Start of guardrail	26m	Yes	Yes	Poor	Metal	N/A	Footpath to be widened.	None	Remove all guardrails. Widen footpath opposite the Butchers to allow enough room for pedestrians to pass safely.

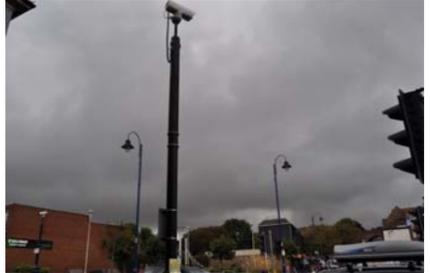
118.2	CCTV camera	CCTV Camera near Butchers	400 x 400	Yes	Yes	Adequate	Metal	N/A	None	None	Reduce number of CCTV Cameras throughout

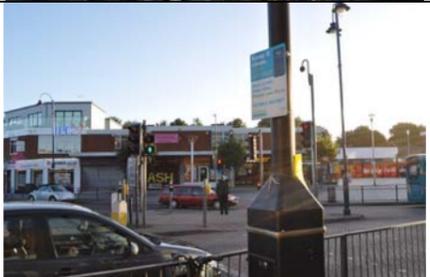
118.2	Keep Medway Clean Sign	On CCTV Post		Yes	No	Adequate	Metal	N/A	None	None	Remove in liaison with the Community Safety team.

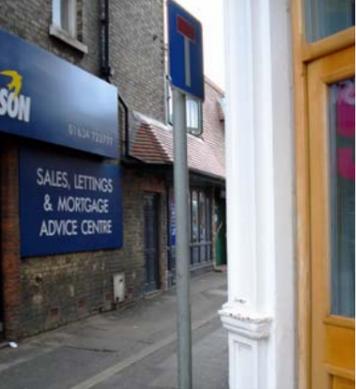
138.9	Road Sign	No through route (816.1)		Yes	Yes	Adequate	Metal	N/A	New Street Name Plate and No Through route Sign	None	Remove existing sign and replace with a new street name plate with a no through route sign attached.

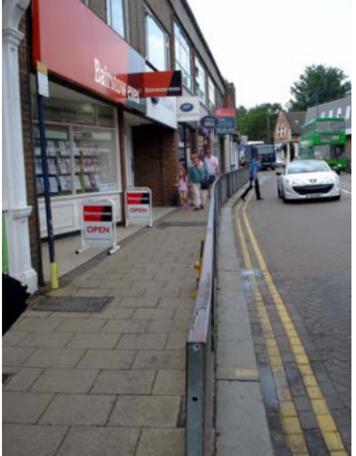
140.9	Guardrail	Start of guardrail	32m	Yes	Yes	Poor	Metal	N/A	None	None	Remove Guardrail

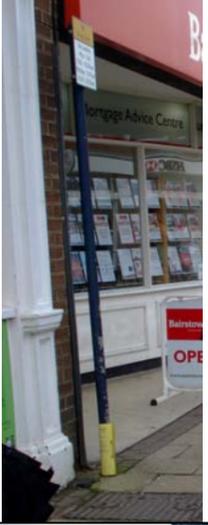
145.4	Loading Plate	'No loading at any time' plate on post	370 (h) 350 (w)	Yes	Yes	Adequate	Metal	20	New Plate reading: No loading Mon – Sat 7.00 – 10.00am Midday – 2.00pm 4.00 – 6.00pm	None	Remove and replace with a new loading plate

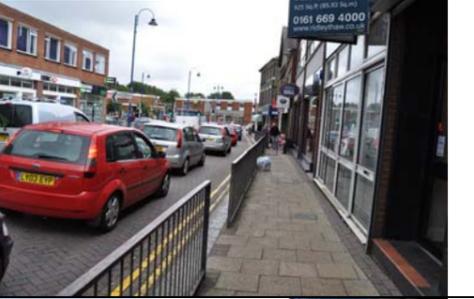
173	Guardrail	End of Guardrail	32m	As before	As before	As before	As before	As before	As before	As before	As before

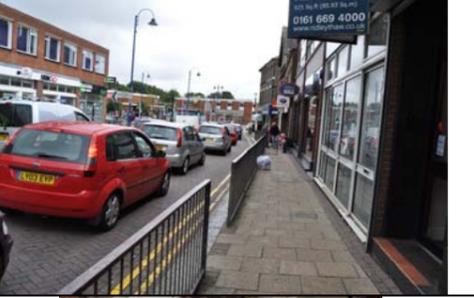
174.8	Guardrail	Start of guardrail	28m	Yes	Yes	Poor	Metal	N/A	None	None	Remove all Guardrail

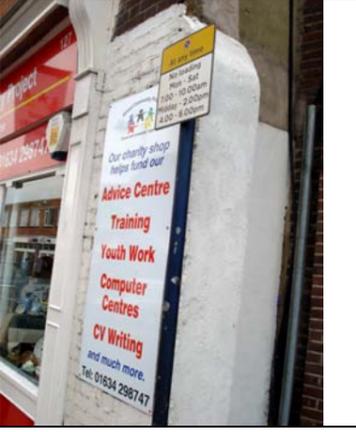
195.7	Loading Plate	'No loading at any time' plate on post	370 (h) 350 (w)	Yes	Yes	Adequate	Metal	20	New Plate reading: No loading Mon – Sat 7.00 – 10.00am Midday – 2.00pm 4.00 – 6.00pm	None	Remove and replace with a new loading plate

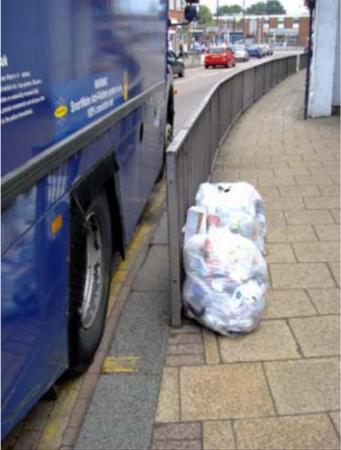
Chainage (m)	Street Furniture	Description	Size (mm)	Reduction Applicable	Legally Correct	Condition	Material	X Height (mm)	Additional restriction/furniture required?	Safety implications if removed	Recommendations/ reasons	Picture Reference
203.5	Guardrail	End of guardrail	28m	As before	As before	As before	As before	As before	As before	As before	As before

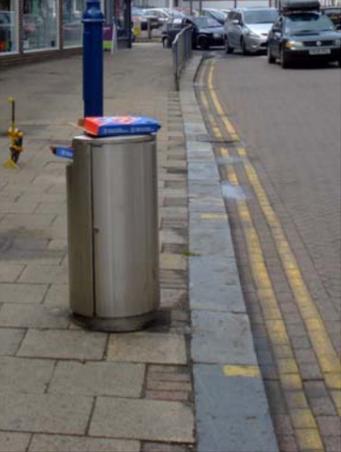
220.8	Litter Bin			No	Yes	Adequate	Metal	N/A	None	None	Keep and relocate on /C HKA 8

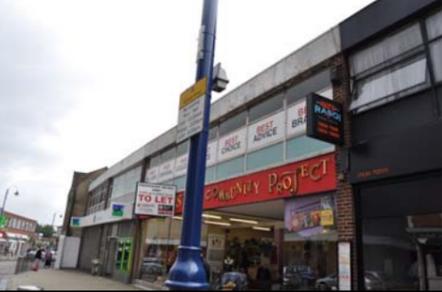
225.8	Loading Plate	'No loading at any time' plate on HKA 8	370 (h) 350 (w)	Yes	Yes	Adequate	Metal	20	New Plate reading: No loading Mon – Sat 7.00 – 10.00am Midday – 2.00pm 4.00 – 6.00pm	None	Remove and replace with a new loading plate

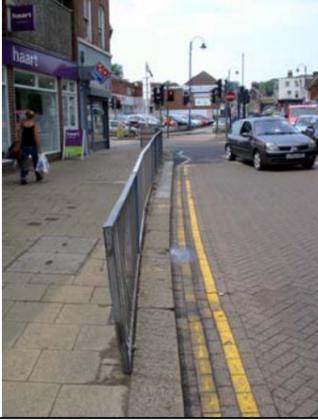
235.2	Guardrail	Start of guardrail	20m	Yes	Yes	Poor	Metal	N/A	None	None	Remove all guardrail

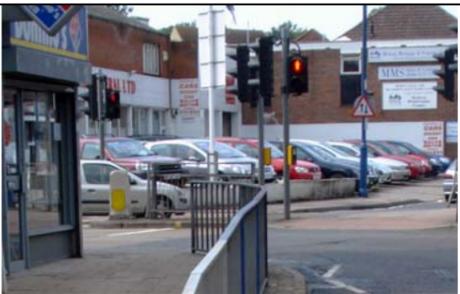
Chainage (m)	Street Furniture	Description	Size (mm)	Reduction Applicable	Legally Correct	Condition	Material	X Height (mm)	Additional restriction/furniture required?	Safety implications if removed	Recommendations/reasons	Picture Reference
255.5	Guardrail	End of guardrail	20m	As before	As before	As before	As before	As before	As before	As before	As before

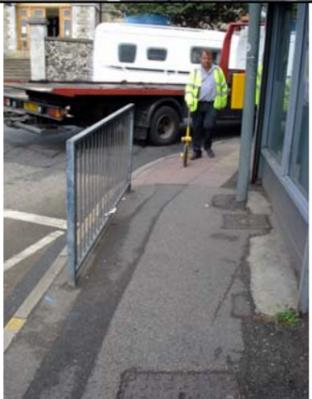
260	Guardrail	Start of guardrail	2m	Yes	Yes	Poor	Metal	N/A	None	None	Remove all guardrail

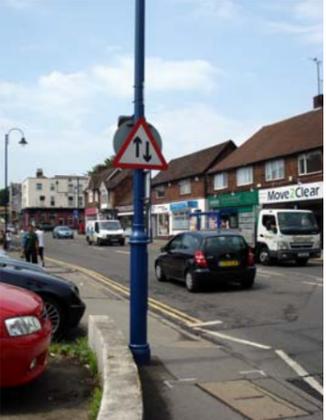
Chainage (m)	Street Furniture	Description	Size (mm)	Reduction Applicable	Legally Correct	Condition	Material	X Height (mm)	Additional restriction/furniture required?	Safety implications if removed	Recommendations/reasons	Picture Reference
286.2	Road Sign	Two direction warning sign on HKA 5		No	Yes	Adequate	Metal	N/A	None	None	Keep and light as principal route

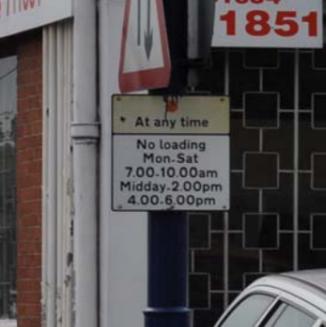
286.2	Loading Plate	'No loading at any time' plate on L/C HKA5	370 (h) 350 (w)	Yes	Yes	Adequate	Metal	20	New Plate reading: No loading Mon – Sat 7.00 – 10.00am Midday – 2.00pm 4.00 – 6.00pm	None	Remove and replace with a new loading plate

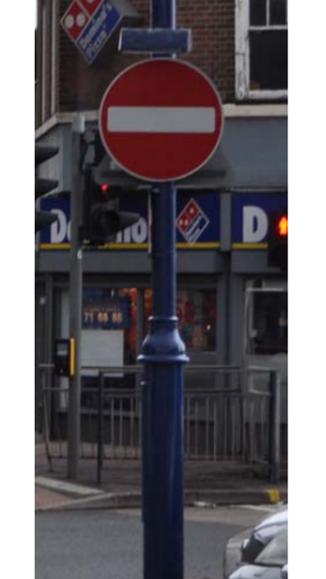
286.2	Road Sign	No Entry on HKA 5		No	Yes	Adequate	Metal	N/A	None	None	Keep

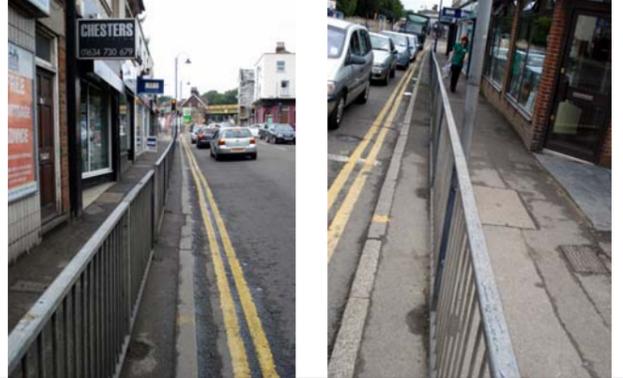
317.9	Guardrail	All Guardrail from 317.9 to the extent of Strood High Street		Yes	Yes	Poor	Metal	N/A	None	None	Remove all guardrail

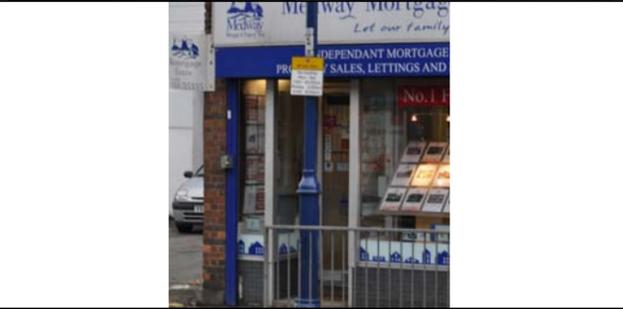
317.9	Loading Plate	'No loading at any time' plate on L/C HKA 3	370 (h) 350 (w)	Yes	Yes	Adequate	Metal	20	New Plate reading: No loading Mon – Sat 7.00 – 10.00am Midday – 2.00pm 4.00 – 6.00pm	None	Remove and replace with a new loading plate
