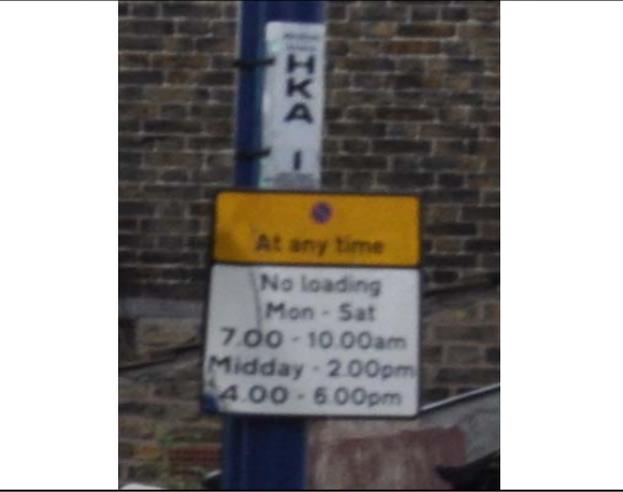
363	Loading Plate	'No loading at any time' plate on L/C HKA1	370 (h) 350 (w)	Yes	Yes	Adequate	Metal	20	New Plate reading: No loading Mon – Sat 7.00 – 10.00am Midday – 2.00pm 4.00 – 6.00pm	None	Remove and replace with a new loading plate

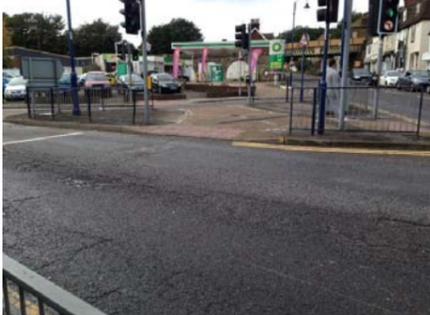
Road	Cuxton Road - Westbound											Date
0	Traffic Island	Guardrail	24m	Yes	Yes	Adequate	Metal	N/A	None	None	Remove all guardrail

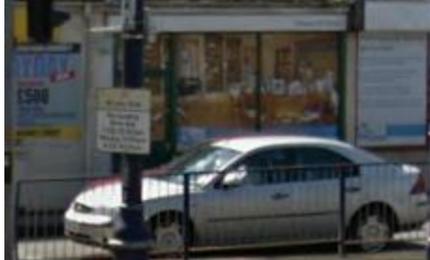
0	Loading Plate	No Loading at any time	370 350	Yes	Yes	Adequate	Metal	20	New Plate reading: No loading Mon – Sat 7.00 – 10.00am Midday – 2.00pm 4.00 – 6.00pm	None	Remove and replace with a new loading plate

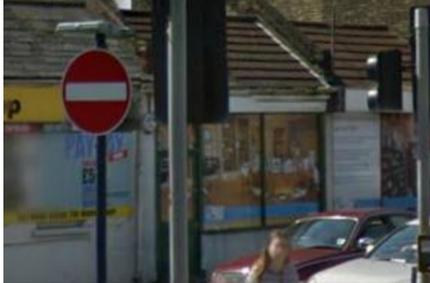
0	Sign	Regulatory No Entry	600	No	Yes	Adequate	Metal		None	Head on collisions	Retain

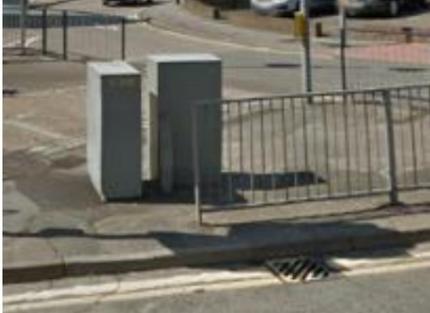
0	Street furniture	Signal cabinets									Relocate

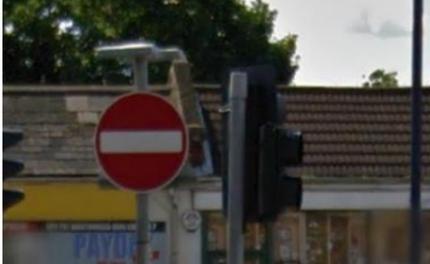
0	Sign	Regulatory No Entry	600	No	Yes	Adequate	Metal		None	Head on collisions	Retain

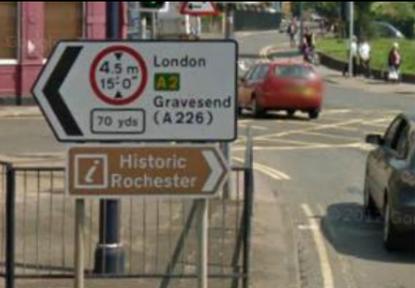
12	Sign	Tourist Directional Historic Rochester	1600 x 300	Yes		Adequate	Metal		None	None	Retain but reduce X height
